**VERIDIAN ON-SITE INADVERTENT DEPLOYMENT INVESTIGATION
VERIDIAN CASE NO. CA99-010
VEHICLE: 1997 JEEP CHEROKEE
LOCATION: MICHIGAN
CRASH DATE: MAY 1999**

1. <i>Report No.</i> CA99-010	2. <i>Government Accession No.</i>	3. <i>Recipient's Catalog No.</i>	
4. <i>Title and Subtitle</i> Veridian On-Site Inadvertent Deployment Investigation Vehicle: 1997 Jeep Cherokee Location: Michigan		5. <i>Report Date:</i> July, 1999

14. <i>Sponsoring Agency Code</i>	
15. <i>Supplementary Notes</i> On-site investigation of an alleged inadvertent air bag deployment.			
16. <i>Abstract</i> This on-site investigation focused on the driver's allegation of an inadvertent deployment of the frontal air bag system in a police 1997 Jeep Cherokee. The driver and passenger air bag system deployed as the driver was traveling on the inboard lane of a divided interstate roadway at an estimated speed of 120 km/h (75 mph). The driver brought the vehicle to a controlled stop on the inboard shoulder approximately 0.2-0.4 km (1/8-1/4 mile) beyond the deployment site. He complained of a superficial contusion of the right anterior forearm that resulted from air bag deployment. Although there was no damage to the body of

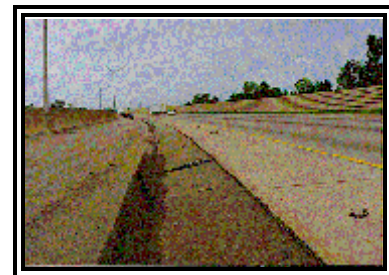
Figure 2. Northbound view of the left shoulder and tire fragments.

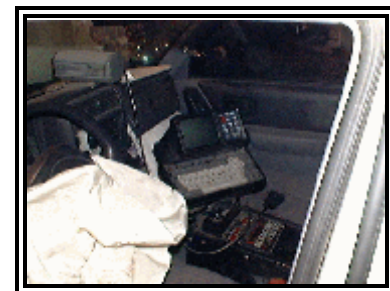
Figure 3. Deployed frontal air bags.

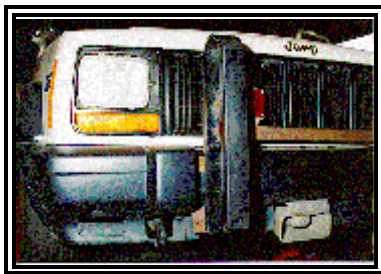
Exterior - The exterior of the Jeep Cherokee was free of impact damage (**Figure 4**) except for the minor rear left bumper corner damage that resulted from a front-to-rear crash that occurred approximately one month prior to this event (**Figure 5**). The surface of the vehicle was covered with a light layer of road film. None of the road film had been removed, thus supporting the lack of a minor crash that did not result in residual body damage. The front push bars were in good condition with no recent evidence of contact.

Figure 4. Front right view of the bumper area.

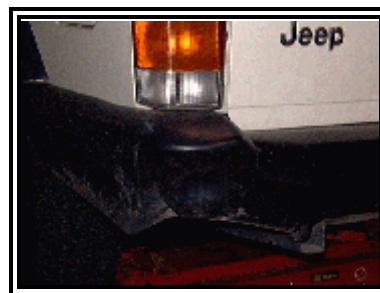
Figure 5. Previous damage to the rear left bumper corner.

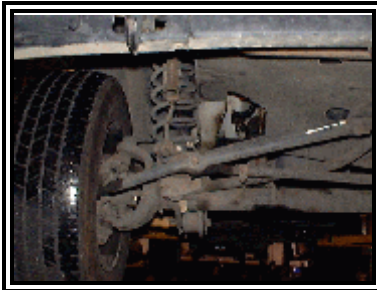
- C The bottom surface of the right tow hook that was mounted to the leading edge of the frame was abraded (**Figure 6**) with a 1.2 cm (0.5") wipe mark (area where the road film had been removed). This abrasion was free of rust and road film and appeared to be recent to the vehicle. The abrasion was extremely minor in severity.

Figure 6. Tow hook (top left) and front undercarriage components.

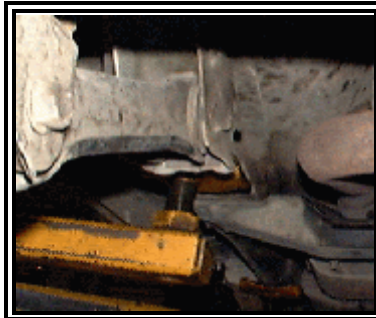
Figure 7. Wipe mark to the front right trailing arm.

- C The inboard bottom edge of the right trailing arm aft of the solid front axle was superficially contacted. A wipe mark that extended 43.2 cm (17.0") rearward of the front bushing appeared to be recent (**Figure 7**). There was no damage or abrasion to the painted surface associated with this contact point.

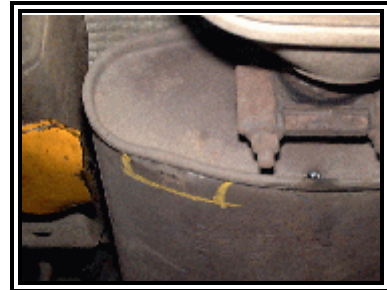
Figure 8. Abrasion to the muffler.

- C A superficial abrasion was noted to the bottom surface of the muffler (**Figure 8**). The abrasion was 1.9 cm (0.75") in width and approximately 0.9 cm (0.375") in length (longitudinal to the vehicle) and was located approximately 2.5 cm (1.0") rearward of the leading edge of the muffler. There was no dent associated with this abrasion. Again, the abrasion was free of rust which indicated it was recent to the vehicle.

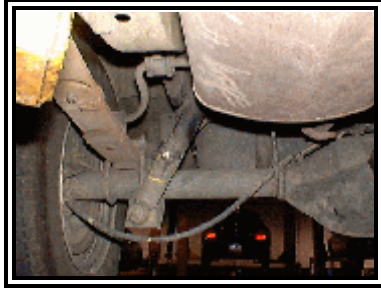
- C The most significant damage to the vehicle was located to the right rear shock absorber. The standard OEM-type shock was mounted forward of the rear axle and consisted of the lower hydraulic/gas unit and the top (female) shield that, when compressed, partially covered the lower unit. While on the lift, the shock was fully extended. A 4.4 cm (1.75") horizontal by 2.5 cm (1.0") vertically oriented dent with abrasion was noted to the lower unit of the shock (**Figure 9**). The dent was approximately 3.2 mm (0.125") in depth. A matching 1.9 x 4.4 cm (0.75 x 1.75") dent with abrasion was noted to the upper shield of the shock. A 14.6 cm (5.75") vertically oriented wipe mark surrounded this abrasion/dent (**Figure 10**). The shock damage appeared to be recent to the vehicle.

Figure 9. Dent to the lower unit of the right rear shock.

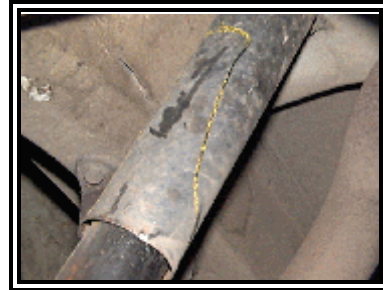
Figure 10. Dent and wipe mark to the upper shield of the shock absorber.

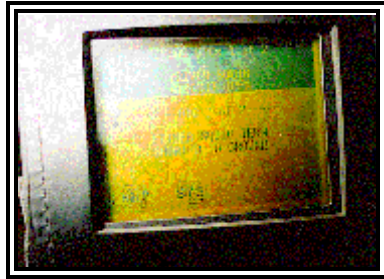
- Ⓒ 1st Test - Body Module Results - None.
- Ⓒ 2nd Test - Engine Results - No DTC's detected, 6 engine starts.
- Ⓒ Air Bag Test Results - **Active** - Driver Squib Circuit Open. Either Squib Terminal Shorted to Ground (**Figure 11**)

Figure 11. Active codes of the BRB II readout.

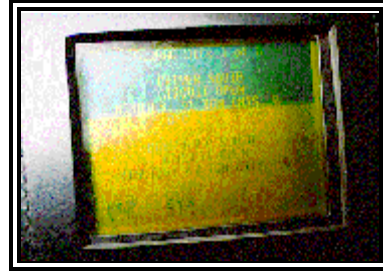
Stored- Driver Squib Circuit Open, Minutes 91, Ignition Counts 0 (**Figure 12**)

Passenger Squib Open, Minutes 47, Ignition Counts 15 (**Figure 12**)

Figure 12. Stored codes of the DRB II readout.

The stored fault codes do not appear to be consistent. That is, the number of minutes and the ignition cycles recorded by the control module for the driver and passenger air bag squibs varied by 44 minutes and 15 cycles. This issue needs to be further researched through Chrysler for interpretation of the data.
