On-scene Investigation / Vehicle to Vehicle
Dynamic Science, Inc. / Case Number: DS99015
1998 Chevrolet Blazer
Arizona
January 1999

| 4. Title and Subtitle In-Depth Accident Investigation | | | | 5. Report Date April 23, 1999 | |

Dynamic Science, Inc.
Accident Investigation
Case Number: DS99015

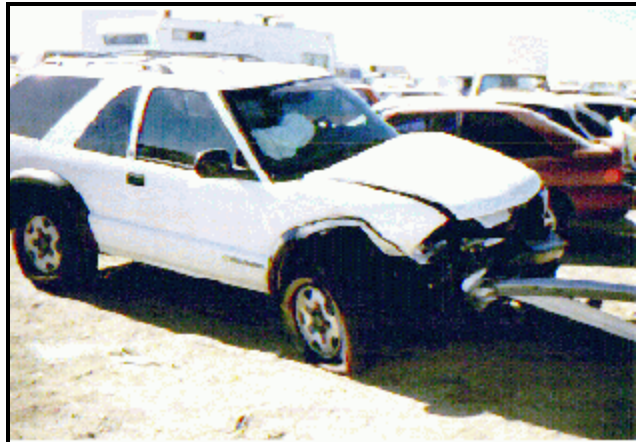
Figure 1. Exterior, case vehicle

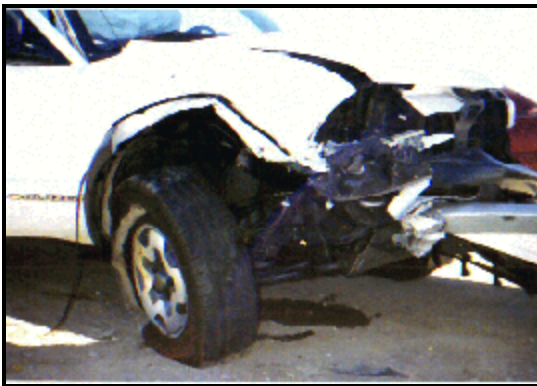
| Damage Description: | Moderate front to rear crush on right front corner. Wheelbase likely shortened. | |

Figure 6. Close up of damage

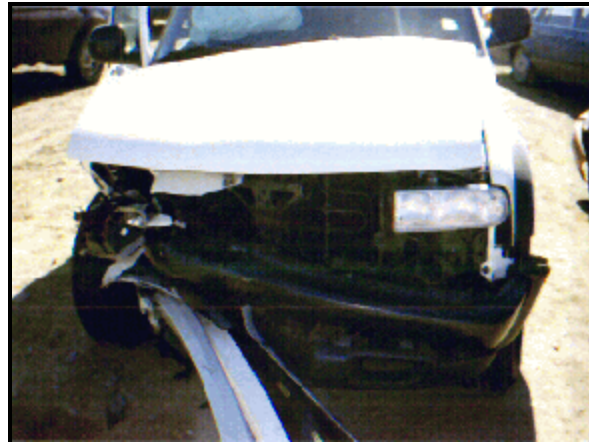
Figure 5. Exterior, case vehicle (front view)

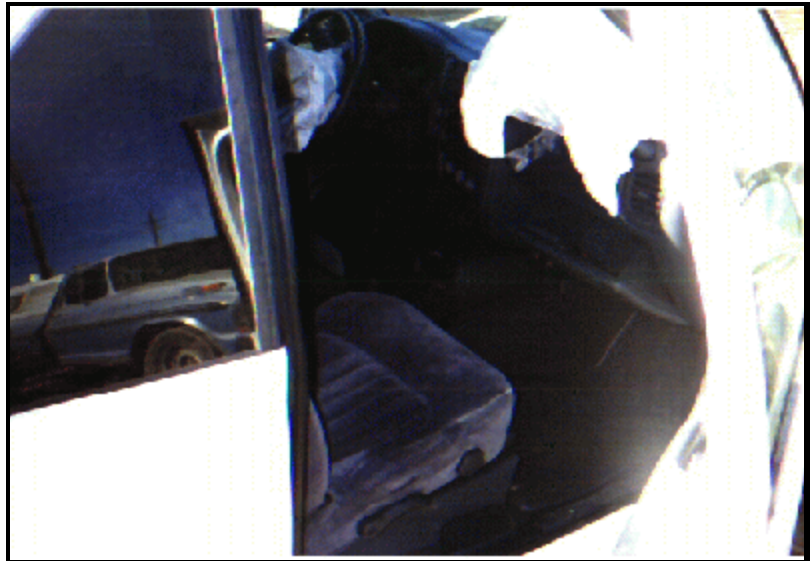
The front right occupant of the case vehicle was seated in an upright manner, with the lap and shoulder belt on, facing towards the center of the vehicle. As the driver of the case vehicle began braking, the front right occupant began moving forward. She likely began loading the lap portion of the belt with her abdomen. Both knees engaged the lower instrument panel. At impact, the passenger side air bag deployed and this occupant continued moving forward and to the right. This occupant sustained bilateral upper chest contusions which appear to have been caused by the deploying air bag. The placental abruption seems to have been caused by seat belt loading and possibly some response to her eventual movement to the right. Given that there were visible contusions to her upper chest, and none to her abdomen, it would seem likely that the air bag was not involved to any great extent.

Figure 6. Right front seat position
