REMOTE AIR BAG DEPLOYMENT REPORT

CASE NUMBER - IN99-016
LOCATION - COLORADO
VEHICLE - 1998 TOYOTA CAMRY LE
CRASH DATE - June 1998

1. <i>Report No.</i> IN99-016		2. <i>Government Accession No.</i>		3. <i>Recipient's Catalog No.</i>	
4. <i>Title and Subtitle</i> Remote Air Bag Deployment Investigation Vehicle - 1998 Toyota Camry LE Location - Colorado			5. <i>Report Date:</i> August 2, 1999

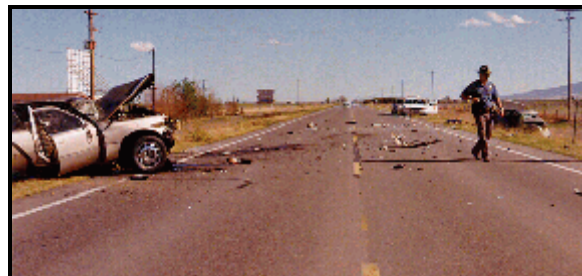
The case vehicle (vehicle #2) was traveling south in the southbound lane of a two-lane, undivided, U.S. highway (**Figure 1**) and, presumably, intended to continue in her southward path of travel. Vehicle #1 was traveling north in the northbound lane of the same U.S. roadway, most likely intending to continue northward. It was daylight, and there was no adverse weather. The roadway was bituminous, dry, straight, and level. Posted speed limit was 105 km.p.h. (65 m.p.h.), and the travel speed for each involved vehicle was estimated by investigating officers to be the same [i.e., 105 km.p.h. (65 m.p.h.)]. The only traffic control devices present were a single broken yellow centerline and a single solid white edge line on each side of the pavement. All were clearly visible. There were no crash avoidance maneuvers visible in police photographs or reported for either vehicle by investigating officers. The crash occurred in the southbound lane of the roadway.

Figure 1: Case vehicle's southbound travel path showing absence of pre-impact braking marks; Note: case vehicle off road to right of Trooper, vehicle #1 off road to left (case photo #01)

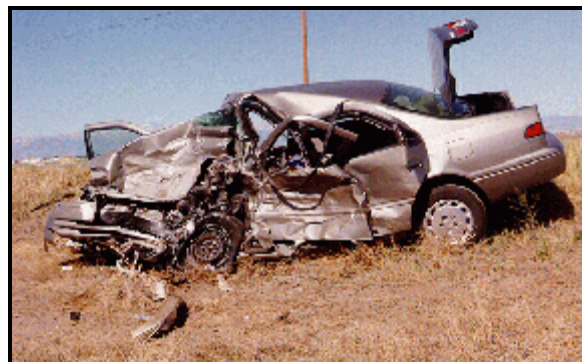
The left two-thirds of the case vehicle's frontal plane was impacted by the front of vehicle #1 (**Figure 2**), causing the case vehicle's driver and front right passenger air bags to deploy. The case vehicle rotated approximately 210 degrees counterclockwise and its center of gravity traveled south-southwestward off the west pavement edge, across the asphalt shoulder, and down a slight embankment--a distance of nearly 8.5 meters (28 feet). The case vehicle was facing north-northwestward at final rest. Vehicle #1 also began a

Figure 2: Case vehicle's frontal and left side direct damage; Note: post-crash location of left front wheel and upper/lower "A"-pillar (case photo #10)

Interior damage to the case vehicle was difficult to assess with the available photographs. The driver’s seating area was reduced by intrusion of the left side of the instrument panel, steering wheel and column, windshield, left front door panel, and the left roof rail and roof (**Figure 2** above). The driver’s seat was also displaced rearward. The steering column and wheel were relocated rearward and downward from their original positions.

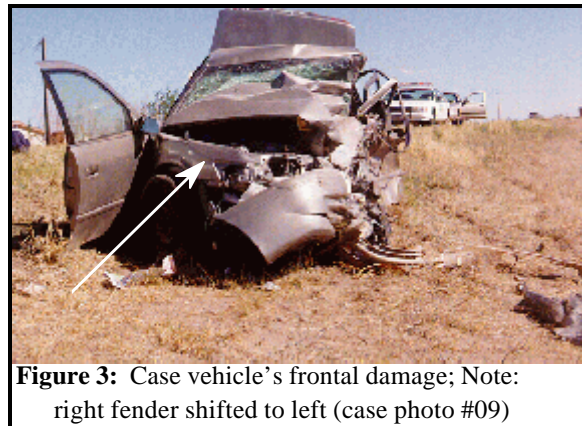
The case vehicle sustained direct contact damage to the left two-thirds of the front (**Figure 3**). Damaged components included: the left two-thirds of the **front fascia** (torn off); the **front bumper** (shoved rearward); **front splash pan** (pushed rearward); **grille**, **engine** compartment front **brackets**, and **radiator** (crushed rearward); **right fender** (pulled leftward); **front headlamp assemblies** (shattered); **hood** (pressed downward onto engine and the rear edge rippled and thrust into the windshield); **left fender** (shoved into the cowl and lower left “A”-pillar); **left front tire and wheel** (crushed rearward into lower “A”-pillar and top of tire tilted inwards at a 30-degree angle); **left “A”-pillar** (lower and upper shoved into a near vertical line); **left side roof** and **roof rail** (buckled at the upper “B”-pillar); **windshield**-in front of the driver’s position, holed and extensively cracked (the left rear portion of the hood penetrated it); **left front door** (forward portion of door panel penetrated the driver’s compartment; top of the door frame pulled outward at a 45 degree angle); and both **left front and left rear door glazings** [shattered (“kernelized”)]. Based on the police photographs, the CDC for the case vehicle was estimated as: **12-FYAW-6 (-10)**. The WinSMASH reconstruction program, CDC-only algorithm, provided a borderline reconstruction, but the results appear reasonable. The case vehicle’s estimated Total, Longitudinal, and Lateral Delta Vs are, respectively: 95.5 km.p.h. (59.3 m.p.h.), -94.0 km.p.h. (-58.4 m.p.h.), and 16.6 km.p.h. (10.3 m.p.h.).

Figure 3: Case vehicle’s frontal damage; Note: right fender shifted to left (case photo #09)

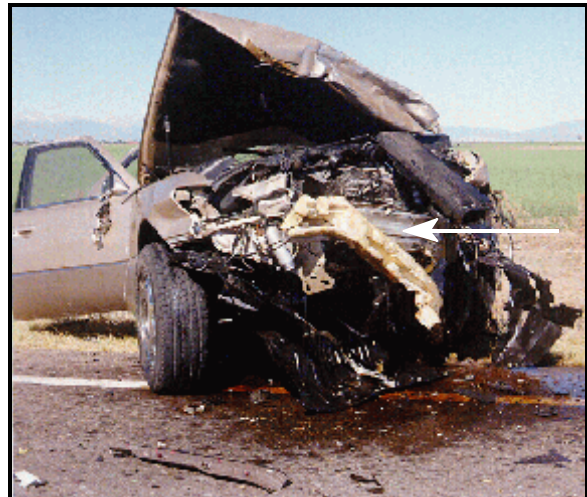
Figure 4: Vehicle #1's damaged frontal plane; Note: vertical bumper shift from impact with case vehicle (case photo #14)

engine (pushed into the cowl), and **cowl** (shoved into the passenger compartment). Based on the available police photographs, the CDCs for vehicle #1's two impacts were: **12-FYEW-5** and **00-TDDO-3** (**Figures 4** and **5**). Vehicle #1's driver [70-year-old female--race, Hispanic origin, height, and weight unknown] was wearing her available, active, three-point, lap and shoulder safety belt system. She was the only occupant in vehicle #1. Her pre-crash seat adjustments, steering wheel position, and posture are not known. She was pronounced dead at the scene and transported to a funeral home.

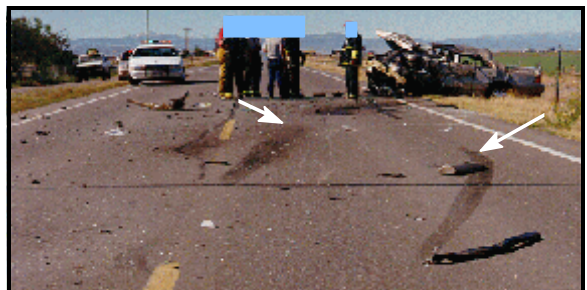
post-impact counterclockwise rotation as well, traveling 9.2 meters (30.2 feet) before initiating a 360 degree rollover (i.e., four ¼ turns) about its longitudinal axis. Vehicle #1 traveled an additional 10.8 meters (35.5 feet) in a north-northeasterly direction during its rollover and came to rest on its wheels facing west, with its damaged frontal plane on the east edge line and its rear on the east roadside (**Figure 1** above). The crash severity for the case vehicle was high [greater than 40 km.p.h. (25 m.p.h.)].

Figure 5: Vehicle #1's post-impact travel path; Note: right front and right rear tire trip points for vehicle’s rollover (case photo #07)
