## REMOTE AIR BAG DEPLOYMENT REPORT

CASE NUMBER - IN99-017

LOCATION - Florida

VEHICLE - 1998 BUICK CENTURY

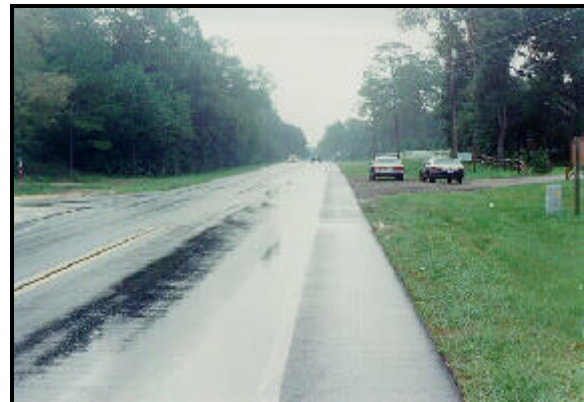
**Figure 1:** Vehicle #2's east-bound approach; case vehicle emerges from gravel drive on right (case photo #01)

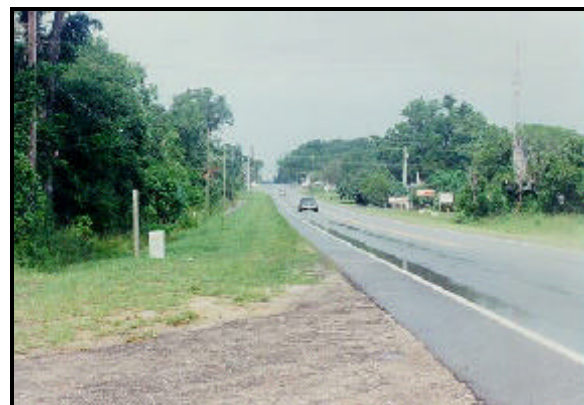
**Figure 2:** Case vehicle driver's view of eastbound traffic and intended left turn, looking west from mouth of driveway (case photo #02)

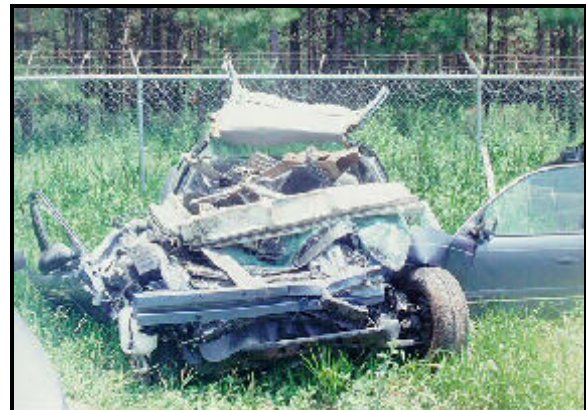
The front of vehicle #2 overrode the front of the case vehicle, with direct contact to the case vehicle's bumper limited to the front left corner area where vehicle #2's front right wheel pushed the case vehicle's frontal components back to the axle (**Figure 3**). The right two-thirds of vehicle #2's front bumper penetrated into the case vehicle's engine compartment, buckling the hood and causing extensive induced damage to the case vehicle's right side. In addition, the case vehicle's instrument panel intruded into the passenger cabin across the entire front seat row, with the steering column jammed against the front edge of the driver's seat cushion and the steering wheel rim almost entirely collapsed (**Figure 4**). The available photographs show that the damage to the case vehicle was altered to permit extrication of the driver, and there is crash debris stacked in the interior. The floor and toe pan are not visible in the available photographs. The CDC for the case vehicle, estimated from photographs, is **12-FDEW-5** with principal direction of force 350 (-10) degrees. This collision is out-of-scope for the WinSMASH reconstruction program and Delta V was not calculated. The crash severity for the case vehicle was high [greater than 40 km.p.h. (25 m.p.h.)]. The crash was virtually unsurvivable for a front row occupant of the case vehicle.

**Figure 3:** Front of case vehicle, with A- and B-pillars cut, roof peeled back and debris piled on (case photo #9)

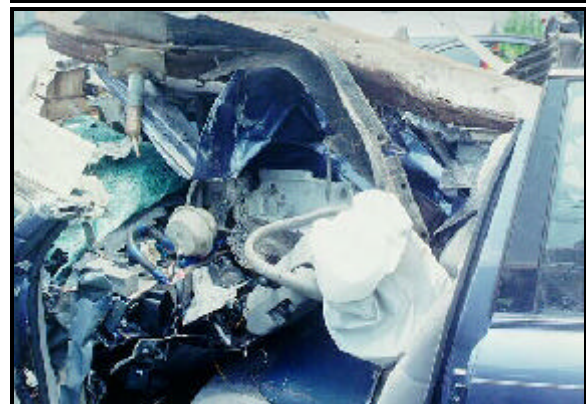
**Figure 4:** Case vehicle driver seat area; Note, deformed and intruded steering assembly and instrument panel (case photo #11)

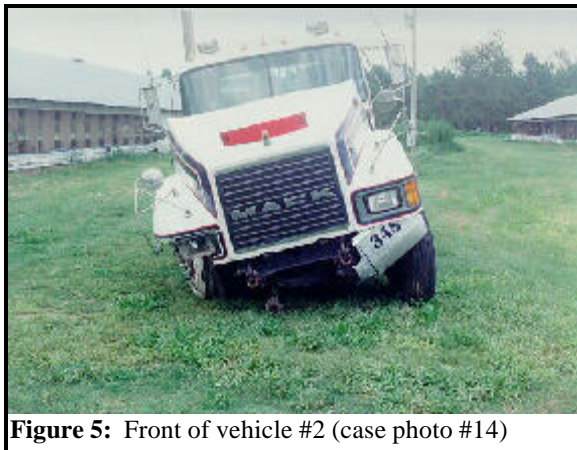
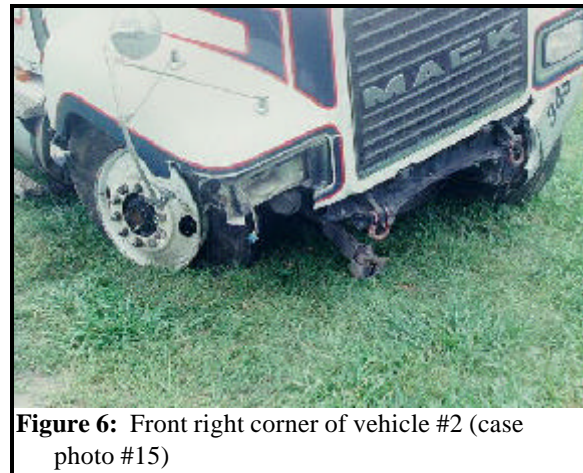
Vehicle #2 was a 1996 Mack model CH613 cab-over-engine 6x4 truck-tractor (VIN: 1M1AA13Y3TW-----) that was towing a semi-trailer. Vehicle #2 was towed from the scene due to disabling damage. The TDC for vehicle #2's impact with the case vehicle, estimated from photographs, is **12-FZEW-2**. The driver [44-year-old male; race, ethnicity, height and weight unknown] sustained police-reported possible injuries. There was no other occupant in vehicle #2.
