On-scene Investigation / Vehicle to Vehicle
Dynamic Science, Inc. / Case Number: DS99017
1999 BMW
Arizona
February 1999

1. Report No. DS99017		2. Government Accession No.		3. Recipient Catalog No.	
4. Title and Subtitle In-Depth Accident Investigation				5. Report Date	
				6. Performing Organization Report No.

Description: This case was initiated in response to a report of a side air bag deployment in a 1999 BMW 3 series four-door sedan.

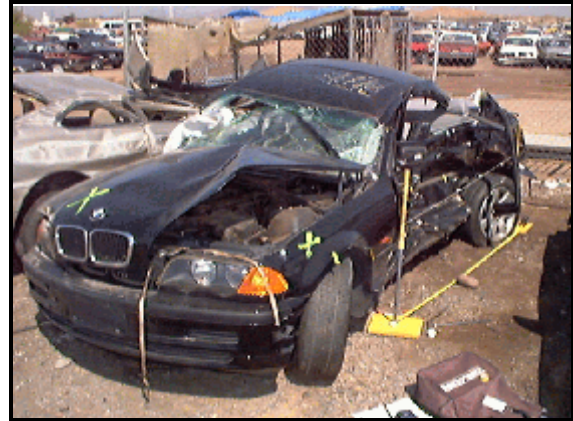
Figure 3. Exterior, front left, Vehicle 1

Vehicle 1 sustained extensive damage to the rear, the left side, and the right side. There was 36 cm (14 in.) of intrusion through the driver's side door. The intrusion was mostly lateral, but there was a longitudinal component also. The driver's seat was forced to the right and rearward into the rear seat area. There was also intrusion of the B-pillar, A-pillar, door sill, and instrument panel. As stated earlier, the driver was entrapped and needed to be extricated by emergency personnel. The roof was cut off by emergency personnel. The ITS deployed, but was cut away also by emergency personnel.

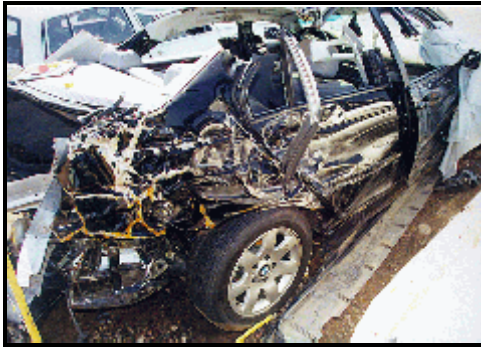
Figure 10. Exterior, Vehicle 1 (right rear)

Description:	1999 BMW 323i four-door sedan	
VIN:	WBAAM334XFPXXXXX	
Odometer:	Unknown	
Engine:	2.3 L	
Reported Defects:	None	
Cargo:	None	
Damage Description:	Extensive lateral crush through the left side. Both left side doors were jammed and the side glass disintegrated. Moderate right side damage extending from the front door to the rear of the vehicle. Major damage to rear of vehicle. All pillars were cut and the roof removed to extricate the single occupant.	
CDC:	Impact #1: 06BZEW3 Impact #2: 12RZEW2 Impact #3: 09LZAW3 Impact #4: Unknown	
Delta V (Impact #1):	Total	33.4 km/h (20.7 mph)
	Longitudinal	33.4 km/h (20.7 mph)
	Lateral	0 km/h (0 km/h)
	Energy	40,160 joules (29,638 ft-lbs)
Delta V (Impact #3):	Total	45.0 km/h (28.0 mph)
	Longitudinal	7.8 km/h (4.9 mph)
	Latitudinal	44.3 km/h (27.58 mph)
	Energy	92,528 joules (68,245 ft-lbs)

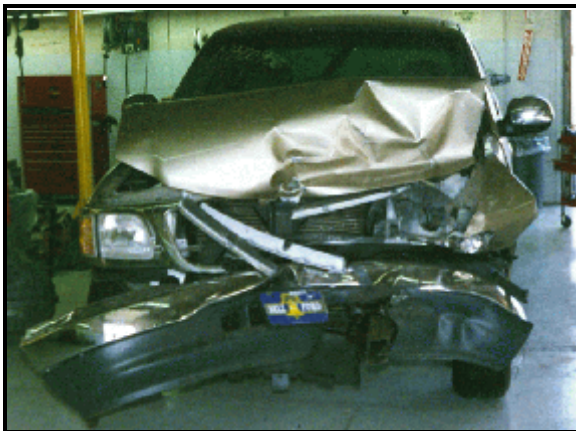
Figure 12. Exterior, Vehicle 2 (front)

Damage Description: Heavy front to rear crush beginning at the left front bumper corner and extending to the middle of the vehicle.

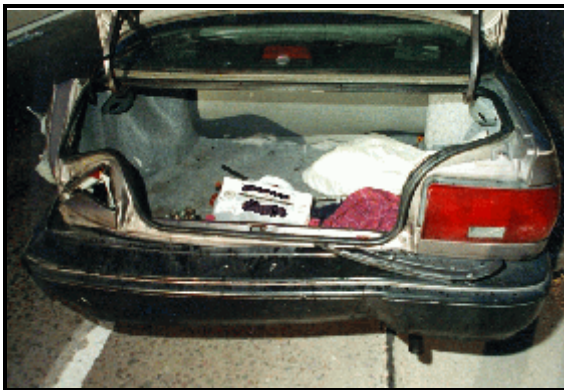
Figure 14. Exterior, Vehicle 3 (rear)

Description:	1991 Geo Prism four door sedan	
VIN:	1Y1SK546XMZxxxxxx	
Odometer:	Unknown	
Engine:	1.6 L L4	
Reported Defects:	None noted	
Cargo:	Unknown	
Damage Description:	Minor bumper crush to left rear bumper corner.	
CDC:	Impact 2: 06BLEE3	
Delta V:	Total	Unknown
	Longitudinal	Unknown
	Latitudinal	Unknown
	Energy	Unknown

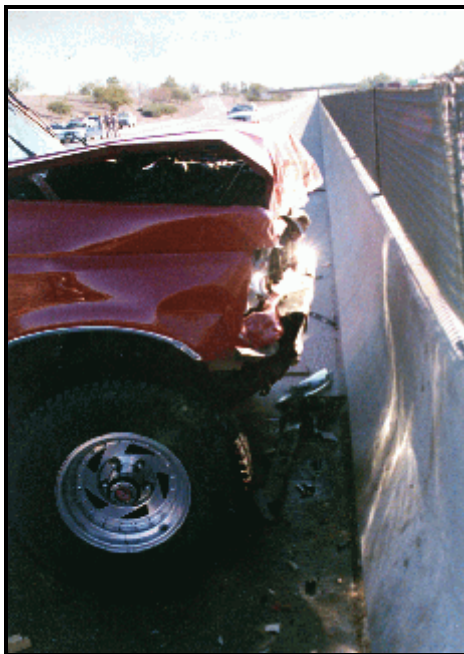
Damage Description: Moderate front bumper crush with some shifting to the left.

Figure 17. Exterior, Vehicle 4 (right side). Note the lack of contact to the barrier.

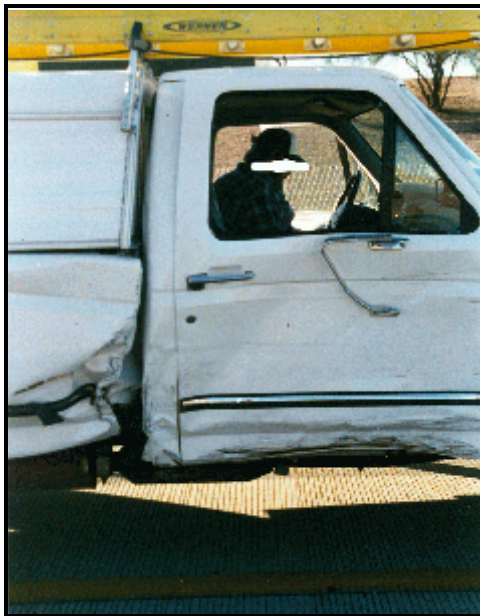
Figure 21. Exterior, Vehicle 5 (right side)

Description: 1997 Ford F250 4x2 regular cab pickup
 VIN: 1FTHF25G3VEBxxxxxx
 Odometer: Unknown
 Engine: 7.5 l EFI V8
 Reported Defects: None noted
 Cargo: Carrying camper shell. Unknown additional weight.
 Damage Description: Moderate front to rear crush at mid-door level and at frame rail level.
 CDC: Impact 4: 01RDEW2
 Delta V: Total Unknown
 Longitudinal Unknown
 Latitudinal Unknown
 Energy Unknown

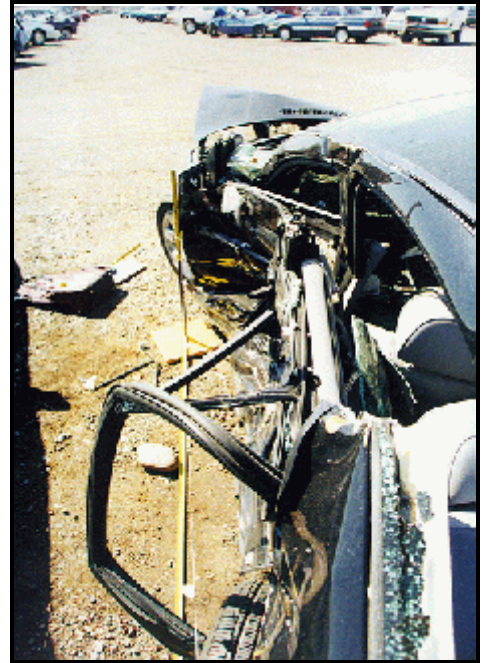
The driver of Vehicle 1 was seated in a normal, upright fashion. She was wearing the available lap and shoulder belt. Her right foot was on the brake and the vehicle was either stopped or slowing. Vehicle 2 struck Vehicle 1 directly from behind. The driver of Vehicle 1 reacted to the 180 degree direction of force by moving rearward into the rear seat back. Vehicle 1 was accelerated forward and to the left and engaged the left rear of Vehicle 3. The driver of Vehicle 1 reacted to this moderate longitudinal impact by moving forward and to the right, possibly loading the lap and shoulder belt to some extent. As Vehicle 1 continued its path across the freeway, it was struck in the left side by Vehicle 4. This was a significant impact and the door mounted left side air bag deployed, as did the left side ITS. The driver reacted to the 260 degree direction of force by moving sharply to the left and striking the intruding left side door surface. Any protection offered by the side air bag was likely offset by the extensive intrusion. All the major torso and abdominal injuries were as a result of the door contact. The ITS had been cut out during extrication. It appears likely, however, that the ITS provided some measure of head protection since there were no reported major head injuries. The driver was entrapped in the vehicle following the left side impact. Vehicle 1 continued on into the next lane and struck the right side of Vehicle 5. The driver did not react much to this collision—she was entrapped to some degree and was likely unconscious. The driver was extricated from the vehicle after the roof was removed by cutting the pillars.

Figure 22. Left side of vehicle showing intruding components

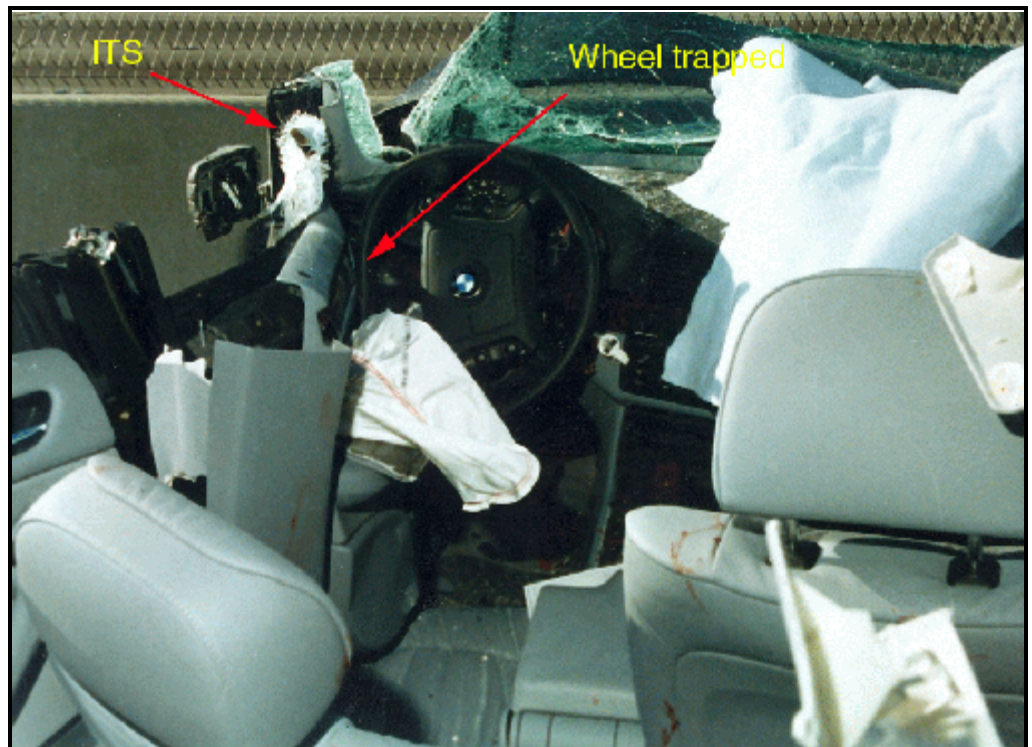
Figure 23. Shows ITS and left side air bag
