On-scene Investigation / Vehicle to Vehicle
Dynamic Science, Inc. / Case Number: DS99018
1995 Ford Aspire
Washington
March 1999

1. Report No. DS99018		2. Government Accession No.		3. Recipient Catalog No.	
4. Title and Subtitle In-Depth Accident Investigation				5. Report Date	
				6. Performing Organization Report No.

Dynamic Science, Inc.
Accident Investigation
Case Number: DS99018

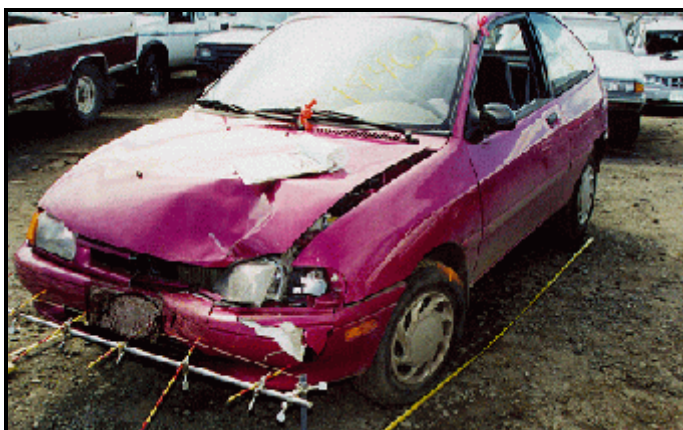
Figure 1. Exterior, case vehicle

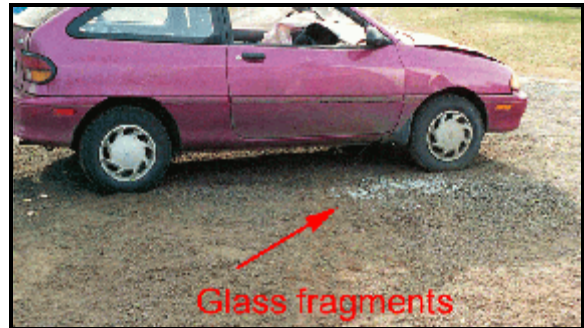
Figure 2. Side glass broken by front right occupant

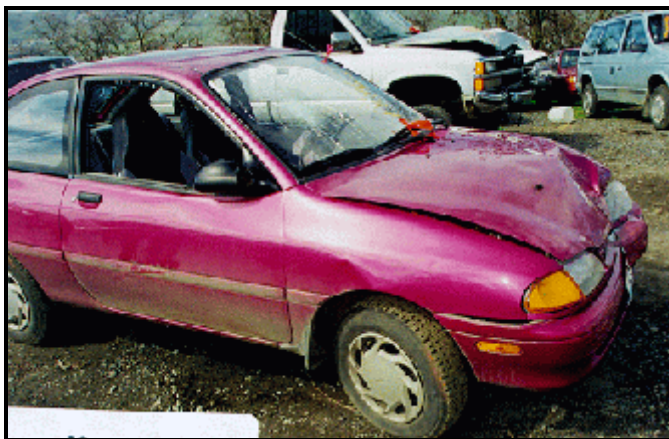
Description:	1995 Ford (Kia Motors, Inc.) Aspire two-door hatchback	
VIN:	KNJLT05H8S6xxxxxx	
Odometer:	98,540 km (61,232 miles)	
Engine:	1.3 L	
Reported Defects:	None noted	
Cargo:	None	
Damage Description:	Moderate rearward crush to entire front bumper, passenger side window disintegrated, “star” impact to windshield.	
CDC:	11FDEW1	
Delta V:	Total	17.2 km/h (10.7 mph)
	Longitudinal	-16.2 km/h (-10.1 mph)
	Latitudinal	5.9 km/h (3.7 mph)
	Energy	11,433 joules (8,438 ft-lbs)

Figure 5. Exterior, case vehicle

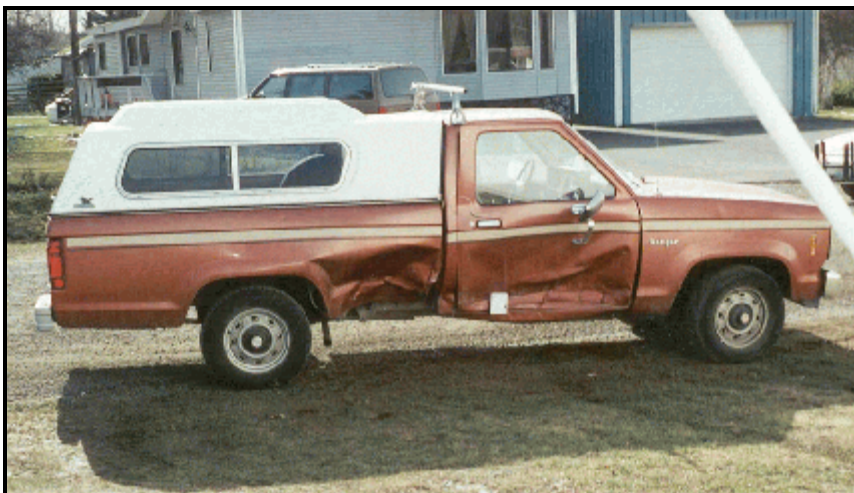
Description: 1983 Ford Ranger 4 x 2 regular cab pickup truck
VIN: 1FTBR10A6DUxxxxx
Odometer: Unknown
Engine: 2.3L 4 CYL
Reported Defects: None noted
Cargo: Camper shell, roof rack.
Damage Description: Moderate lateral damage to right of vehicle.
CDC: 02RYEW3
Delta V:
Total 11.4 km/h (7.1 mph)
Longitudinal -3.9 km/h (-2.4 mph)
Latitudinal -10.7 km/h (-6.6 mph)
Energy 9,693 joules
(7,159 ft-lbs)

Figure 6. Exterior, other vehicle

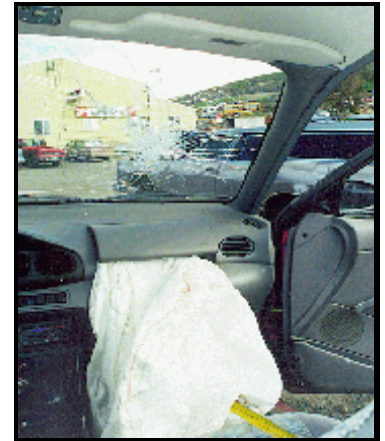
Figure 7. Front right seat position, front view

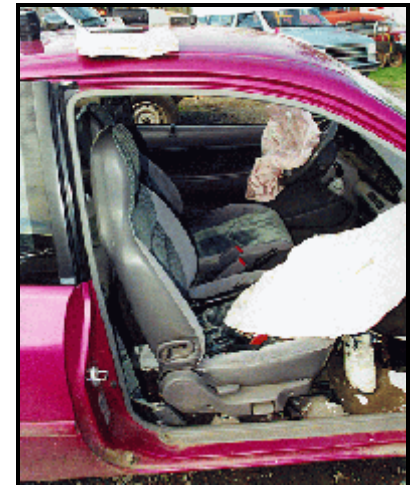
Figure 8. Front right seat, side view

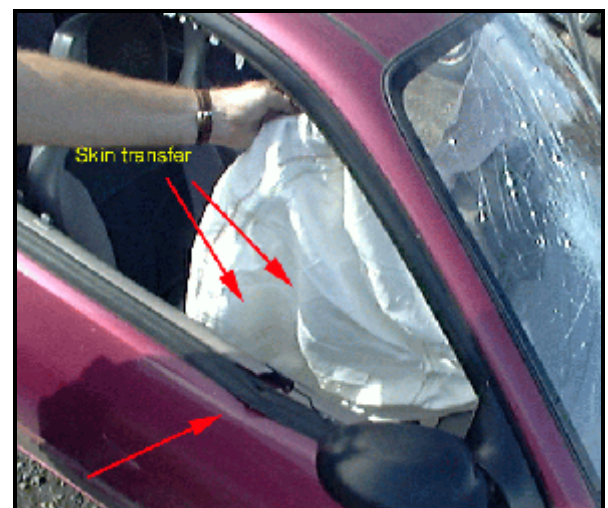
At impact, the occupant was forward of the seat and her head was nearly level with the instrument panel. As the air bag deployed, the right side of the air bag struck the left side of this occupant's face—causing the facial abrasions. There were two areas of skin transfer to the right side of the passenger side air bag measuring 13 cm (5.1 in.) longitudinally for the upper one and 28 cm (11.0 in.) longitudinally for the lower one. The occupant's head was forced sharply to the right where it struck the side glass and the lower window frame—causing the jaw fracture. The plastic fascia covering the frame was broken and the side glass disintegrated. The investigating officer stated that he found hair from the occupant in the plastic fascia. The movement to the right and the rotation about the frame likely caused the subluxation injury.

Figure 9. Interior, case vehicle—air bag / side glass frame interaction

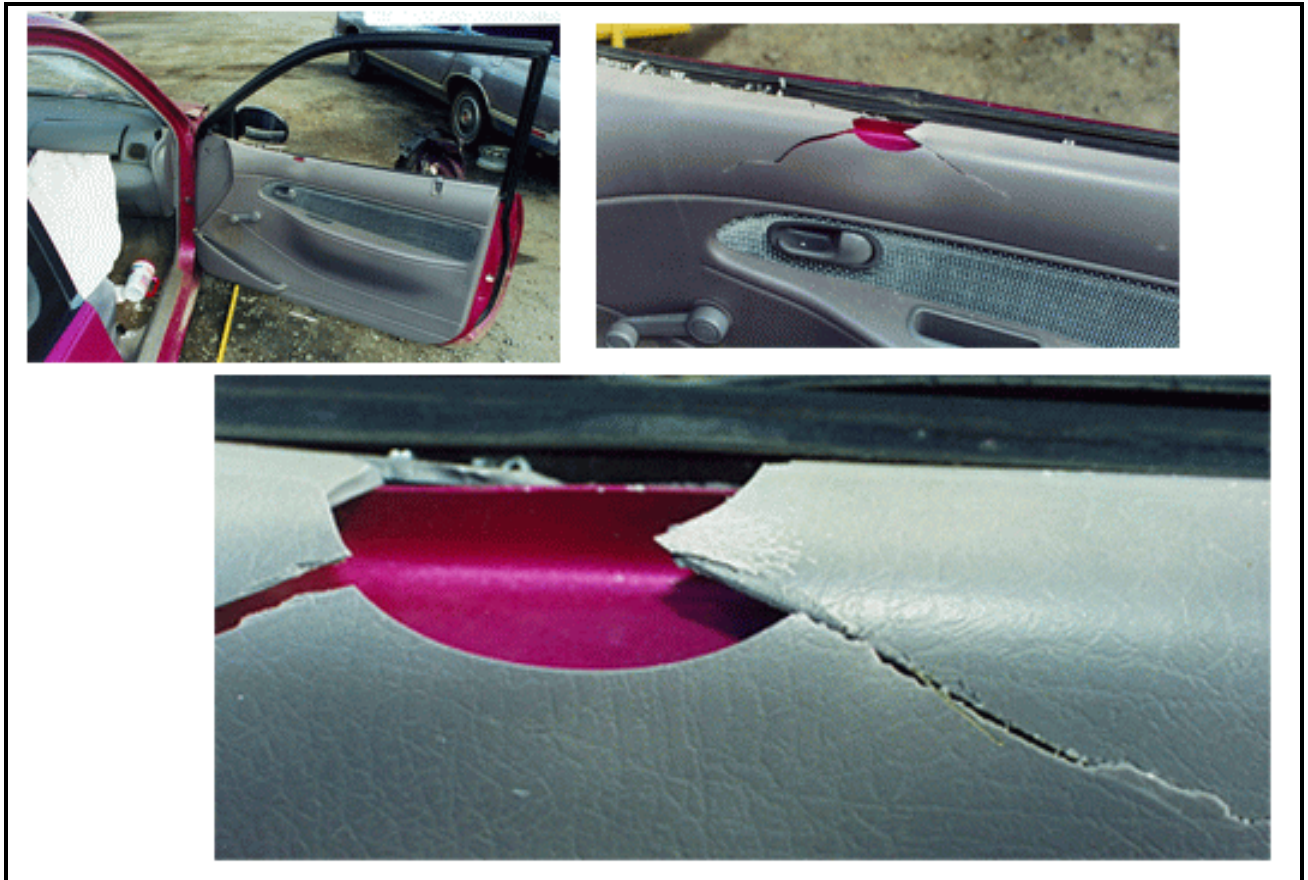
Figure 10. Side glass frame/door contact

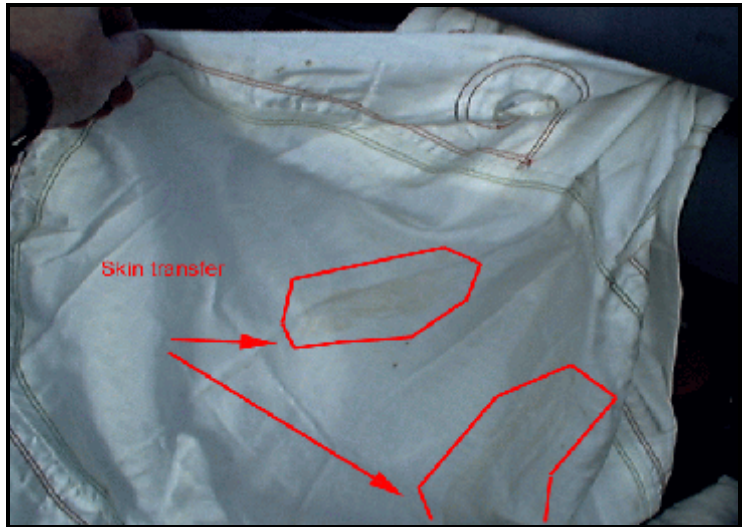
Figure 11. Close-up of skin transfers to right side of passenger air bag
