**ONSITE SIDE IMPACT OCCUPANT PROTECTION INVESTIGATION**

**VERIDIAN CASE NO: CA99-019**

**VEHICLE: 1998 MERCEDES BENZ C280**

**CRASH DATE: JUNE, 1999**

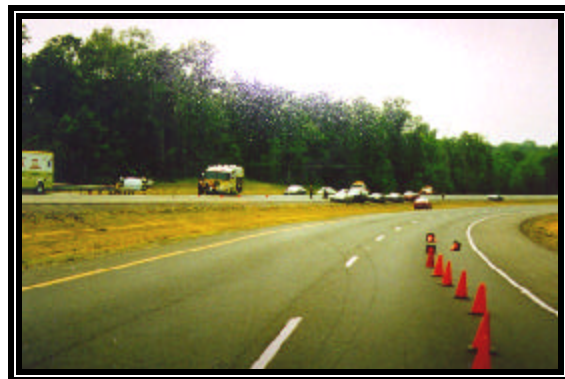
This single vehicle crash occurred during the daylight hours in June, 1999. At the time of the crash, it was daylight and the weather was not a factor. At the crash scene, the roadway was a four-lane north/south divided state route. A depressed grass median (Vee shaped cross-section) approximately 13 m (40 ft) wide separated the northbound and southbound lanes. There was a sweeping right curve and negative grade for the northbound traffic. The measured radius of the curve was approximately 335 m (1,100 ft). The northbound grade was an estimated -5%. The speed limit in the area of the crash was 89 km/h (55 mph). **Figure 1** is a northbound trajectory view at the crash scene taken during the police investigation.

**Figure 1:** On-scene trajectory view of the Mercedes.

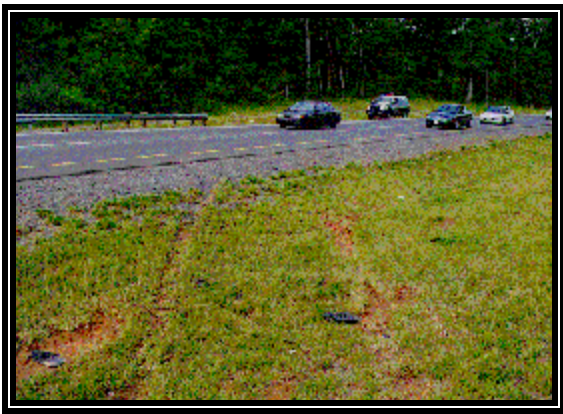
The Mercedes departed the northbound lanes in a counterclockwise yaw. Upon entering the median, the vehicle had rotated approximately 145 degrees (relative to its initial direction of travel). The vehicle's rotation diminished as it traversed an angled trajectory through the depressed median. Two tire tracks through the median were identified during the scene inspection. The nature of the tracks indicated the Mercedes was sliding laterally, **Figure 2**. As the vehicle began traveling up the median's back slope, its left side tires began to lift. The vehicle entered the southbound lanes of the roadway with the right side rims impacting the raised pavement edge. The Emergency Tensioning Retractors (ETR) (i.e. seat belt pretensioner) may have been activated by this impact. The impact also tripped the Mercedes and initiated a right side leading lateral roll. Two impacts to the pavement edge were identified by the police and SCI scene inspections, **Figure 3**. The vehicle was traveling approximately 64 km/h (40 mph) at the initiation of the tripped rollover.

**Figure 2:** View of the marks through the median.

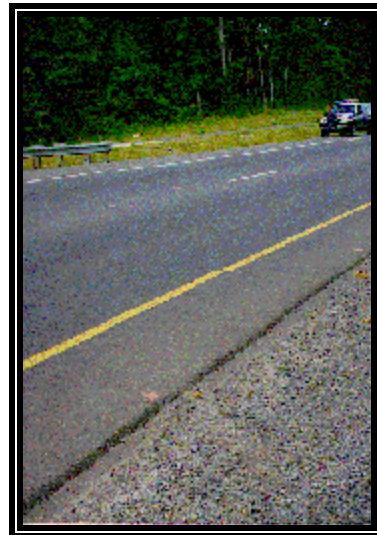
**Figure 3:** View of the rim impacts to the pavement edge.

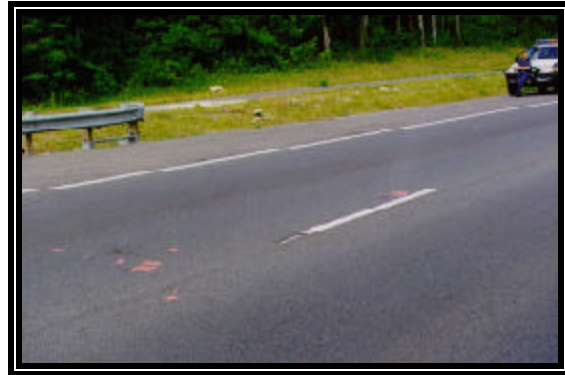
The Mercedes vaulted and rolled approximately 2 quarter turns (180 degrees) and impacted the pavement with the left front corner of the roof. The roof crushed down impacting the driver's head and resulted in the driver's fatal closed head injury. The vehicle then rolled 1 quarter turn (270 degrees total) with the left side rims impacting the pavement immediately outboard of the southbound centerline. Two rim gouges identified this impact, **Figure 4**. The left side impact air bag deployed due to this impact.

**Figure 4:** View of the left rim gouges.

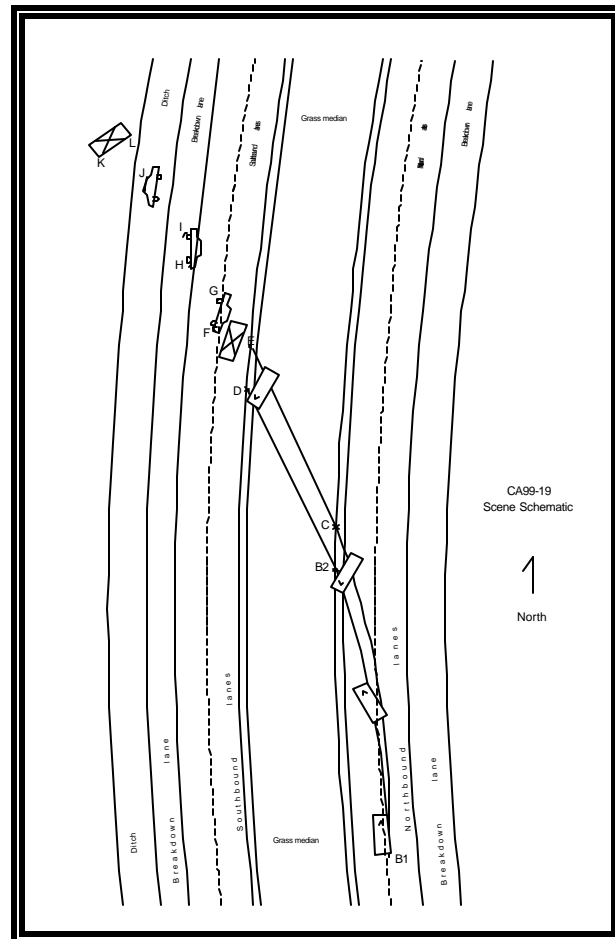
The vehicle continued to roll approximately 4 quarter turns with the left side rims impacting the pavement (a second time) in the southbound breakdown lane. The Mercedes then rolled 3 additional quarter turns impacting the back slope of the ditch bordering the southbound lanes with its right side. An impression of the right A pillar and roof line into the back slope of the ditch was identified during inspection of the scene. The right side impact air bag deployed at this time. The Mercedes then rolled up the back slope and came to rest on its roof. In total, the vehicle rolled 10 quarter turns (2-1/2 rolls) over a distance of approximately 31 m (103 ft). **Figure 5** is a schematic of the rollover crash event.

**Figure 5:** Crash Schematic.

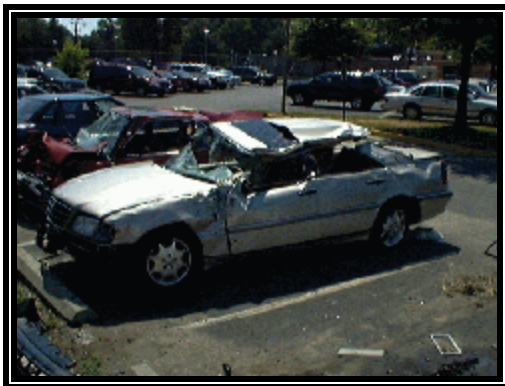
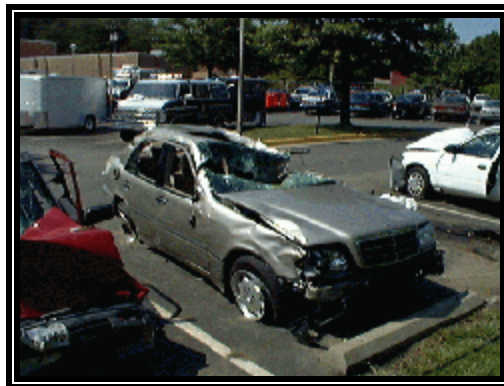
The 1998 Mercedes Benz C280 sustained damage consistent with a lateral 2 ½ revolution lateral rollover crash event and is depicted in **Figures 6 and 7**. The primary vehicle damage was to the left front aspect of the roof resultant to its impact with the ground. The left A, B and C-pillars deformed and were displaced laterally to the right. The residual vertical deformation measured approximately 20 cm (8 in). Dynamically, the vertical deformation was greater and crushed the left aspect of the roof down to the level of the left front head rest, **Figure 8**. The rightward lateral displacement measured approximately 15 cm (6 in). The windshield was fractured. The backlight and all side glazings disintegrated in the event. The left front door was jammed shut due to deformation. All other doors remained closed during the crash and were operational. The Collision Deformation Classification (CDC) of the damage was 00-TPDO-4. The left A, B and C-pillars were cut during the extrication of the driver. Additional minor body damage occurred during the process of up-righting the vehicle.

**Figure 6:** Left front three-quarter view of the Mercedes Benz C280.

**Figure 7:** Right front three-quarter view of the Mercedes Benz C280.

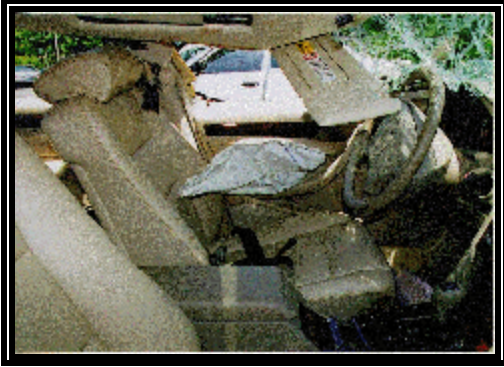
**Figure 8:** Interior view of the magnitude of roof deformation.

The interior damage of the Mercedes Benz consisted of the deployment of the side impact bags and the driver's contact with the roof. The driver's head contact resulted from the vehicle's inverted ground impact and the resultant roof deformation (refer to Figure 8). Bloody transfers to the headliner directly above the left front seat identified this contact, **Figure 9**. The area measured approximately 18 cm x 23 cm (7 in x 9 in) and was located approximately 25 cm (10 in) aft of the windshield header and 18 cm (7 in) left of the left roof rail.

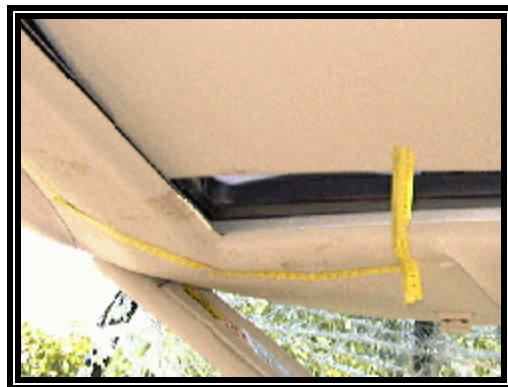
**Figure 9:** View of the head contact to the headliner.

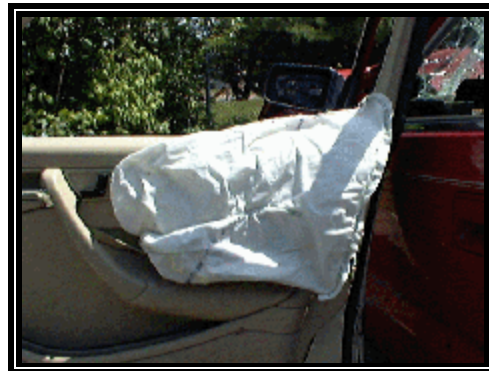
The side impact air bag module was located above the arm rest in the upper aft aspect of the door, **Figure 10**. Both door mounted side impact air bags deployed as a result of the multiple rollover crash event. The bag deployed from the longitudinal center seam of the door's interior trim panel. The bag was trapezoidal in shape and measured approximately 51 cm by 30 cm (20 in by 12 in), width by height. There was no contact evidence to either side impact air bag. The following nomenclature identified the left and right side impact air bag, respectively:

**Figure 10** View of the right side impact air bag.
