**INFLATABLE SIDE IMPACT OCCUPANT PROTECTION INVESTIGATION**

**VERIDIAN CASE NO: CA99-020**

**VEHICLE: 1999 BMW M COUPE**

**CRASH DATE: JULY 1999**

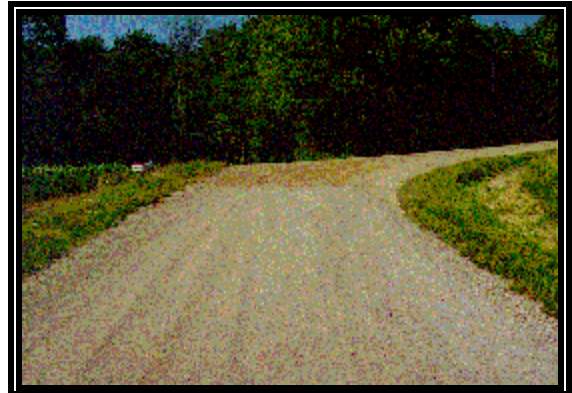
**Figure 1:** Westbound trajectory view approaching the hillcrest.

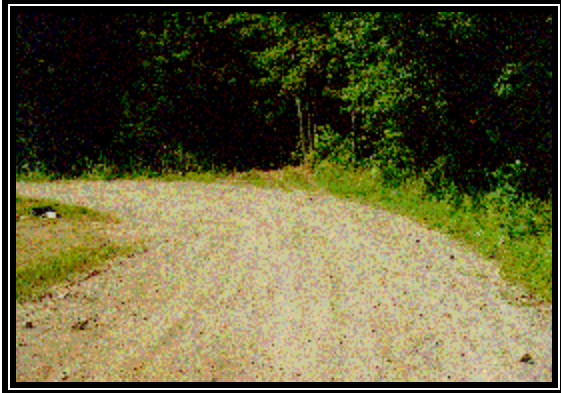
The BMW was driven by a 25 year old male and was traveling westbound at a high rate of speed. The front right passenger was a 25 year old male. Both occupants were restrained by the vehicle's manual belt system. The driver and passenger were on vacation from out-of-state and were unfamiliar with the road. As the vehicle crested the hill and descended into the crash scene, the driver initiated a late counterclockwise steering maneuver in an attempt to negotiate the left curve, **Figure 2**.

**Figure 2:** Westbound trajectory view approximately 15 m (50 ft) from the roadside departure.

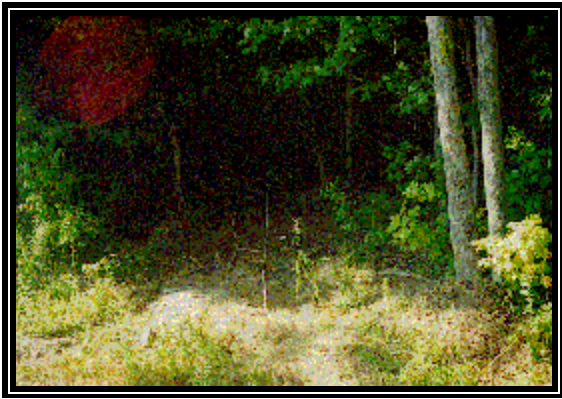
The force of these impacts tripped the vehicle and initiated the right side lateral roll. The vehicle rolled one quarter turn and its right side impacted the ground. The force of the impact caused the deployment of the right side impact air bag. The vehicle then rolled an additional quarter turn (2 quarter turns in total) while sliding through the brush and sideswiping several small trees. The BMW came to rest on its roof facing northward. The final rest of the vehicle measured approximately 18 m (60 ft) from the point of the roadside departure. Refer to **Figures 3 and 4**. **Figure 5** is a schematic of the crash scene.

**Figure 3:** View of the point of roadside departure.

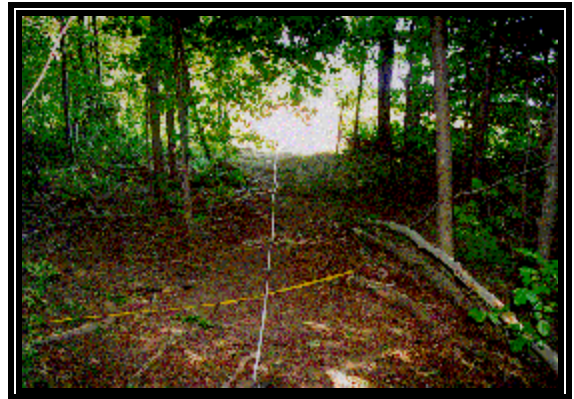
**Figure 4:** Look back from the BMW's final rest position, 18 m (60 ft) from the road edge.

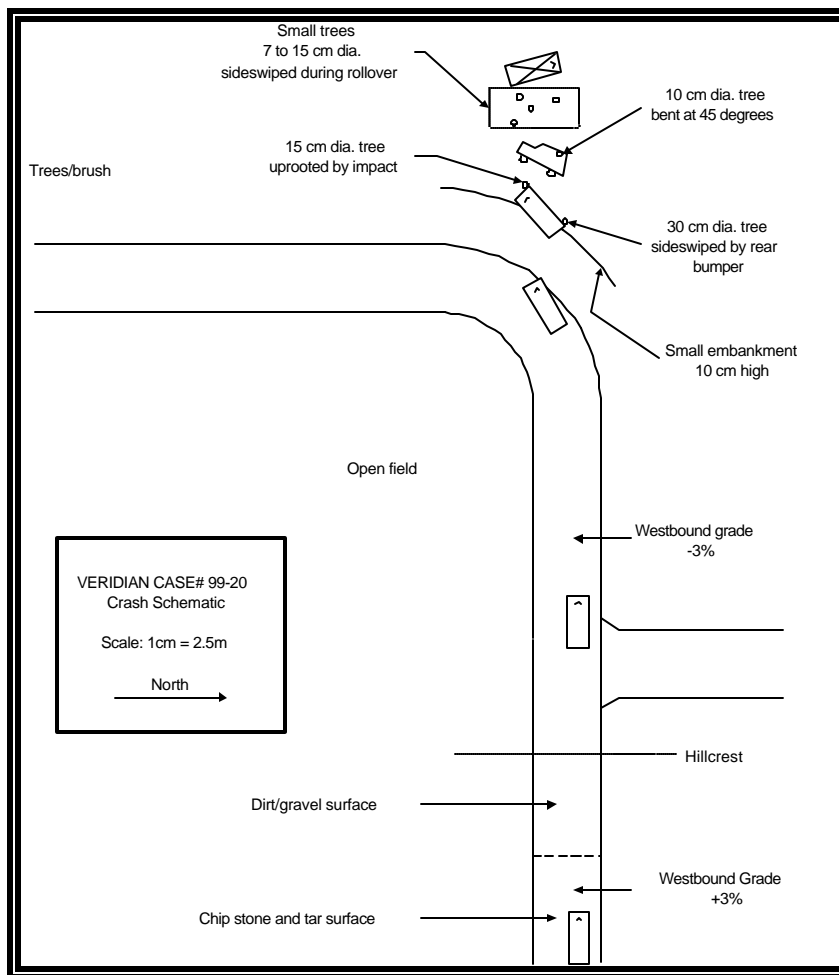
**Figure 5:** Schematic of the crash scene.

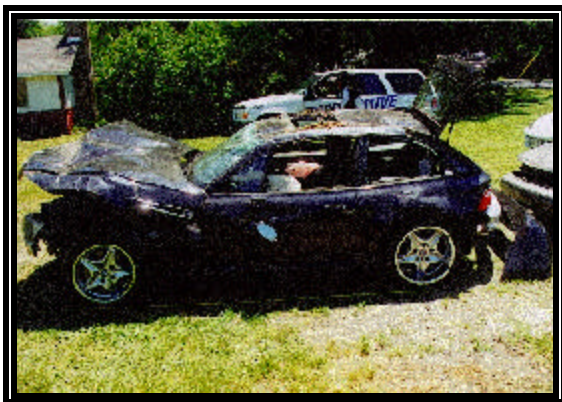
The contact damage to the BMW was consistent with an impact to the frontal right corner area and a 2 quarter turn roll-over. Refer to **Figures 6 and 7**. The impact to the front right corner occurred outboard of the right end of the front bumper. Inspection of the vehicle's front bumper system revealed the rigid bumper reinforcement was manufactured from a formed aluminum section and was attached to energy absorbing devices (EAD's). The EAD's were mounted to the vehicle's under-frame. Abrasions on the bodies of the respective EAD's indicated the bumper system compressed approximately 1.9 cm (3/4 in) and returned to its original position through full restitution. The bumper fascia was fractured and displaced. The profile of the front bumper was not deformed by the impact. The overall length of the BMW was unchanged. The force of the impact was absorbed primarily by the structures of the right front suspension/wheel and fender. The right front tire was debanded and the right side wheelbase was foreshortened 19.1 cm (7.5 in). The left side wheelbase dimension was unchanged. The nature of the frontal vehicular damage was beyond the analytical scope of the WINSMASH model. Forensic analysis of the damage based on SCI experience indicated the delta V of this impact was approximately 19-24 km/h (12-15 mph). The Collision Deformation Classification (CDC) of the impact was 01-FREN-01. This impact coupled with the furrowing of the right side tires were the main tripping mechanisms of the rollover.

**Figure 6:** Left side view of the 1999 BMW M Coupe.

The left side of the BMW revealed minor roll-over damage that occurred as the vehicle neared final rest. The left rear quarterpanel (Figure 6) buckled inward. Its surface was scratched and abraded by ground contact. The scratches were oriented primarily in the longitudinal direction. The glazing of the left rear window had disintegrated. The vehicle probably rolled up onto the quarterpanel in the latter stages of the rollover and then settled back onto its roof at rest. The left side outboard mirror was displaced from its mount and had dented the exterior panel of the left door. The damage to the door probably occurred during the process of up-righting the vehicle. The door was still operational.

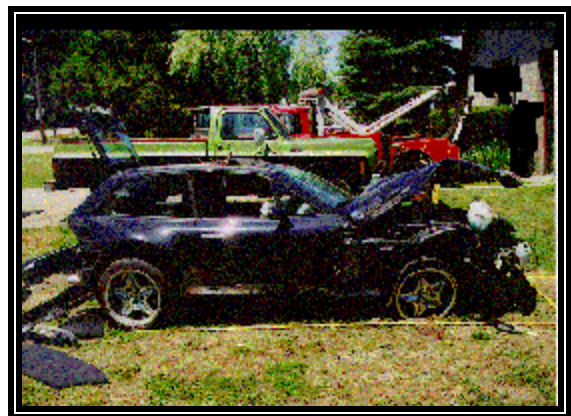
**Figure 7:** Right side view of the BMW.

The right side of the BMW sustained sideswiping type damage from contact with several small trees as it departed the roadside and due to contact with the ground. The scratches and abrasions were directed longitudinally rearward. There was rearward deformation of the leading edge of the right door and wooden debris were lodged in the area, refer to Figure 7. The right door remained operational. The right corner of the rear bumper snagged a tree during the initial stages of the roadside departure. This snagging was evidenced by the rearward

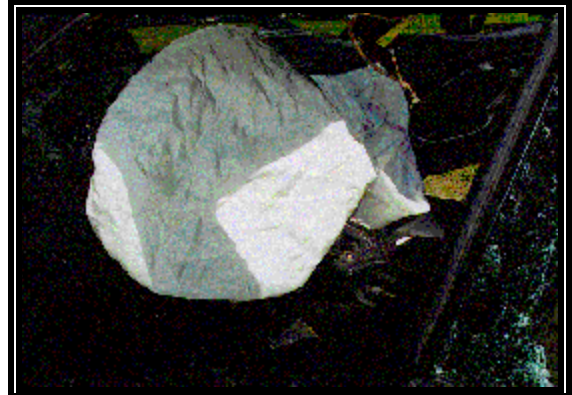
The driver air bag was located in the typical manner in the center hub of the steering wheel rim, **Figure 8**. Note, the steering wheel was rotated approximately 180 degrees counterclockwise at inspection. The air bag measured 61 cm (24 in) in diameter in its deflated state and was not tethered. The bag was vented by a single 2.8 cm (1.1 in) port located in the 12 o'clock sector on the back side of the bag. Multiple blood spatters were located throughout the 4 to 8 o'clock sectors on the face of the bag. There was no direct contact evidence identified on the air bag. The following nomenclature identified the driver air bag:

**Figure 8:** Driver air bag. Note, the steering wheel is rotated 180 degrees CCW.

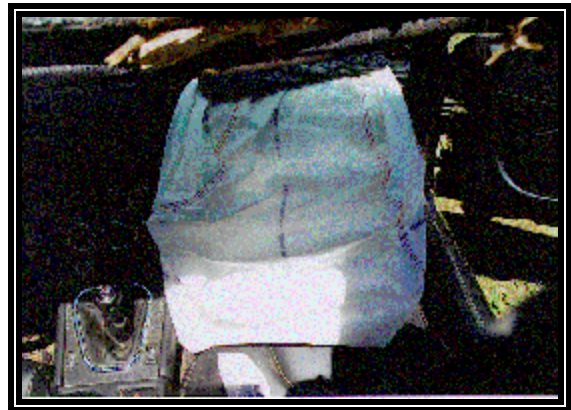
The front right passenger air bag deployed from a top-mount configuration located in the right aspect of the instrument panel, **Figure 9**. The module cover flap was trapezoidal in shape, measured 33 cm (13 in) wide and tapered to 25 cm (10 in) over its 18 cm (7 in) height. The flap was tethered by a single 5 cm (2 in) wide strap. The cover flap contacted and fractured the windshield during the deployment sequence. The face of the passenger air bag measured 48 cm by 36 cm (19 in by 14 in), width by height, and extended 46 cm (18 in) rearward of the module. It was tethered by two 15 cm (6 in) wide straps sewn to the face of the bag. The bag was vented by a 8 cm (3 in) diameter vent port located on the outboard side panel. Black vinyl transfers were noted on the face of the air bag and were linked to contact with the interior surface of the module cover flap. There was no evidence of direct contact from the front right passenger to the air bag. The following nomenclature was located on two bar code labels attached to the module:

**Figure 9:** View of the front right passenger air bag.

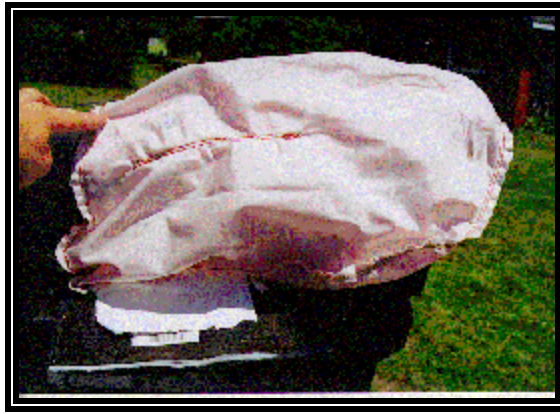
The right side impact air bag, **Figure 10**, was located in the central aspect of the door immediately above the arm rest. The module cover flap measured 24.1 cm by 10.7 cm (9.5 in by 4.2 in), width by height, and hinged on its lower edge. The bag deployed through a 18 cm by 8 cm (7 in by 3 in) opening in the trim panel. The side impact air bag measured 46 cm by 30 cm (18 in by 12 in), width by height, in its deflated state. There was no contact evidence on the air bag. The following manufacturer's information identified the air bag:

**Figure 10:** View of the right side impact air bag.
