**VERIDIAN ON-SITE SIDE IMPACT AIR BAG INVESTIGATION**

**VERIDIAN CASE NO. CA99-21**

**VEHICLE - 1997 CADILLAC DEVILLE**

**CRASH DATE - JUNE, 1999**

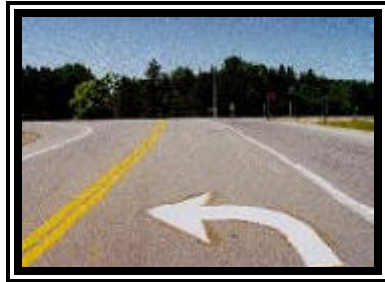
The 83 year old male driver of the 1997 Cadillac Deville was operating the vehicle westbound (**Figure 1**) on the 3-lane intersecting roadway. He stopped for the stop sign and failed to detect the Plymouth as he turned left to proceed south. The 39 year old female driver of the 1997 Plymouth Grand Voyager SE was operating the vehicle northbound at a (driver) reported speed of 72 km/h (45 mph) and negotiating a left curve (**Figure 2**) when she observed the Cadillac turn left across her path of travel. Upon recognition of the impending harmful event, the driver braked in avoidance (ABS equipped).

**Figure 1. Westbound approach for the 1997 Cadillac Deville.**

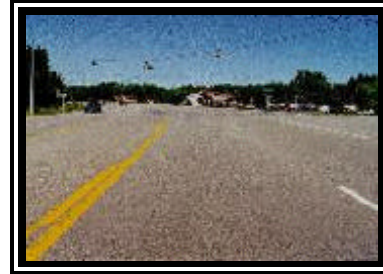
**Figure 2. Northbound approach for the 1997 Plymouth Grand Voyager SE.**

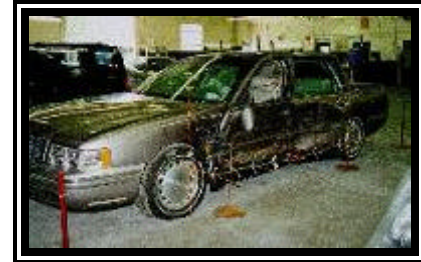
The Cadillac Deville sustained moderate left side damage as a result of the impact with the Plymouth Grand Voyager (**Figure 3**). The direct contact damage began 23.0 cm (9.1 in) aft of the left front axle and extended rearward 181.0 cm (71.3 in) to the left rear door. The combined direct and induced damage length (Field L) was 241.0 cm (94.9 in). Six crush measurements were documented at the level of the mid-door: C1= 0 cm, C2= 20.0 cm (7.9 in), C3= 31.0 cm (12.2 in), C4= 30.0 cm (11.8 in), C5= 18.0 cm (7.1 in),

C6= 0 cm. The Plymouth's front left headlight assembly was embedded between the left front fender and the leading edge of the front door. The crush pattern shattered the left front side glazing and produced induced buckling to the roof area at the left A and B-pillar. Induced damage was also noted to the left side window frames and rear door panel which bowed outward from the impact force. Reduction in the left side wheelbase measured 5.0 cm (2.0 in). The windshield fractured at the left upper/lower A-pillar from exterior impact forces as the right lower windshield fractured from the (interior) front right passenger air bag.

**Figure 3. Left side damage to the 1997 Cadillac Deville.**

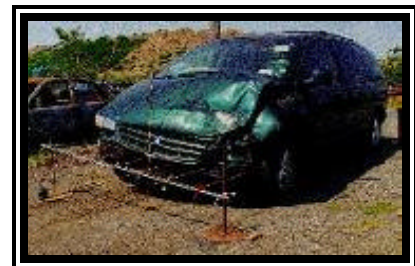
The Plymouth Grand Voyager SE sustained moderate frontal damage as a result of the impact with the Cadillac Deville (**Figure 4**). Although the initial direct contact damage began at the front left bumper corner and extended 49.0 cm (19.3 in) inboard, subsequent wrap damage to the remainder of the front end occurred during sustained contact between the vehicles prior to separation. This resulted in a direct damage length which extended 154.0 cm (60.6 in) inboard along the *bumper fascia*. The impact deformed the full frontal width resulting in a combined direct and induced damage length (Field L) of 131.0 cm (51.6 in). Six crush measurements were documented at the level of the reinforcement bar (bumper cover separation): C1= 33.0 cm (13.0 in), C2= 31.0 cm (12.2 in), C3= 24.0 cm (9.4 in), C4= 19.0 cm (7.5 in), C5= 14.0 cm (5.5 in), C6= 6.0 cm (2.4 in). The front left headlight assembly separated and was found in the forward

**Figure 4. Frontal damage to the 1997 Plymouth Grand Voyager SE.**

door seam of the Cadillac. Induced damage was noted to the left fender which was displaced slightly rearward (left front wheel not restricted/deflated). Reduction in the left side wheelbase measured 4.0 cm (1.6 in). The windshield was undamaged with all side glazing intact. The end structure was displaced 5.0 cm (2.0 in) to the left [ $>10.2$  cm (4.0 in) of end shifting required to increment the principal direction of force].

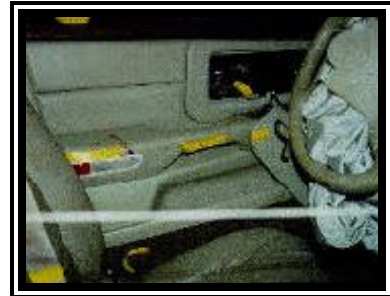
Interior damage to the Cadillac Deville identified through the vehicle inspection was moderate and was attributed to intrusions and occupant contact (**Figure 5**). Superficial routine wear marks were documented to the latchplate of the front left 3-point manual lap and shoulder restraint along with (impact related) fabric transfers/blood spattering to the upper and lower sections of the webbing. The lower retractor assembly was restricted by the B-pillar intrusion with the belt in the extended (used) position. Blood transfers were noted to the lower portion of the driver air bag along with white vinyl transfers from expansion within the module. An indentation was identified on the left front armrest, door panel and knee bolster (padded type) along with scuff marks to the left instrument panel. The door panel hardware was scratched and out of place. A small scratch mark and blood transfer were documented on the left A-pillar. No loading to the steering wheel rim was found (tilt column between the full up and center positions). Blood spattering was noted on the face of the passenger air bag attributed to the driver's forearm injury as he exited the vehicle post-crash. The right windshield was fractured from deployment of the passenger air bag. Lateral intrusions into the driver space included 16.0 cm (2.3 in) of B-pillar intrusion, 11.0 cm (23.4 in) of door panel intrusion and 8.0 cm (12.2 in) of sill intrusion. Additional intrusions were documented to the rear left space which included 25.0 cm (12.3 in) of door panel intrusion and 19.0 cm (12.2 in) of sill intrusion.

**Figure 5. Occupant contact damage to the vehicle interior.**

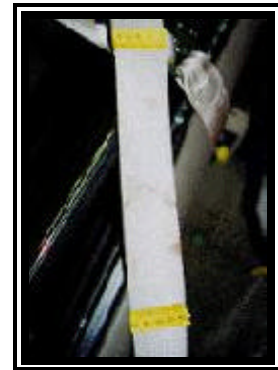
At impact, the driver initiated a forward/lateral trajectory in response to the 10 o'clock impact force and loaded the manual restraint and deployed driver air bag. Belt usage was confirmed by fabric transfers and the pattern of blood spattering to the upper and lower portions of the webbing (**Figure 7**) which were consistent with usage at the time of the crash, further evidenced by the restricted retractor assembly with the belt in the extended (used) position. Improper belt usage resulted in multiple contusions to the left upper chest area. No injuries were reported as a result of loading the deployed driver air bag. Loading of the left door panel resulted in a fractured left scapula, contusions of the left ribs (with a collapsed left lung) and a left pneumothorax, evidenced by the indentations and scuff marks documented to this component. He also sustained contusions of the left pelvis and thigh from contact to the door armrest as evidenced by the indentation and scuff marks documented to this component. As the driver continued the forward/lateral trajectory, his left elbow and (posterior) forearm struck the door hardware resulting in a laceration and avulsion of the soft tissue as evidenced by the displaced hardware and blood transfers to the surrounding area. This mechanism forced the wristwatch into the forearm resulting in a laceration and abrasion, evidenced by the size/shape of the injury relative to the kinematic response pattern.

**Figure 7. Blood and fabric transfers to the shoulder restraint.**

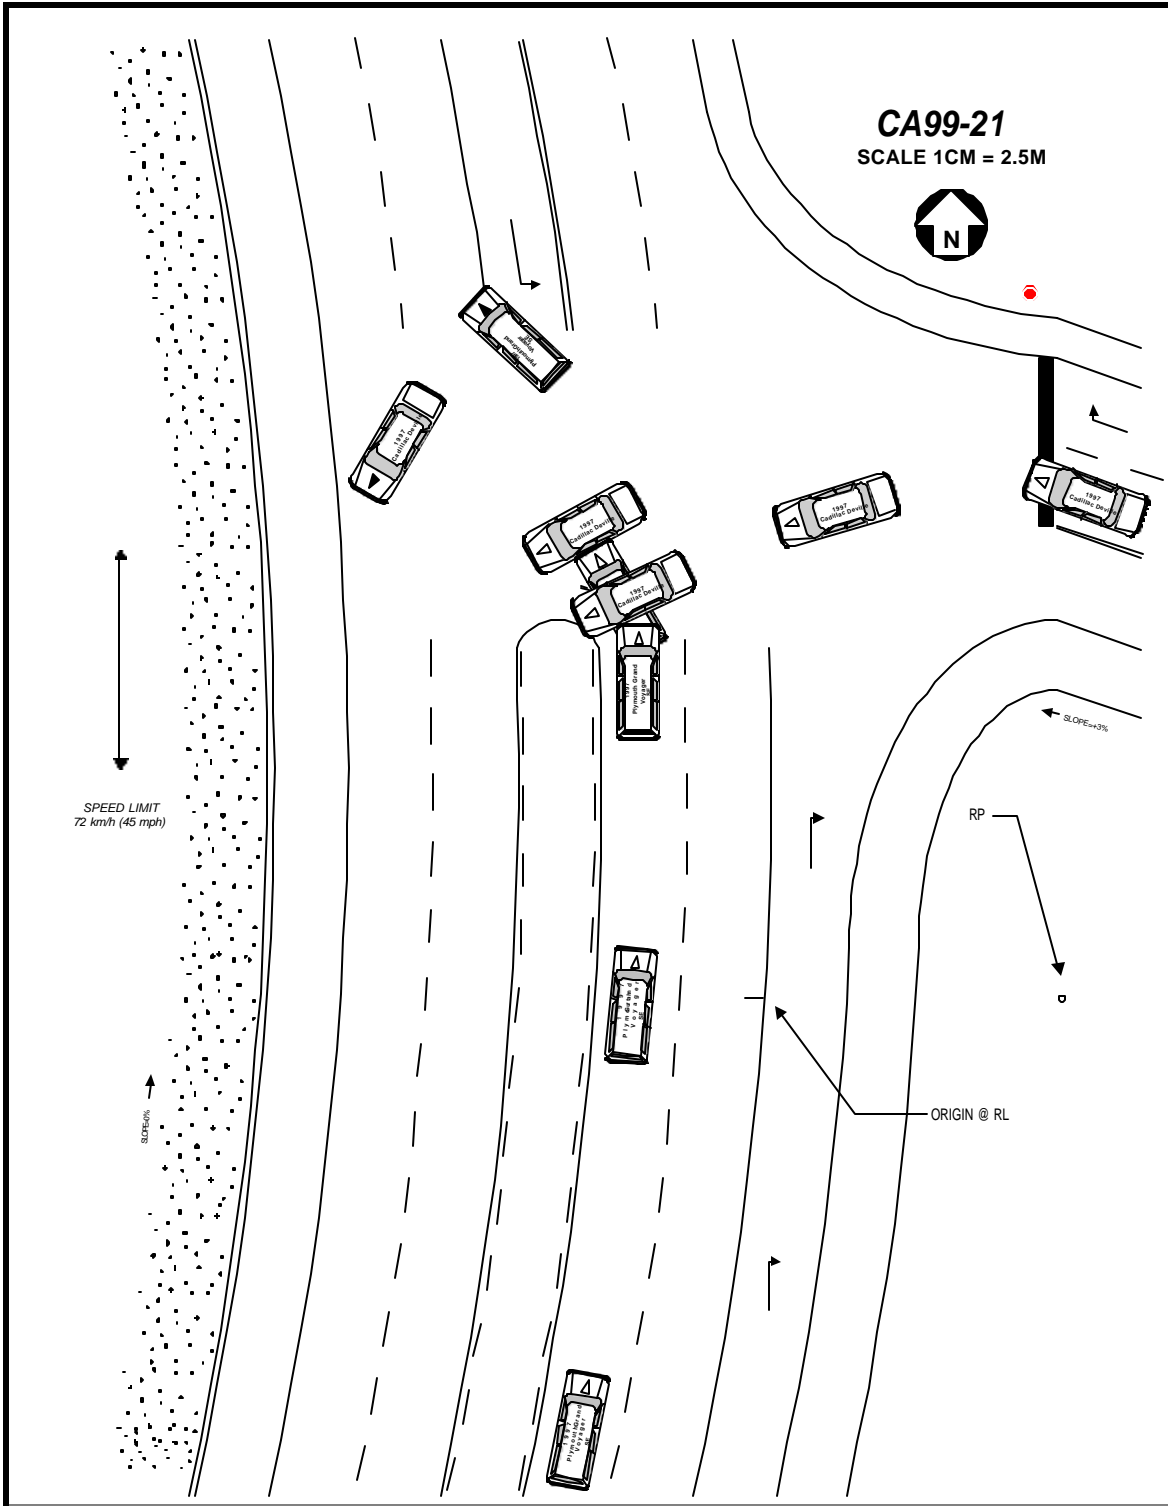
Figure 8. Scene Diagram

This two vehicle crash occurred during the afternoon hours of June, 1999. At the time of the crash, it was daylight with no adverse conditions as the roads were dry. The crash occurred on a state route that consisted of four travel lanes (see **Figure 8 - page 8**) that curved to the left for northbound traffic. The northbound travel lanes were divided by a painted median while the southbound lanes included a designated left turn lane. The intersecting road consisted of three lanes with a positive grade to the west which curved left for westbound traffic. Traffic control at the rural 3-leg intersection included a stop sign for westbound traffic (with an overhead red flashing signal) with a posted speed limit of 72 km/h (45 mph).
