**ON-SITE REDESIGNED DRIVER AIR BAG DEPLOYMENT/
FATALITY INVESTIGATION**

VEHICLE: 1999 CHEVROLET CAMARO

VERIDIAN CASE NO. CA99-22

CRASH DATE: JULY, 1999

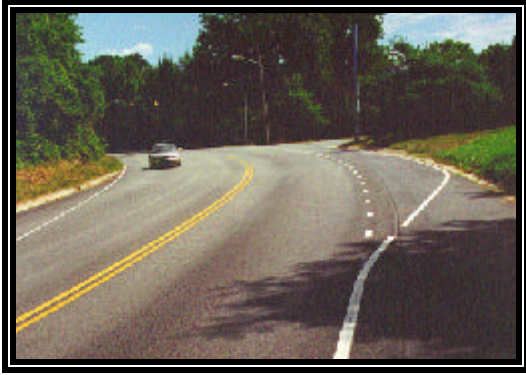
Figure 1: Southbound trajectory view.

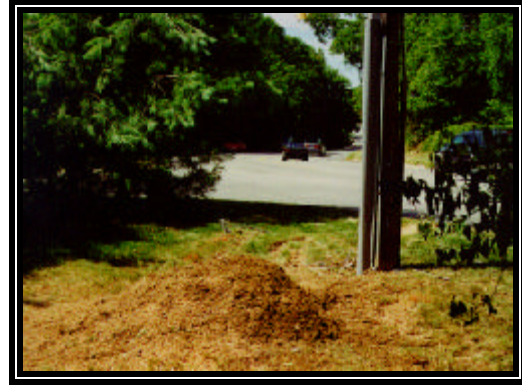
Figure 2: Look back view from the POI.

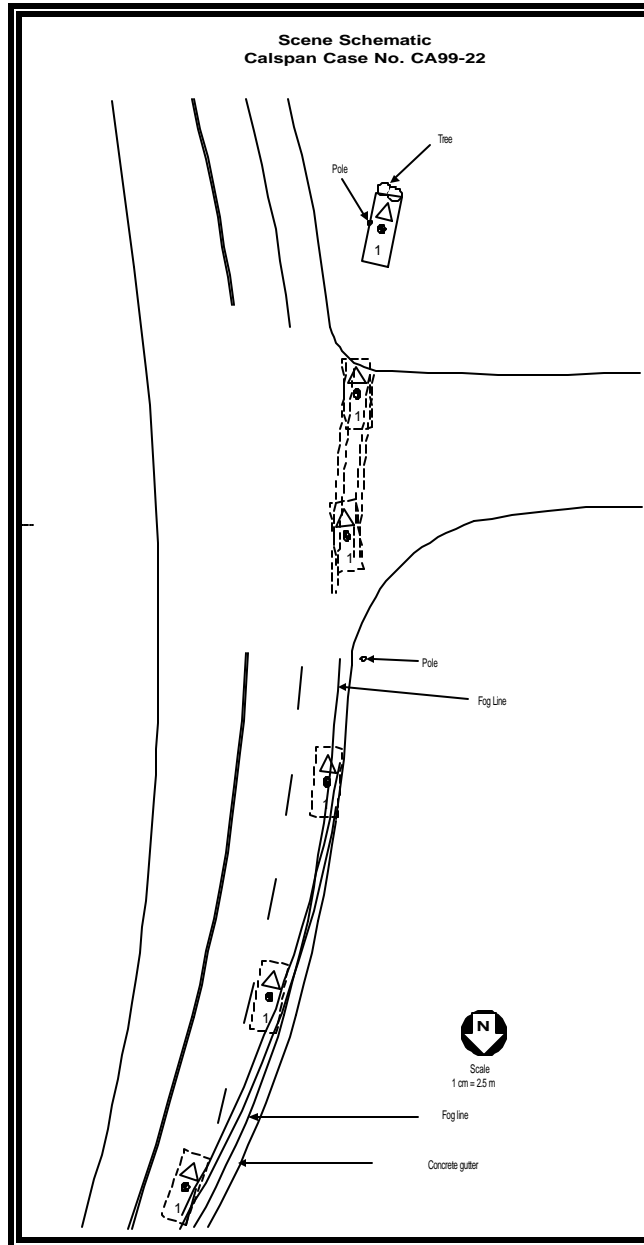
The Camaro then traveled into the southwest intersection quadrant, shearing a guy wire, and impacting a 152 cm (60 in) diameter tree with the right aspect of the vehicle's front plane. The Barrier Equivalent Delta V of the frontal impact was 86 km/h (53 mph). The vehicle's redesigned Automatic Restraint System deployed as a result of the 12 o'clock impact force. The driver was out-of-position with his chest against the steering wheel at impact, as a result of the vehicle's pre-crash dynamics and braking. His forward position impeded the deployment of the driver air bag and caused the bag to deploy out of the top of the module. The sudden deceleration of the impact caused inertial loading of the steering column. Refer to the Automatic Restraint System and Driver Kinematics sections that follow. The Camaro then rotated clockwise into a left side impact with a utility pole and came to rest.

Figure 3: Schematic view of the crash.

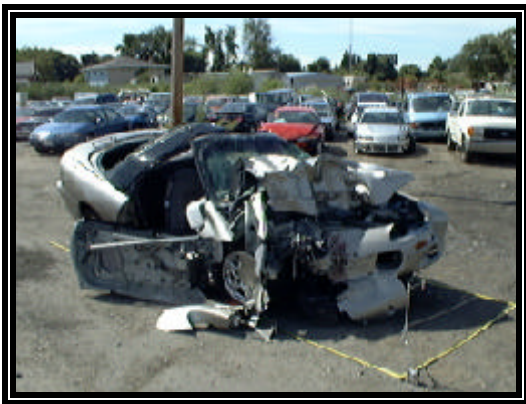
Figures 4 and 5 are the right front and left side views of the Chevrolet Camaro, respectively. The Camaro sustained 86 cm (34 in) of direct damage to the right and center aspects of the front plane as a result of the impact to the tree. The direct contact began 5 cm (2 in) left of center and extended to the right front bumper corner. The crush profile measured at the elevation of the front bumper was as follows: C1=12.7 cm (5.0 in), C2=68.6 cm (27.0 in), C3=101.6 cm (40.0 in), C4=106.7 cm (42.0 in), C5=99.1 cm (39.0 in), C6=101.6 cm (40.0 in). The 12 o'clock direction of the impact force deformed the frontal structures of vehicle rearward into the engine compartment. The magnitude of the impact force caused buckling of the vehicle's uni-body structure between the A- and C-pillars. The right side wheelbase was foreshortened 41.9 cm (16.5 in). The windshield was fractured and all glazings disintegrated from the impact forces. The Collision Deformation Classification (CDC) of the frontal impact was 12-FDEW-04. The Barrier Equivalent delta V of the frontal impact calculated by the WINSMASH model was 86 km/h (53 mph). The longitudinal and lateral components were -86 km/h (-53 mph) and 0 km/h (0 mph), respectively.

Figure 4: Right front three-quarter view of the Chevrolet Camaro.

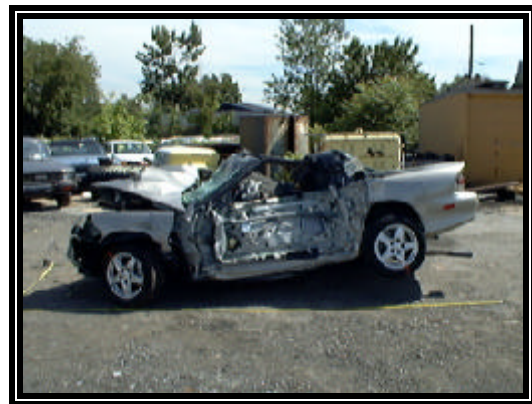
Figure 5: Left side view of the Camaro.

Immediately prior to the tree impact, the Camaro's left front fender sideswiped a utility pole. The contact was identified by longitudinal scrapes and scuffing that began 33 cm (13 in) forward of the left front axle and extended 102 cm (40 in) rearward to the approximate A-pillar location (refer to Figure 5). The CDC of this contact was 12-LFES-01. The offset frontal impact with the tree caused the vehicle to rapidly rotate clockwise into direct contact with the pole. The direct left side contact with the pole began 69 cm (27 in) aft of the left front axle and extended 165 cm (65 in) rearward. The left side crush profile measured as follows: C1=10 cm (4.0 in), C2=41.1 cm (16.2 in), C3=40.6 cm (16.0 in), C4=31.8 cm (12.5 in), C5=20.3 cm (8.0 in), C6=6.4 cm (2.5 in). The maximum crush occurred at C2, the B-pillar location. The CDC of the left side impact was 10-LPAW-03. The Barrier Equivalent delta V was 43 km/h (27 mph). The longitudinal and lateral components were -38 km/h (-24 mph) and 22 km/h (14 mph), respectively. The Camaro's impact speed into the fixed objects can be approximated by combining the above Barrier Equivalent speeds. Using the combined sped formula, the impact speed of the Camaro was approximately 95 km/h (59 mph).

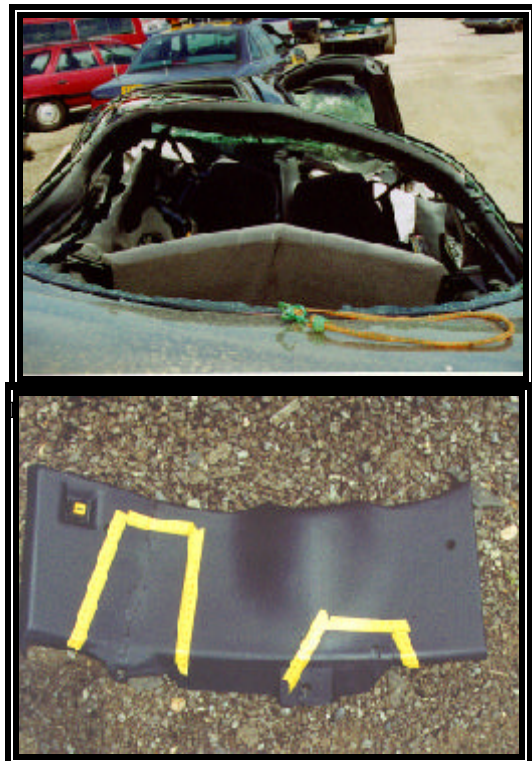
The driver's forward inertial loading fractured the tilt mechanism of the steering wheel and deformed the 4 to 10 o'clock sectors of the rim longitudinally forward. The maximum displacement in the rim's 6 o'clock sector measured 12.2 cm (4.8 in). Steering column shear capsule displacement was 6 mm (1/4 in) by visual estimate. The driver's knee bolster exhibited two contacts from the driver's lower extremities, **Figure 7**. The left lower extremity contact fractured the bolster. The contact measured 7.1 cm x 14.7 cm (2.8 in x 5.8 in) width by height and was located 19.8 cm (7.8 in) left of the steering column centerline. The driver's right knee contacted the lower edge of the bolster 5.7 cm (2.3 in) right of the steering column centerline. This contact measured 9.7 cm x 5.1 cm (3.8 in x 2.0 in), width by height.

Figure 7: View of the driver's knee bolster.

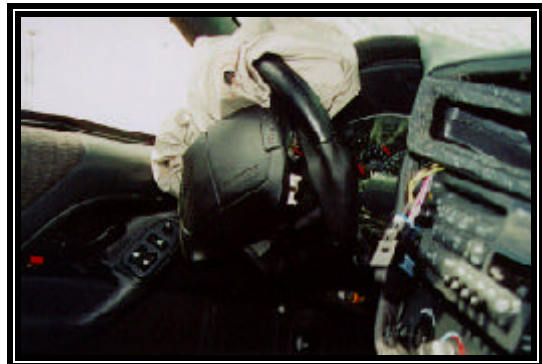
The driver air bag was located in the typical manner in the center hub of the steering wheel, **Figure 8**. The air bag membrane measured 61 cm (24 in) in diameter and was not tethered. The bag was vented by two 2.5 cm (1.0 in) diameter ports located in the 3 and 9 o'clock sectors on the back side of the bag. A bar code label was located in the bag's 12 o'clock sector with the following nomenclature:

Figure 8: View of the driver air bag.

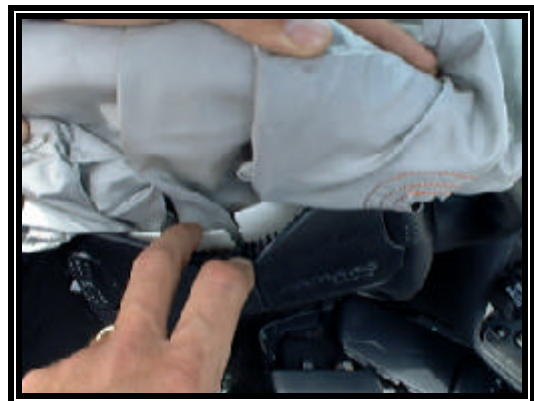
The I-configuration cover flaps were symmetrical and measured 10.1 cm x 11.4 cm (4.0 in x 4.5 in), width by height. The air bag module was constructed of white sheet vinyl 3 mm (1/8 in thickness) and covered by a black vinyl (type) cloth. All of the interior seams of the module separated during the deployment, however, the cover flaps did not rotate open. The exterior cloth separated along the top seam and partially about the center seam. Refer to **Figure 9**. The driver's chest was positioned against the module and prevented the flap rotation. Expansion of the captured air bag membrane caused pressure to build within the module and membrane. The over-pressure

Figure 9: View of the flap separation.

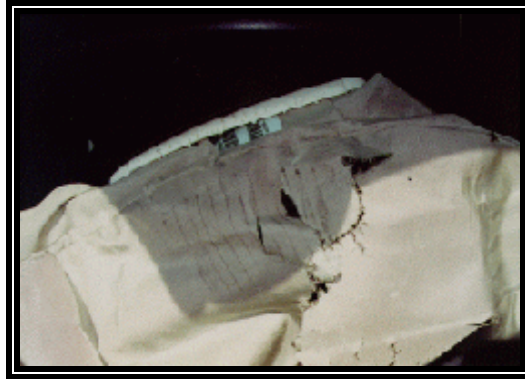
caused the bag to deploy out of the 12 o'clock sector (top) of the module. As the membrane deployed through the top seam, the jagged edge of the module abraded the membrane evidenced by the patterned vinyl transfers. These abrasions weakened the membrane and the over-pressure caused a 15 cm (6 in) rupture in the 12 o'clock sector on the back side of the bag, **Figure 10**.

Figure 10: View of the ruptured air bag.
