ON-SITE DRIVER AIR BAG NON-DEPLOYMENT/FATALITY INVESTIGATION

VEHICLE: 1995 CHEVROLET S-10 PICK-UP

VERIDIAN CASE NO. CA99-028

CRASH DATE: SEPTEMBER 1998

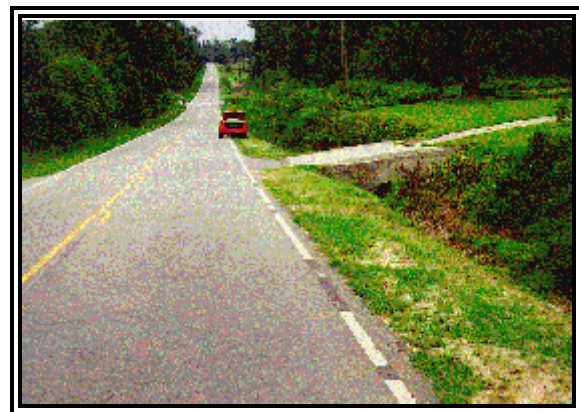
This single vehicle crash occurred during the daylight hours in September, 1998. At the time of the crash, it was daylight and the weather was not a factor. The crash occurred off the right shoulder of a two-lane north/south, straight roadway with an asphalt surface, **Figure 1**. The road grade was a negative 3 percent (estimated) in the northbound direction. The right (east) shoulder was grass/sand and measured approximately 1.7 m (5.6 ft) in width. The shoulder then sloped into a 1.5 m (5.0 ft) deep ditch that paralleled the roadway. The ditch's centerline measured approximately 3.8 (12.5 ft) from the road edge. There was a private residence on the east side of the road. Its driveway crossed the ditch line via a culvert and concrete approach that measured approximately 7.3 m x 1.5 m (24 ft x 5 ft), length by height. The concrete approach was the point of

Figure 1: Northbound trajectory view and the point of impact.

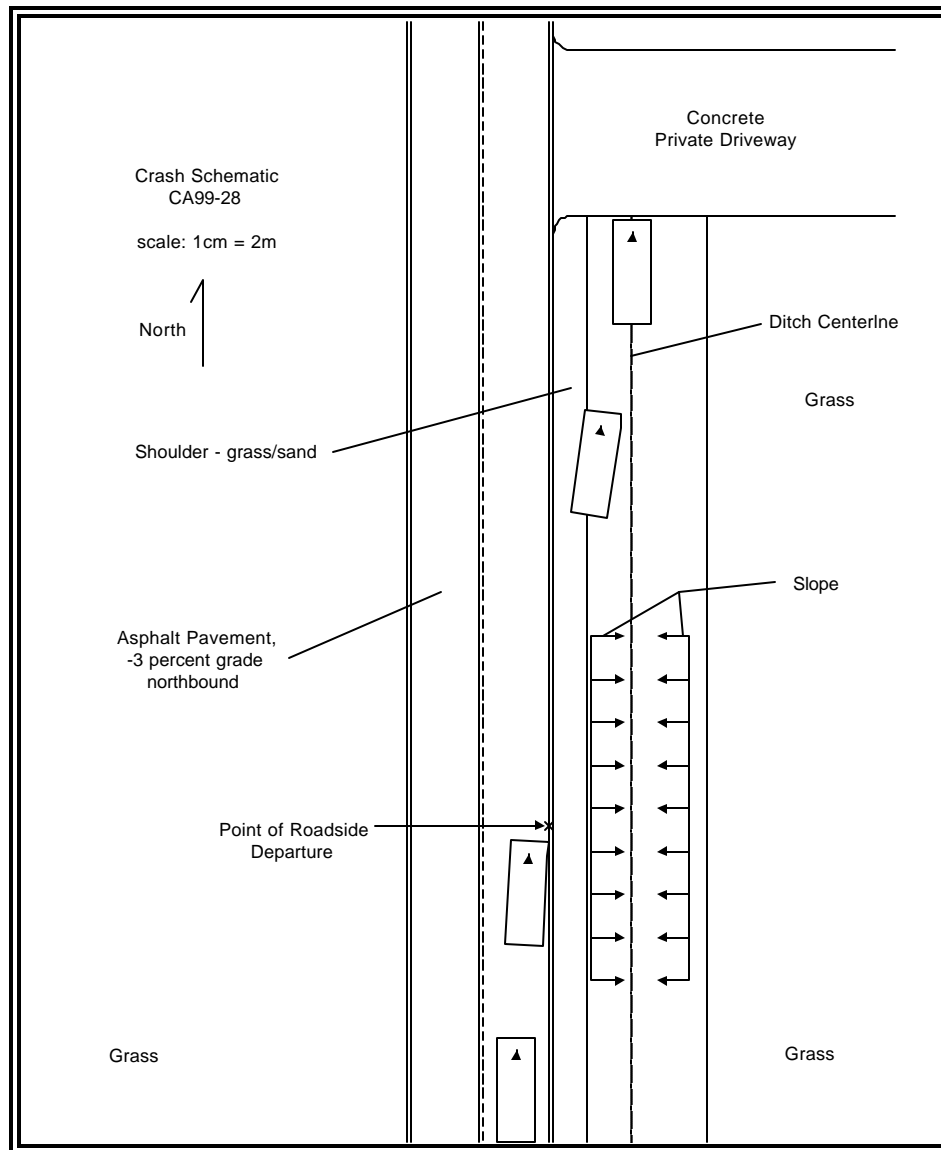
Figure 2: Crash schematic.

The right side wheels of the S-10 traveled across the shoulder and down the side slope and into the 1.5 m (5.0 ft) deep ditch. The vehicle then followed the ditch line and impacted the concrete driveway approach with its frontal plane. Due to the depth of the ditch, the S-10 was rolled approximately 51 degrees to the right. The pick-up came to rest at the point of impact. The Barrier Equivalent delta V of the impact calculated by the WINSMASH model was 56.0 km/h (34.8 mph), longitudinal -56.0 km/h (34.8 mph)/lateral 0 km/h (0 mph). The driver air bag failed to deploy in the above threshold crash. Technical representatives for General Motors participated in the vehicle's inspection and downloaded data that resided in the air bag system's Diagnostic Energy Reserve Module (DERM).

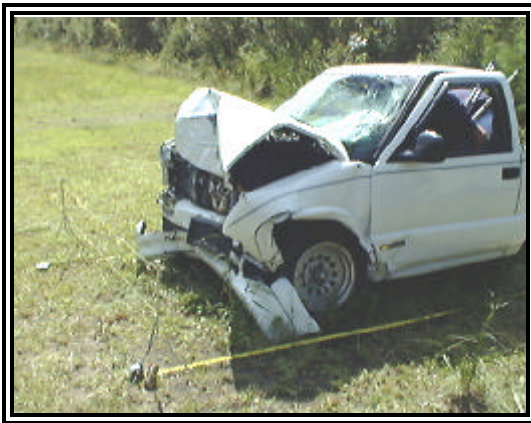
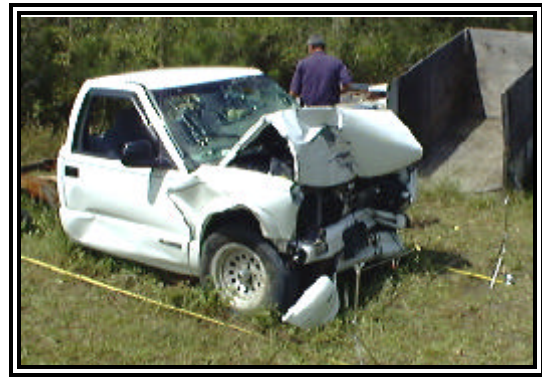
The S-10's frontal plane sustained direct contact damage across its entire 142 cm (56 in) end width. **Figures 3 and 4** are the left front and right front three-quarter views of the vehicle, respectively. The vehicular damage was similar in nature and magnitude to that of a NHTSA 56 km/h (35 mph) NCAP test.

The force of the impact compressed the frontal structures rearward into the engine compartment. The crush profile measured as follows: C1=45.7 cm (18.0 in), C2=51.8 cm (20.4 in), C3=62.0 cm (24.4 in), C4=68.1 cm (26.8 in), C5=67.1 cm (26.4 in), C6=45.7 cm (18.0 in). Both front fender's were deformed. The hood buckled in the typical manner and could not be opened. The left door was jammed shut. The right front door was operational, but restricted. The windshield was fractured from both the driver's head contact and the exterior crash force. The side window glazings and backlight disintegrated upon impact. The left and right wheelbase measurements were foreshortened 33.8 cm (13.3 in) and 16.0 cm (6.3 in), respectively. The compressive forces of the crash caused contact between the back of the cab and forward edge of the pick-up bed. The Barrier Equivalent Delta V calculated by the WINSMASH model was 56.0 km/h (34.8 mph). The Collision Deformation Classification (CDC) was 00-FDEW-3. Although the vehicular damage was within the 12 o'clock sector, a non-horizontal impact force (00) was coded due to the orientation of the vehicle at impact.

Figure 3: Left front three-quarter view of the Chevrolet S-10 pick-up.

Figure 4: Right front three-quarter view of the S-10.

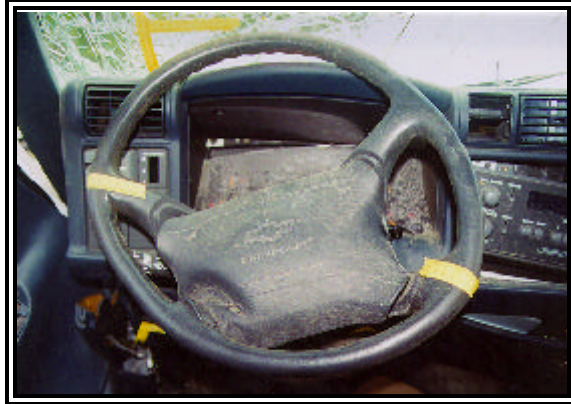
Interior damage to the vehicle identified during the course of the vehicle inspection was associated to both the exterior force of the crash and interior contact from the occupant. The lower aspect of the windshield fractured from the exterior crash force and a star-shaped fracture, inboard of the left A-pillar, resultant to head contact was also identified. The fracture was located 23 cm (9 in) right of the A-pillar and 25 cm (10 in) below the windshield header (measured the plane of the windshield). The fixed steering column was completely displaced from its shear capsules due to driver loading. The shear displacement measured 8.1 cm (3.2 in). There was 5 cm (2 in) of deformation to the lower half of the 4-spoke steering wheel rim as a result of edge loading. The deformation occurred in the plane of the rim and collapsed the spoke in the 8 o'clock sector, **Figure 5**.

Figure 5: View of the steering wheel deformation.

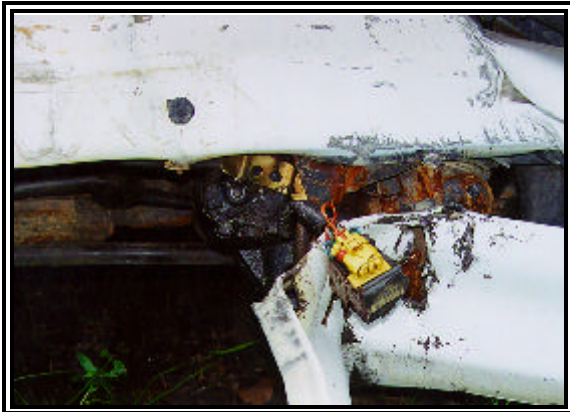
Figures 6 and 7 are views of the forward left and right impact sensors, respectively. Both sensors were directly involved in the crash damage. The left sensor was displaced free from its mount by the rotation of the steering box during the impact. The rearward crush of the front bumper damaged the sensor. Its phenolic casing was fractured. The electrical wiring was intact. The right sensor was still mounted to the lower radiator support upon inspection, however, it was loose. The sensor was mounted by two rivets. The structural deformation of the support pulled the lower rivet of the sensor free. The vertical orientation of the mounting surface had rotated down approximately 28 degrees (CCW in a left view). The electrical circuitry to the sensor was intact. The sensors' residual positions and damages would not have effected the ability of the SIR system to identify and command deployment. Sensor closure would have occurred early in the "barrier-type" crash experienced by the Chevrolet S-10 and initiated the deployment sequence. The structural deformations and damages to the sensors occurred late in the crash event history. The post-crash condition of the forward impact sensors was not the root cause of the SIR non-deployment.

Figure 6: View of the forward left impact sensor.

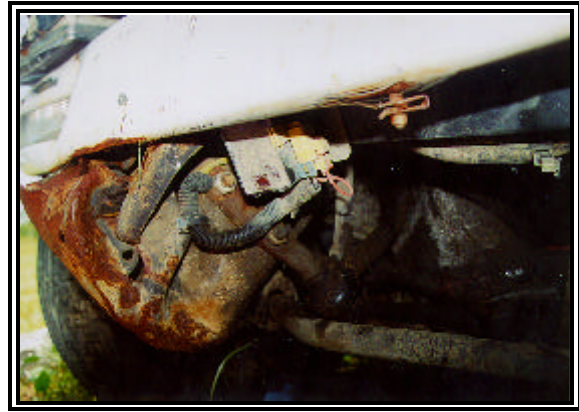
Figure 7: View of the forward right impact sensor.
