**REMOTE REDESIGNED AIR BAG DEPLOYMENT INVESTIGATION
SCI TECHNICAL SUMMARY REPORT**

VERIDIAN CASE NO. CA99- 030

RABSS VEHICLE -1998 DODGE NEON

CRASH DATE - OCTOBER 1998

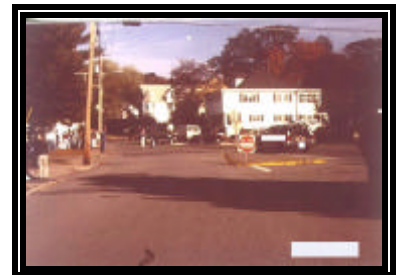
The 36-year-old female driver of the Dodge Neon was operating the vehicle southbound at a high rate of speed on an approach to the 3-leg intersection (**Figure 1**) when the driver violated the “Do Not Enter” sign and traveled into the northbound travel lane, through the intersection and into the path of the Windstar. Her daughter, seated in the front right position, stated that it appeared the driver had suffered a seizure. The 30-year-old female driver of the Ford Windstar was operating the vehicle westbound on approach to the same intersection. There were no skid marks within either vehicle’s trajectory indicative of any driver avoidance maneuvers. The Neon was reported by police as traveling approximately 80-96 km/h (50-60 mph) prior to the crash.

Figure 1. Southbound approach for 1998 Dodge Neon

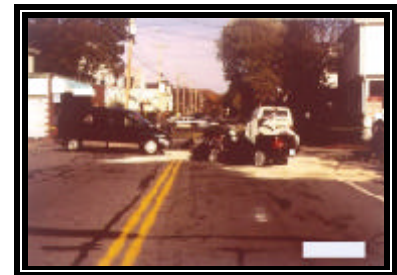
As the Dodge Neon entered the intersection, the entire frontal plane impacted the entire frontal plane of the Ford Windstar. Impact resulted in severe damage to both vehicles. The impact induced deceleration was sufficient to deploy the frontal air bag system in both vehicles. The damage algorithm of the WinSMASH program computed velocity changes of 57 km/h (35 mph) for the Neon, and 41 km/h (26 mph) for the Windstar based on the CDC values and estimated crush profiles. The principal direction of force was in the 11 o’clock sector for the Neon, and in the 1 o’clock sector for the Windstar. The Neon rotated counterclockwise (CCW) approximately 90 degrees and came to rest in the eastbound travel lane facing northeast. The Windstar rotated CCW approximately 90 degrees and came to rest in the westbound travel lane facing south.

Figure 2. Point of impact and final rest positions

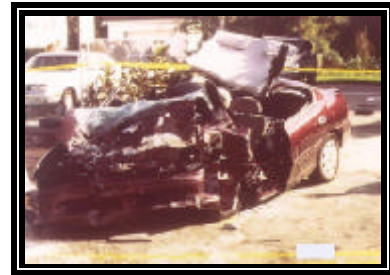
The 1998 Dodge Neon sustained severe frontal damage as a result of the impact with the Ford Windstar (**Figure 3**). The Collision Deformation Classification (CDC) for the impact to the Neon was 11-FDEW-6. The direct contact damage began at the left bumper corner and extended approximately 150 cm (59") laterally across the entire frontal plane. The contact damage was concentrated mainly on the front of the vehicle forward of the passenger area. The hood and engine compartment were displaced rearward from engagement against the front of the Windstar. The windshield was cracked and out of place, and the left front window was shattered from impact forces. The left sill was buckled from the extensive crush. Both front wheels were restricted, and the left front tire was deflated. The right front wheel had separated from the axle. The right front door was sprung open from impact forces and displacement rearward. The left rear door was jammed and unable to be opened. The backlight was shattered from impact forces. Six crush measurements were estimated at the level of the bumper and were as follows: C1 = 112 cm (44"), C2 = 96 cm (38"), C3 = 82 cm (32"), C4 = 62 cm (24"), C5 = 36 cm (14"), C6 = 12 cm (5").

Figure 3. Frontal damage to Dodge Neon

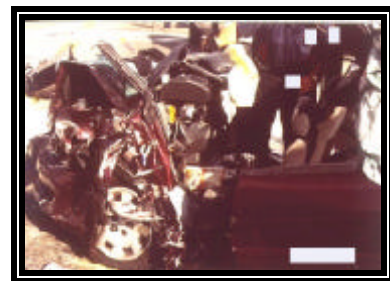
Interior damage to the Dodge Neon was severe and attributed to exterior deformation and passenger compartment intrusion. Severe longitudinal component intrusion included the upper and lower instrument panel, toepan, and left A-pillar (**Figure 4**). The left side upper instrument panel and steering column were displaced vertically, most likely a combination of occupant loading and rescue efforts. The steering wheel hub/rim was deformed from occupant loading on the top and bottom aspects. Scuff marks were visible on the left knee bolster (rigid plastic type) and left aspect of the center console. The left knee bolster was cracked and out of place from probable occupant loading (**Figure 5**). The center instrument panel was also cracked and out of

Figure 4. Interior damage to Dodge Neon

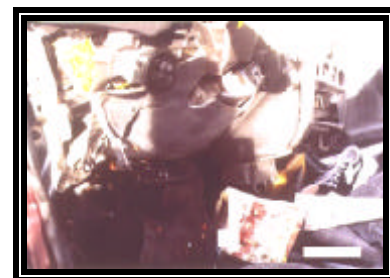
Figure 5. Knee bolster deformation in Dodge Neon

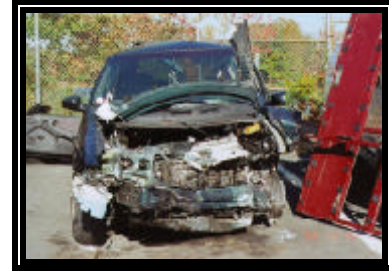
The 1995 Ford Windstar sustained severe damage as a result of the impact with the 1998 Dodge Neon (**Figure 6**). The CDC for this impact to the Ford Windstar was 01-FDEW-5. The damage extended across the entire frontal plane. The windshield was crushed from impact forces. The sheet metal in the hood was separated from the hood frame and the front bumper was separated from the vehicle. The left A-pillar was displaced rearward and the roof buckled above the left front door. The left front wheel was restricted from the rearward displacement of the left fender.

Figure 6. Frontal damage to 1995 Ford Windstar

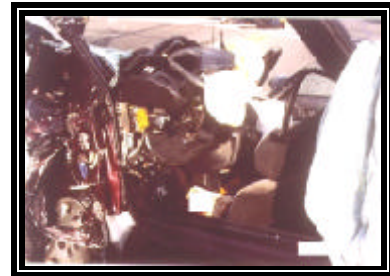
The 1998 Dodge Neon was equipped with redesigned frontal air bags for the driver and front right passenger positions. The air bags had deployed as a result of the impact with the Ford Windstar. Air bag warning labels were affixed to each sun visor. The driver's air bag was housed in the center of the steering wheel with a single cover flap design (**Figure 7**). No contact evidence was visible on the air bag or exterior surface of the module cover flap. The air bag was vented by two ports located at the 11 o'clock and 1 o'clock sectors on the rear aspect of the air bag. The air bag was tethered, evidenced by the circular stitching on the center of the air bag.

Figure 7. Dodge Neon driver's air bag

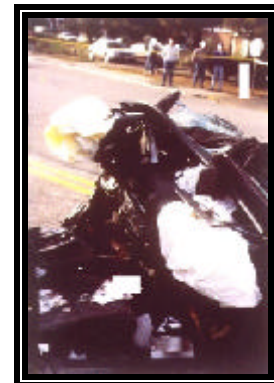
The front right passenger air bag deployed from the right upper-instrument panel area with a single cover flap design hinged at the top aspect (**Figure 8**). The module cover flap was rectangular in shape. No contact evidence was identified on the air bag or exterior surface of the module cover flap. It was not known if the air bag was tethered or vented by external ports.

Figure 8. Dodge Neon front right passenger's air bag
