## REMOTE AIR BAG DEPLOYMENT REPORT

CASE NUMBER - IN99-036

VEHICLE - 1998 BUICK CENTURY CUSTOM

CRASH DATE - June 1998

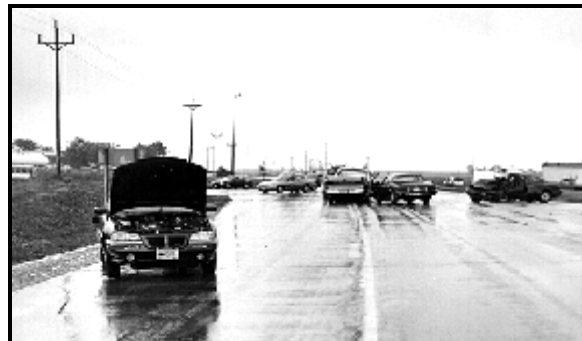
**Figure 1:** Eastbound view of crash scene; Note: FARS vehicle #1 in left foreground, vehicle #2 straddling the centerline, vehicle #4 immediately to right of vehicle #2, and the case vehicle at far right (case photo #01)

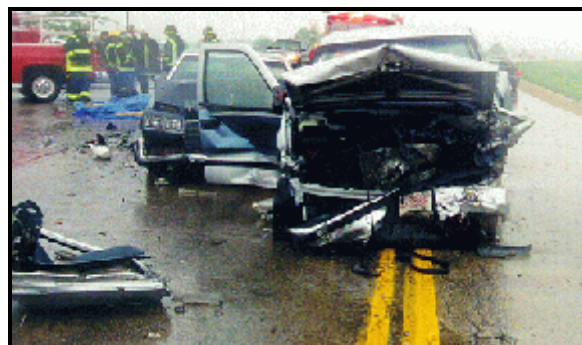
The front right of vehicle #2 (**Figure 2** above)

**Figure 2:** Front damage to vehicle #2; Note: front right damage from impact #1, front left damage from impact #2, and right side damage from impact #3 (case photo #16)

impacted the back left of the stopped vehicle #1, causing vehicle #1 to angle towards the north roadside post-impact and come to rest facing west-southwest. This first impact caused vehicle #2 to be deflected into the eastbound lane and collide (impact #2) with the case vehicle (vehicle #3) in an offset, head-on impact, causing the case vehicle's driver and front right passenger air bags to deploy. Both vehicle #2 and the case vehicle rotated counterclockwise, with vehicle #2 coming to rest facing south and the case vehicle coming to rest facing northeast (Figure 3 above). Eastbound vehicle #4 was following the case vehicle (vehicle #3) and, when vehicle #2 and the case vehicle came to rest blocking the eastbound travel lane, vehicle #4 struck the right front fender of vehicle #2 with its front left (impact #3). Vehicle #2 rotated counterclockwise and vehicle #4 rotated slightly counterclockwise and they came to rest side-by-side, facing east, with vehicle #2 straddling the centerline and vehicle #4 close by in the eastbound lane. The Police Crash Report indicated that the case vehicle was involved in impact #3 with vehicle #2 and vehicle #4, but it is this contractor's belief that the case vehicle's final rest position and damage pattern resulted from impact #2 and do not result from a possible involvement in that third impact. As well, the right front fender damage to vehicle #2 begins at its right front door's forward seam and extends to the front bumper, a length that would have included most of vehicle #4's front end width.

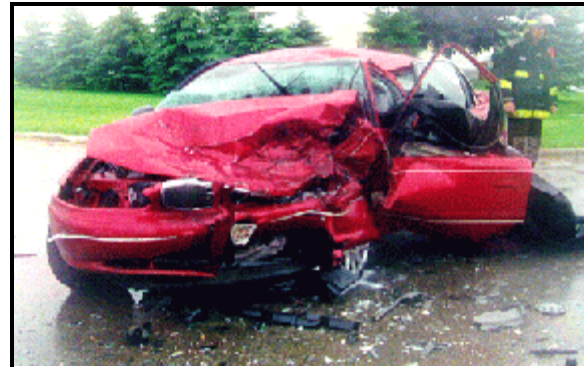
Figure 3: Front left damage to the case vehicle (case photo #04)

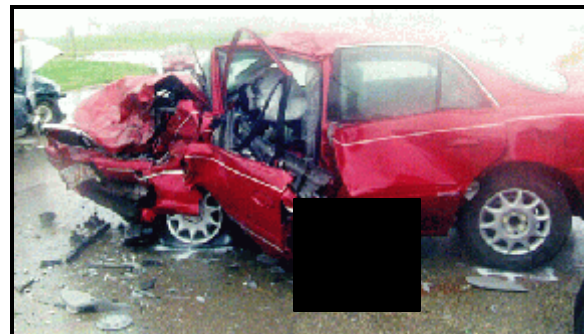
Figure 4: Left side view of case vehicle; Note: driver partially ejected (case photo #07)

The case vehicle sustained direct contact damage to the left half of the frontal plane, including the following components (Figure 4 above): the front bumper, fascia, and splash pan displaced rearward; the grille and both headlamp assemblies shattered; the left half of the hood pushed rearward and tent-folded; the back hood edge contacted, creased, and splintered the lower portion of the windshield; the left front fender pushed back into the cowl and the lower left A-pillar; the left front tire and wheel assembly pushed rearward into the lower left A-pillar, which resulted in a vertical upper left A-pillar; and the upper left A-pillar received direct contact. The left lower and upper A-pillar damage caused the left front door to be sprung open and the unrestrained driver to be partially ejected. The left front door glazing was shattered

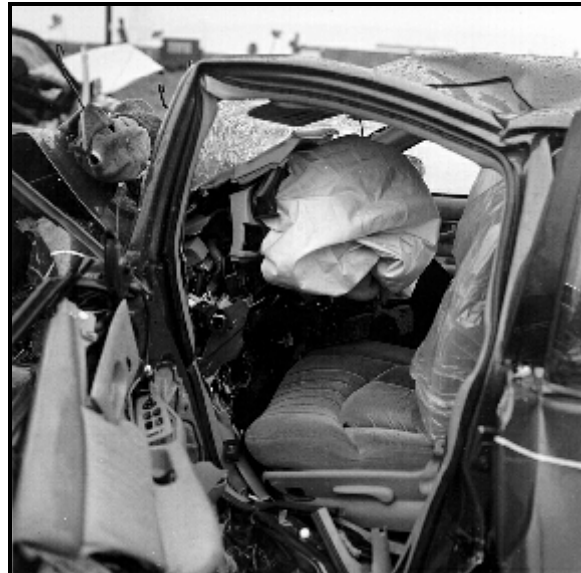
There was severe intrusion into the case vehicle's driver seat area (**Figure 5**). The toe pan was pushed rearward and the foot well upward. The left side of the instrument panel was shoved rearward and upward. The left lower and upper A-pillars were crushed inward and rearward. The steering column and wheel were pushed up and rearward. The left side of the front header was buckled down and the windshield glazing sagged inward. The left side rail buckled downward. An estimated CDC for the case vehicle from acquired commercial photographs is **12-FYAW-6**, principal direction of force 0 degrees. The WinSMASH reconstruction program, with CDC-only estimated crush profile, was used on the case vehicle's single impact (impact number two of the three in the crash sequence). These CDC-only calculations provide a borderline reconstruction, but the results appear reasonable. The Total, Longitudinal, and Lateral Delta Vs are, respectively: 67 km.p.h. (42 m.p.h.), -67 km.p.h. (-42 m.p.h.), and 0.0 km.p.h. (0.0 m.p.h.). The crash severity for the case vehicle was high [greater than 40 km.p.h. (25 m.p.h.)].

**Figure 5:** Case vehicle's driver seat area; Note: intruding components caused reduction of occupant space (case photo #12)

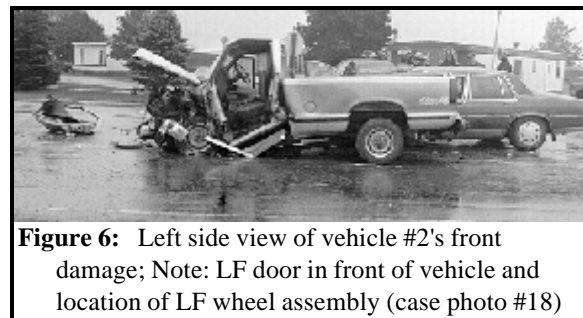
Vehicle #2 was a rear wheel drive, 1988 Chevrolet K2500, 3/4-ton, 4x4 pickup truck (VIN: 1GCFK24K7JZ-----). Vehicle #2 was towed from the scene due to disabling damage (**Figure 6**). The driver [18-year-old male; race, ethnicity, height, and weight unknown] sustained police-reported “A” (incapacitating) injuries and was transported by ambulance to a medical facility. He was alone in vehicle #2.

**Figure 6:** Left side view of vehicle #2's front damage; Note: LF door in front of vehicle and location of LF wheel assembly (case photo #18)

Damage to vehicle #2 resulting from the vehicle-to-vehicle impact with the case vehicle consisted of: left half of the front bumper, grille, left headlamp assembly, front engine compartment brackets on left side, left side of radiator, left side of hood with a center contact divot from case vehicle's A-pillar, left front fender, and the left front tire and wheel assembly. For impact #2, an estimated CDC for vehicle #2 from on-scene photographs is: **12-FYEW-4**, with principal direction of force 0 degrees. The WinSMASH reconstruction program, with CDC-only estimated crush profile, was used on vehicle #2's impact with the case vehicle (impact #2 of the three in the crash sequence). The Total, Longitudinal, and Lateral Delta Vs are, respectively: 52 km.p.h. (32 m.p.h.), -52 km.p.h. (-32 m.p.h.), and 0.0 km.p.h. (0.0 m.p.h.).

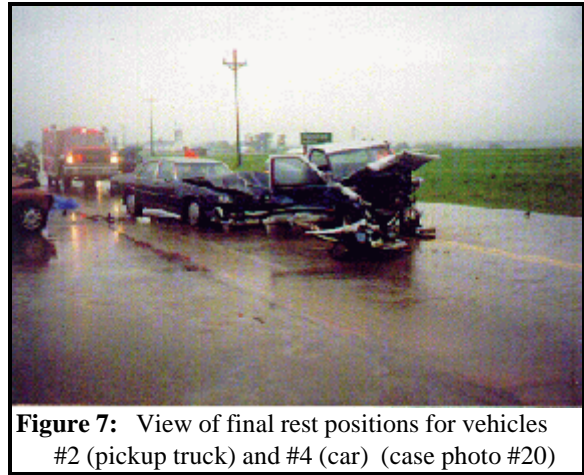
Vehicle #4 was a rear wheel drive, 1983 Buick LeSabre Limited, four-door sedan (VIN: 1G4AP69Y8DH-----). Vehicle #4 was not involved in any contact with the case vehicle and was towed from the scene due to disabling damage (**Figure 7**). The driver [18-year-old male; race, ethnicity, height and weight unknown] sustained police-reported “C” (possible) injuries and was transported by ambulance to a medical facility. He was alone in vehicle #4.

**Figure 7:** View of final rest positions for vehicles #2 (pickup truck) and #4 (car) (case photo #20)
