TRANSPORTATION RESEARCH CENTER

ON-SITE CHILD AIR BAG-RELATED FATALITY INVESTIGATION

CASE NUMBER - IN99-037
LOCATION - TEXAS
VEHICLE - 1994 PLYMOUTH VOYAGER SE
CRASH DATE - March, 1999

February 17, 2003

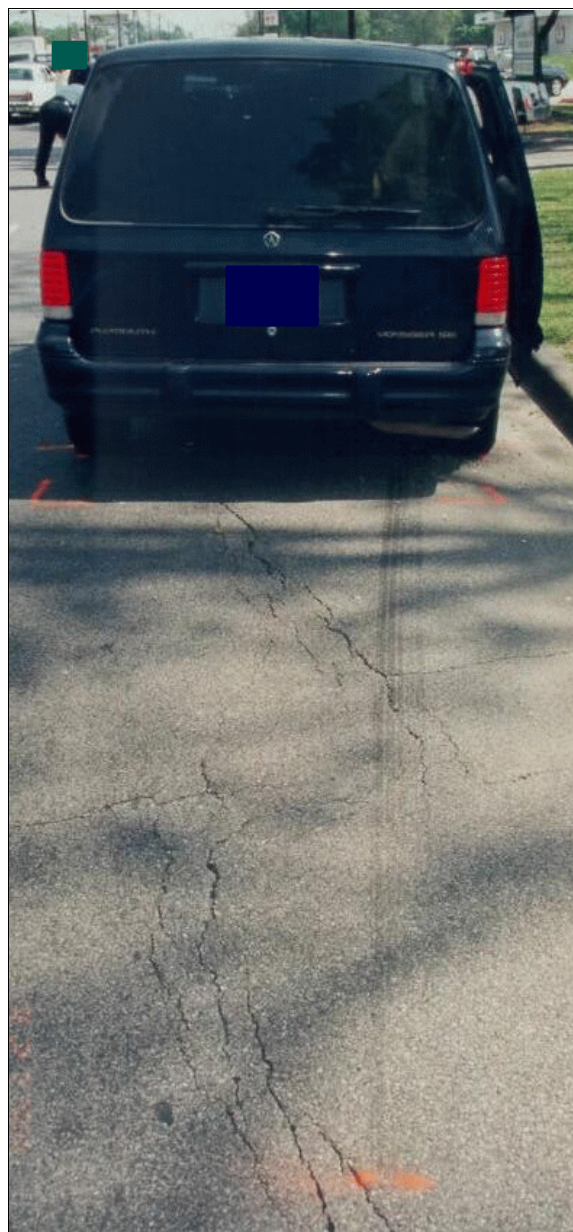
Figure 1: On-scene eastward view showing case vehicle's pre-crash trajectory and final rest position; Note: rightward yawing skid mark (case photo #63)

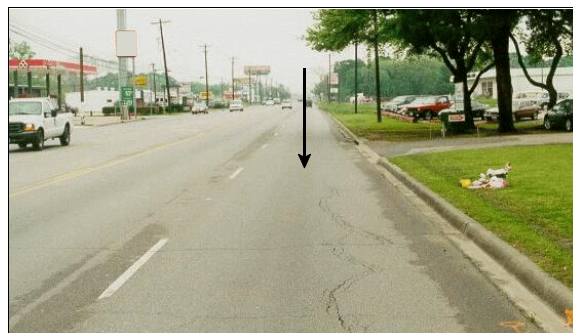
Figure 2: Approximate point of impact (arrow) in outside northeastbound lane between case vehicle and Honda (case photo #02)

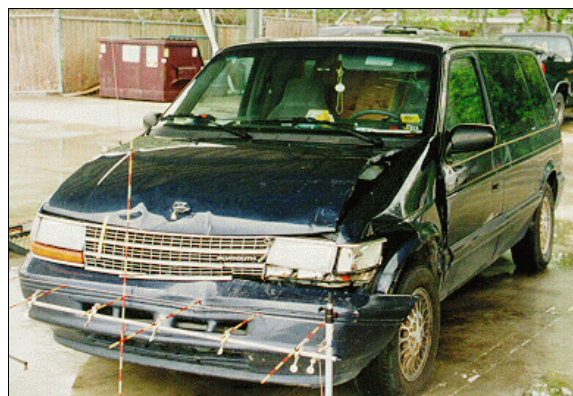
The front of the case vehicle (**Figure 3**) impacted the back of the Honda (**Figure 4** below), causing the case vehicle's driver and front right passenger supplemental restraints (air bags) to deploy. The Honda was knocked forward, and both vehicle's came to final rest in the outside northeastbound lane. The case vehicle came to rest heading in a east-northeasterly direction. The Honda came to rest heading in a northeasterly direction approximately 0.9 meters (3 feet) from

Figure 3: Case vehicle's frontal damage viewed from left of center; Note: damage from impact with back of Honda (case photo #11)

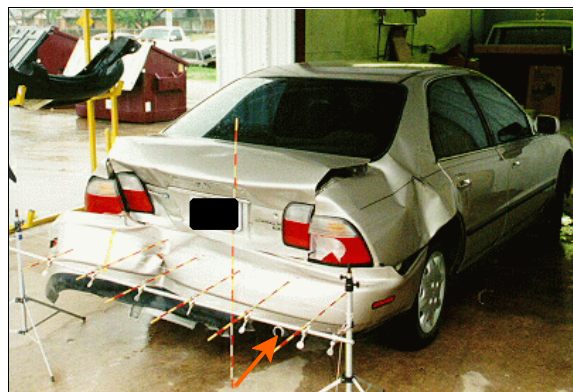
Figure 4: Deformation to back of Honda from impact with case vehicle; Note: impact offset toward right side and location (arrow) of tailpipe—see **Figure 5** below (case photo #58)

vehicle front bumper had an impression of the Honda's tailpipe towards the center indicating the crash was offset (**Figures 4 and 5** above). The case vehicle's wheelbase on both the left or right sides was not altered (i.e., shortened or extended). The case vehicle's front bumper, bumper fascia, grille, hood, radiator, and left headlight and turn signal assemblies were directly damaged and crushed rearward. The case vehicle's left front tire was partially, physically restricted from the front end damage, and none of the tires were deflated during the crash. Only the left fender sustained induced damage from the frontal impact.

The back impact to the Honda caused the back bumper and trunk lid to be crushed inward (**Figure 4** above and **Figure 15** below). Direct damage started at the back right bumper corner and extended, a measured distance of 117 centimeters (46.1 inches), leftward along the back bumper. Maximum crush was measured at 37 centimeters (14.6 inches) at C₂. The total field L

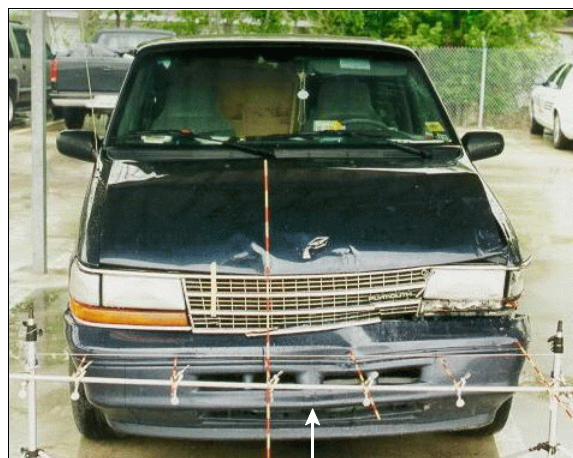
Figure 5: Case vehicle's frontal damage; Note: direct damage extends from front left corner rightward to yellow tape and slight imprint (arrow) from Honda's tailpipe (case photo #07)

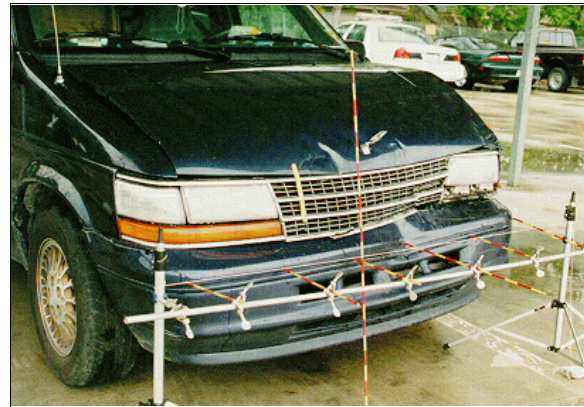
Figure 6: Case vehicle's frontal damage viewed from right of center (case photo #13)

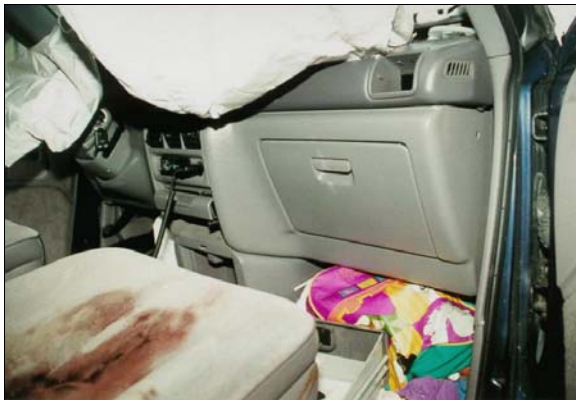
Figure 7: Case vehicle's front right seating area showing blood evidence on front right seat cushion, scuffs to glove box door, and blown out air vent in right instrument panel (case photo #32)

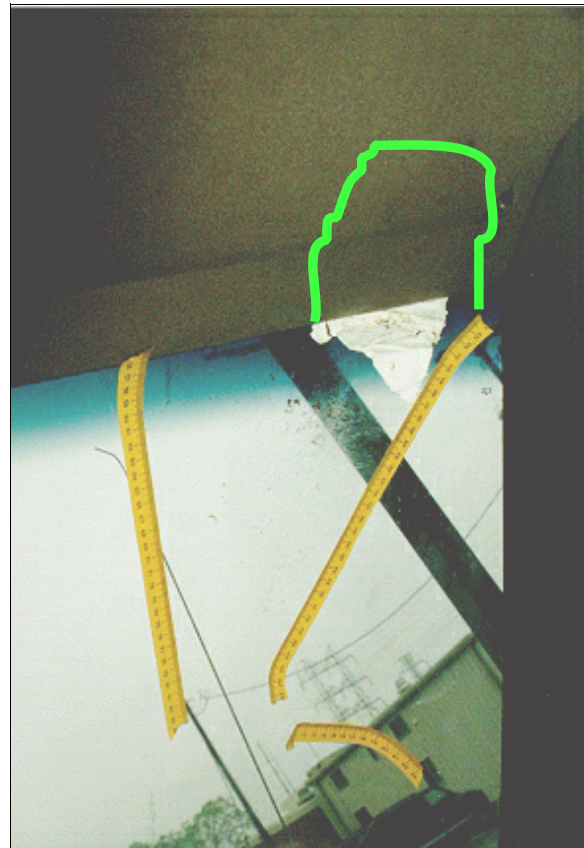
Figure 8: Case vehicle's front right seating area showing skin and body fluid transfers to windshield, front header, and sun visor from decapitated head; Note: paper from air bag has been jammed between front header and windshield (case photo #36)

The windshield on the right side towards the header was contacted by the decapitated head of the outside-seated front right passenger. Furthermore, the right header and/or sun visor was also contacted by the decapitated head. The windshield header on the passenger side had a piece of paper from the air bag jammed between the header and windshield. This paper (Figure 8 above) was most likely driven upwards to this location by the front right passenger's head (Figure 8 above). There was also an area of puddled blood on the front right seat cushion and a blood splatter to the front right seat back from the decapitated head of the outside-seated front right passenger (Figure 9). In addition, there were blood splatters scattered throughout the entire front seat area. The left windshield had a spider web crack towards the left "A"-pillar which most likely resulted from contact by a piece of cargo from within the case vehicle; however, it is possible that the driver's left hand contacted the windshield, but there were no lesions reported to this extremity. The rearview mirror was knocked off most likely from contact by the front right air bag as the air bag expanded upwards because of the loading from the two front right occupants. Finally, the energy absorbing steering column showed no visible evidence of compression, and there was no visible evidence of intrusion.

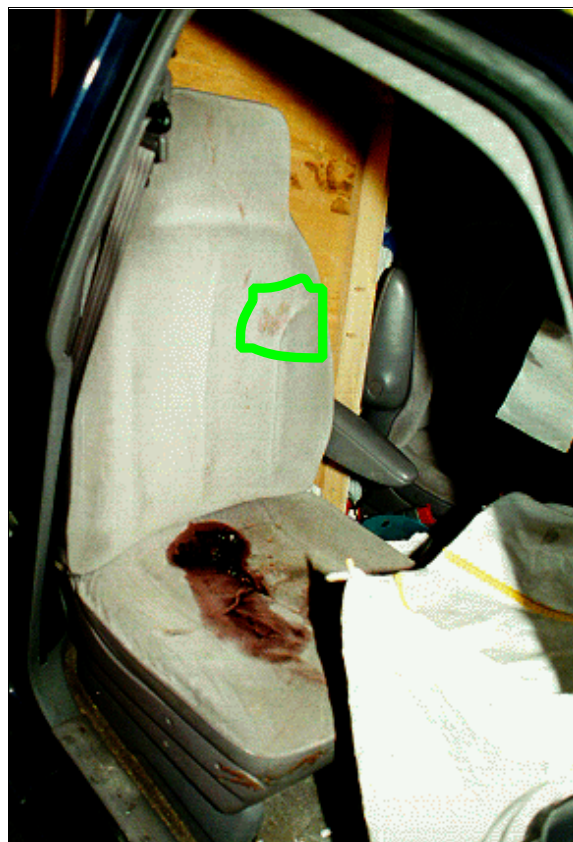
Figure 9: Case vehicle's front right seat showing pooled blood on seat cushion and head contact (i.e., outlined) to seat back (case photo #31)

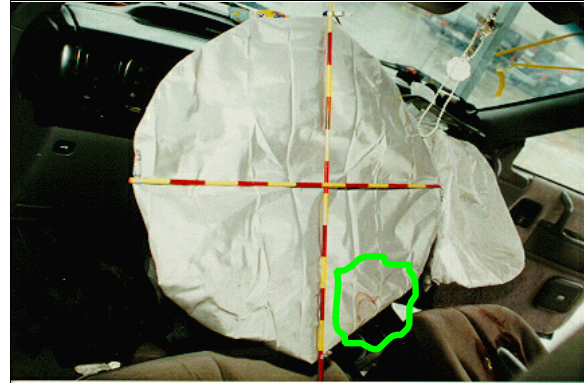
and 6 centimeters (2.4 inches) vertically for the upper flap and 7 centimeters (2.8 inches) vertically for the lower flap. An inspection of the air bag module's cover flaps and air bag revealed that the cover flaps opened at the designated tear points, and there was no evidence of damage to the air bag or the cover flaps; however, the air bags deployment did result in a 2 centimeter (0.8 inch) tearing at the module's four corners. The driver's air bag was designed without any tethers. The driver's air bag had two vent ports, approximately 3 centimeters (1.2 inches) in diameter, located at the 11:30 and 12:30 o'clock positions. The deployed driver's air bag was round with a diameter 63 centimeters (24.8 inches). An inspection of the driver's air bag revealed a lipstick imprint and make-up smear, measuring 13 x 11 centimeters (5.1 x 4.3 inches), on the lower right quadrant of the front surface (**Figure 10**).

Figure 10: Case vehicle's driver air bag showing lipstick and make-up smear (i.e., circled) on lower right quadrant (case photo #39)

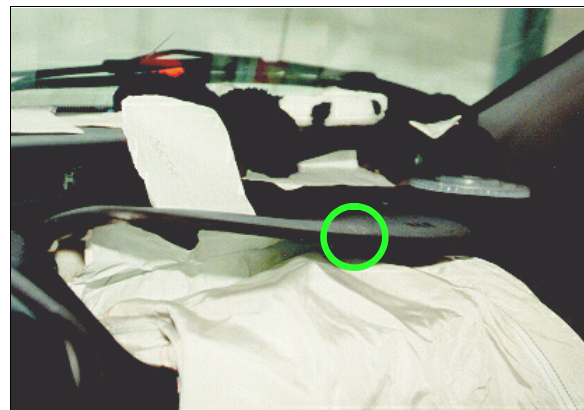
Figure 11 Case vehicle's front right air bag module's cover flap showing misalignment resulting from contact with front right passenger and skin transfer in circled area (case photo #48)

The case vehicle's driver braked, attempting to avoid the crash. As a result of this attempted avoidance maneuver, the resulting clockwise yaw, and the nonuse of the available safety belts, the outside-seated front right passengers moved forward and slightly to the left just prior to impact. Since part of the inside-seated front right passenger's body was located behind the outside-seated front right passenger, the inside passenger's (4-year-old) weight helped push the outside passenger (2-year-old) forward where her knees impacted the glove box in the right instrument panel. The case vehicle's impact with the Honda enabled the case vehicle's outside-seated front right passenger to continue forward, slightly leftward, and upward toward the 340 degree Direction of Principal Force as the case vehicle decelerated. Furthermore, a portion of the inside passenger's body was compressing her outside sister against the instrument panel. As a result, the outside-seated front right passenger's head/neck was positioned directly atop the cover flap and deploying air bag near the moment of deployment (**Figures 11** and **12** above).

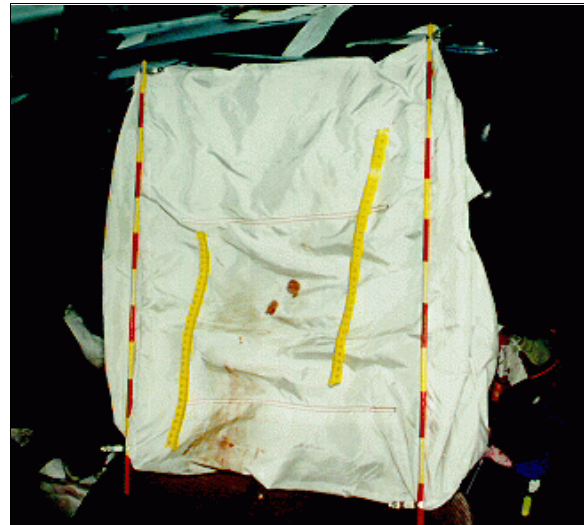
Figure 12: Vertical view of case vehicle's front right passenger air bag showing skin and body fluid transfers down entire front of air bag (case photo #44)

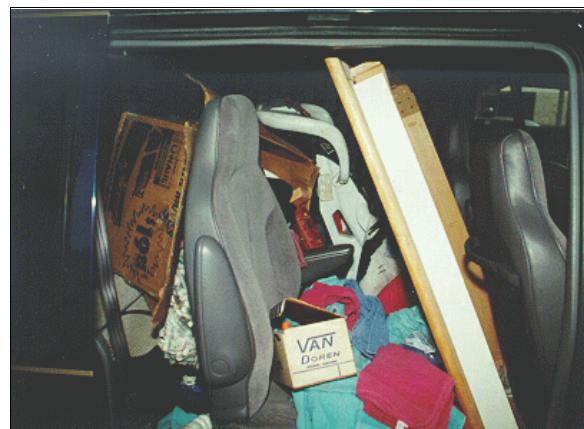
Figure 13: Case vehicle's second seating area viewed from sliding door showing excess cargo loaded behind front seats; Note: child safety seat stuffed between second left seat's seat back and table (case photo #53)

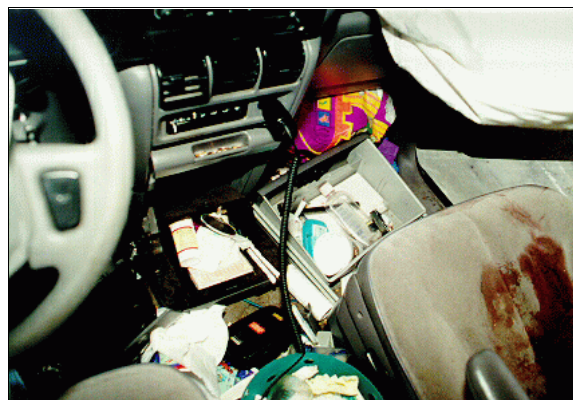
Figure 14: Case vehicle's center and front right floor board area showing final rest positions of both front right passengers; Note: case passenger was found seated in rolled out glove box with back against seat cushion (case photo #26)

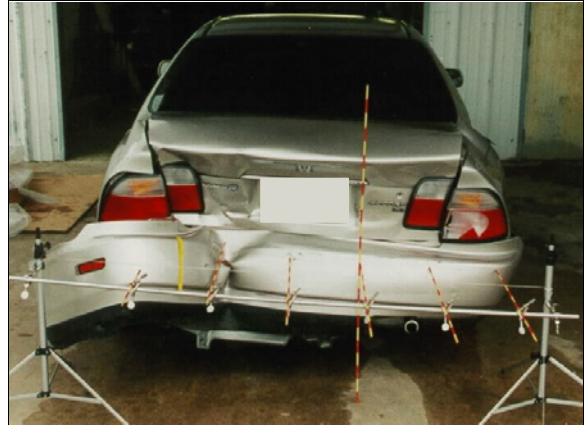
Figure 15: Honda's damaged back showing offset nature of crush profile; direct damage extends leftward from back right corner to yellow tape (case photo #56)
