**REMOTE REDESIGNED AIR BAG DEPLOYMENT INVESTIGATION
SCI TECHNICAL SUMMARY REPORT**

VERIDIAN CASE NO. CA99-037

RABSS VEHICLE - 1998 LINCOLN TOWN CAR

CRASH DATE - SEPTEMBER 1998

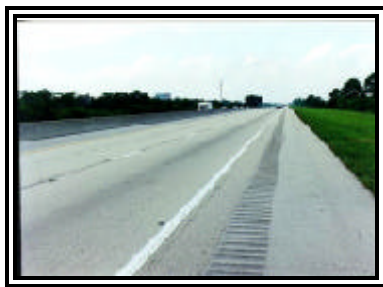
The 69-year-old female driver of the 1998 Lincoln Town Car was operating the vehicle in the right lane of the two northbound traffic lanes of an interstate (**Figure 1**) when she approached debris from a truck tire tread lying in the outboard lane of the northbound traffic lanes. The driver initiated a right steering input to avoid the tire debris. The right side tires departed the travel lane onto the right shoulder. As the tires overrode the tactile warning devices (rumble strips), the driver applied a steering input to redirect the Lincoln back onto the outboard northbound travel lane (**Figure 2**). The subsequent steering input was excessive which induced a counterclockwise (CCW) rotation to the vehicle as its center of gravity continued in a northerly direction. The vehicle traversed the travel lanes as it continued to rotate CCW, departing the left (inboard) shoulder (**Figure 3**). Based on the police schematic, the Lincoln traveled a longitudinal distance of 66.1 meters (217.0') from the point at which the vehicle entered the right shoulder to the impact with the median barrier.

Figure 1. View looking north

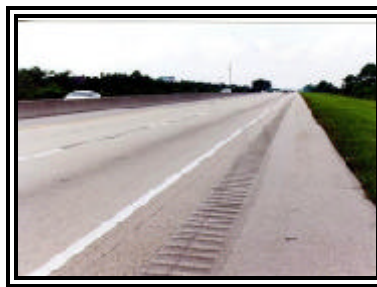
Figure 2. Tire marks on right shoulder

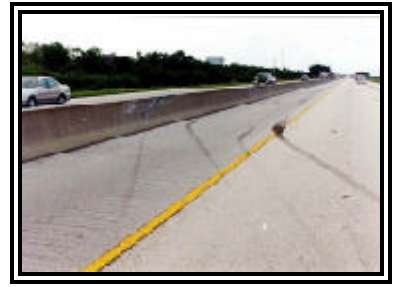
Figure 3. Tire marks to point of impact

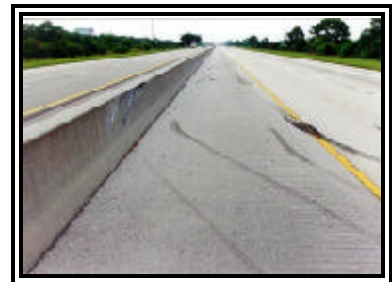
As the Lincoln Town Car impacted the concrete barrier, the front-left portion of the vehicle contacted the barrier approximately 46 cm (18") above the roadway (**Figure 4**). The vehicle continued into the barrier at an approximate heading angle of -45 degrees causing the entire front plane of the vehicle to contact the barrier. The principal direction of force was in the 2 o'clock sector. The impact resulted in moderate damage to the front of the vehicle. The damage algorithm of the WinSMASH program computed total velocity changes of 16.5 km/h (10.3 mph). The longitudinal and latitudinal components were -10.6 km/h (-6.3 mph) and -12.6 km/h (-7.9 mph) respectively. The impact induced deceleration was sufficient to deploy the frontal air bag system.

Figure 4. Point of impact and post impact tire marks along the median barrier

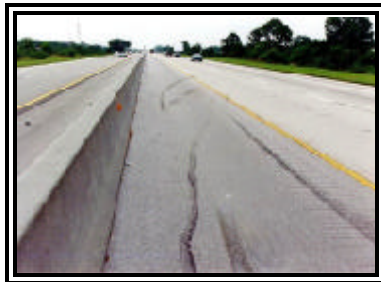
direction. The lateral loading of the right rear wheel caused a fracture of the rear axle. The wheel was snagged by the brake and suspension components and dragged by the vehicle. The vehicle continued along the barrier approximately 5 meters (17') (**Figure 5**) as evidenced by considerable scuff marks from the left front wheel. The vehicle then swerved to the right induced by the right rear wheel, and traveled approximately 71 m (232') in a northerly direction back across the traffic lanes. The vehicle entered the right shoulder with the clockwise rotation diminishing as the vehicle traveled onto the grassy area adjacent to the shoulder, where it came to rest facing in an easterly direction (**Figure 6**).

Figure 5. Post impact tire marks along median barrier

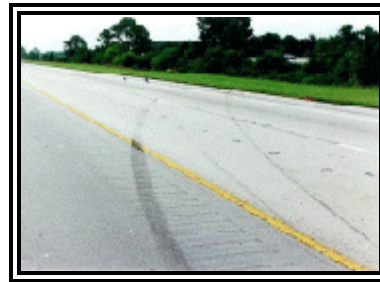
Figure 6. Tire marks showing path to final rest

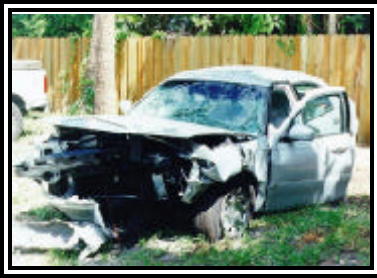
The 1998 Lincoln Town Car sustained severe frontal damage with significant damage to the front left area (**Figure 7**). The vehicle also sustained a reduction of the left and right side the wheelbase. The Collision Deformation Classification (CDC) for this impact with the median barrier was 02-FDEW-2. The direct contact damage began at the front right bumper corner and extended approximately 149 cm (59") to the

Figure 7. Damage to the Lincoln Town Car

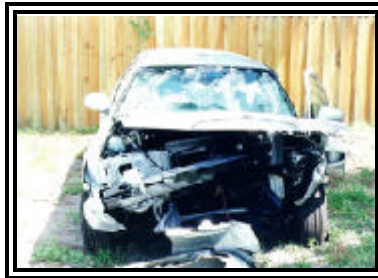
front left bumper corner. The combined direct and induced damage spanned the full width of the vehicle (**Figure 8**). Six crush measurements were estimated at the level of the radiator support and were as follows: C1 = 38 cm (15"), C2 = 38 cm (15"), C3 = 25 cm (10"), C4 = 15 cm (6"), C5 = 8 cm (3"), C6 = 0 cm. The contact damage was limited primarily to the front plane of the vehicle. The left front wheel/tire was restricted and deflated from rearward displacement against the frame. The rear axle was fractured, and the right rear wheel was displaced (**Figure 9**).

Figure 8. Frontal damage to the Lincoln Town Car

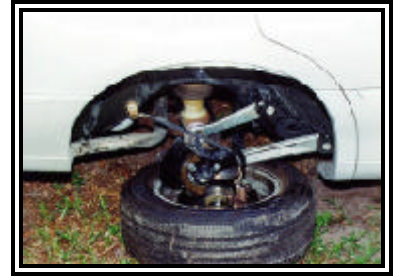
Figure 9. Displaced right rear wheel

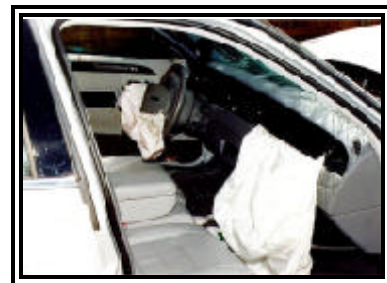
Interior damage to the Lincoln Town Car was rated as minor (**Figure 10**). There were no apparent intrusions. No deformation was identified on the knee bolster (rigid plastic type) or steering wheel rim. Blood smears were noted on the steering wheel rim, airbag, left interior door panel, left front seat, and center arm rest.

Figure 10. Interior view of Lincoln Town Car
