REMOTE AIR BAG DEPLOYMENT REPORT

CASE NUMBER - IN99-038

LOCATION - Alabama

VEHICLE - 1998 CHEVROLET LUMINA LS

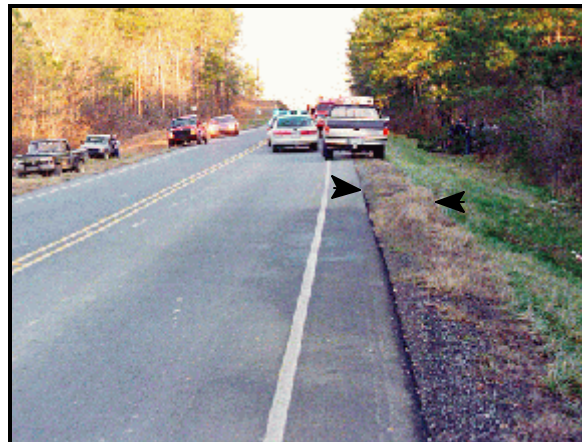
The case vehicle was traveling south in the southbound lane of a two-lane, undivided, state route and was intending to continue its southerly travel path (**Figure 1**). It was daylight, clear weather, 60 degrees, and no reported road defects or material in the road. The roadway was bituminous, dry, a slight left curve southbound, a positive grade to the south, and no vision obstructions. Posted speed limit was 89 km.p.h. (55 m.p.h.) and the investigating officers estimated the case vehicle's pre-impact travel speed at 113 km.p.h. (70 m.p.h.). Traffic controls consisted of a double solid yellow (no passing) centerline and a single solid white edge line on each side of the pavement. They were clearly visible. Investigating officers did not indicate any attempted avoidance maneuvers by the driver nor did any of the police photographs evidence such maneuvers. The crash occurred off the right (west) pavement edge.

Figure 1: Case vehicle's pre-impact travel path;
Note: off-road tire tracks (case photo #01)

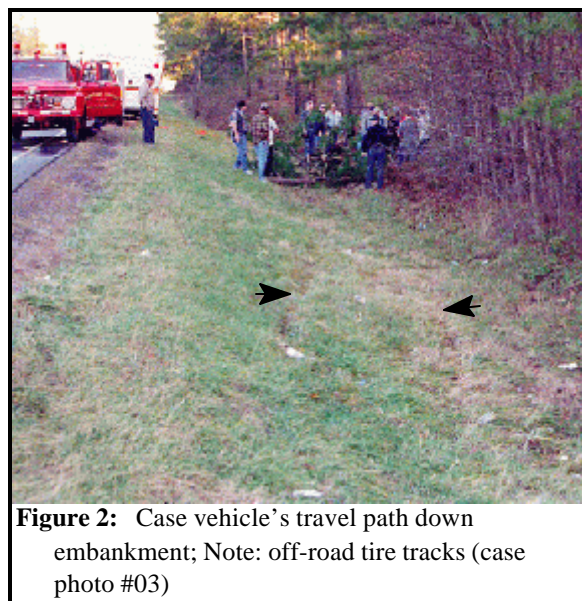
Coming out of a left-hand curve, the southbound case vehicle exited the right (west) pavement edge at a shallow angle. Police photographs indicate that the case vehicle's off road travel path continued at that shallow angle across a paved shoulder, across a gravel and earth shoulder extension, down an embankment, and into a tree line (**Figure 2**). The case vehicle's front plane impacted and knocked down a small evergreen tree (estimated to have been a nondeployment impact), continuing on and striking two large trees (one behind the other), causing the case

Figure 2: Case vehicle's travel path down embankment; Note: off-road tire tracks (case photo #03)

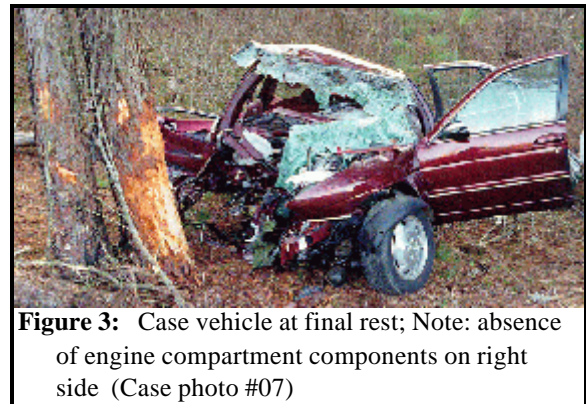
As stated previously, direct damage from contact with the first evergreen tree was masked by the subsequent severe crush with the larger trees. The following discussion of damaged vehicle components results from studying acquired police scene photographs of the case vehicle at final rest (**Figure 3**): the front bumper, fascia, and splash pan displaced rearward; the grille and both headlamp assemblies shattered; the hood torn from its mounting; the right side of the engine compartment is devoid of components; the right front fender and right front tire and wheel assembly not visibly attached to vehicle; the right upper A-pillar was cut post-crash and allowed the right front door to fall almost parallel to the ground with its glazing shattered (its original post-crash position is not known); the right rear door glazing was shattered; the right half of the engine cowl was shoved rearward; the windshield was splintered (its lateral split may have been induced by extrication activities); the roof header was contacted right of center; and the left front fender was pulled to the right.

Figure 3: Case vehicle at final rest; Note: absence of engine compartment components on right side (Case photo #07)

No CDC with the first evergreen tree could be estimated. A CDC for the second impact with the larger trees (estimated from police photographs) is: **12-FDAW-7**, primary direction of force of 10 degrees (010). The WinSMASH reconstruction program, barrier algorithm with a CDC-only estimated crush profile, provided a borderline reconstruction, but the results appear reasonable. The estimated Total, Longitudinal, and Lateral Delta Vs are: 110.7 km.p.h. (68.8 m.p.h.), -107.0 km.p.h. (-66.5 m.p.h.), and -28.7 km.p.h. (-17.8 m.p.h.). The crash severity for the case vehicle was high [greater than 40 km.p.h. (25 m.p.h.)].

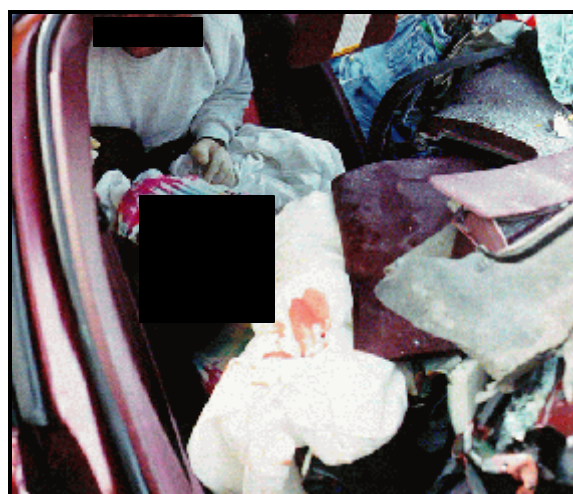
Photographic views into the case vehicle's interior were limited but it is obvious that there was severe intrusion of the instrument panel's right side into the front right passenger seat area. Part of the windshield was hanging down into the greenhouse. The right-side toe pan and foot well were shoved rearward and upward. The deployed front right passenger air bag was covered with blood stains, most likely from the front right passenger.

Figure 4: Interior view of case vehicle; Note: rearward movement of instrument panel's right side (case photo #09)
