REMOTE AIR BAG DEPLOYMENT REPORT

CASE NUMBER - IN99-041

LOCATION - ARIZONA

VEHICLE - 1998 HONDA ACCORD EX

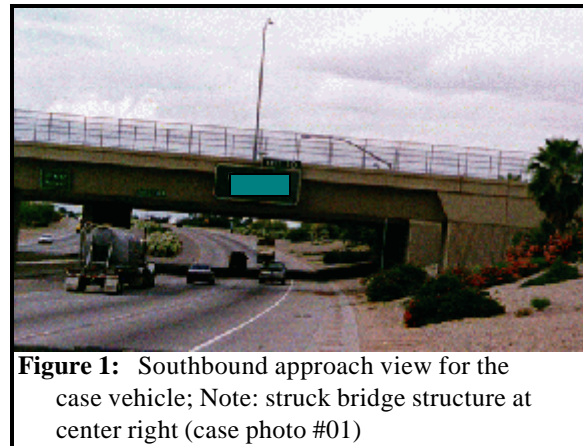
The case vehicle was traveling south in one of three southbound lanes of a six-lane, divided, urban expressway, intending to continue its southbound travel path (**Figure 1**). Ambient conditions were darkness, but lighted, clear weather, and light traffic density. The roadway was concrete, dry, curve left, a negative grade to the south, and no apparent roadway defects. The posted speed limit was 89 km.p.h. (55 m.p.h.), with the case vehicle's travel speed estimated at the speed limit by the investigating officer. Traffic control devices were limited to pavement markings: a single solid white edge line on the right (west) roadway edge; two lane lines consisting of a recurrent series of five raised white delineators, with the first being reflectorized; and a single solid yellow edge line on the left (east) roadway edge. All traffic control devices were clearly visible. The crash occurred off the roadway, beyond the paved right (west) shoulder.

Figure 1: Southbound approach view for the case vehicle; Note: struck bridge structure at center right (case photo #01)

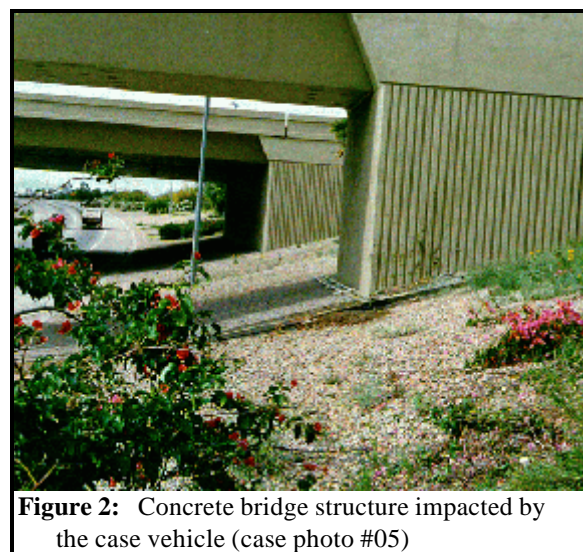
Figure 2: Concrete bridge structure impacted by the case vehicle (case photo #05)

were attempted. The front of the case vehicle struck a massive concrete bridge wing wall, causing its driver and front right passenger air bags to deploy (**Figure 2** above). The case vehicle rebounded rearward approximately 0.6 meters (two feet) and rotated slightly clockwise an unknown number of degrees (**Figure 3**).

The case vehicle impacted a massive concrete bridge wing wall that was part of a railroad overpass, with only the extreme front left bumper corner not making contact with the wall. There was minor abrading to the surface of the wall, but there was no evidence that the wall fractured or was otherwise damaged.

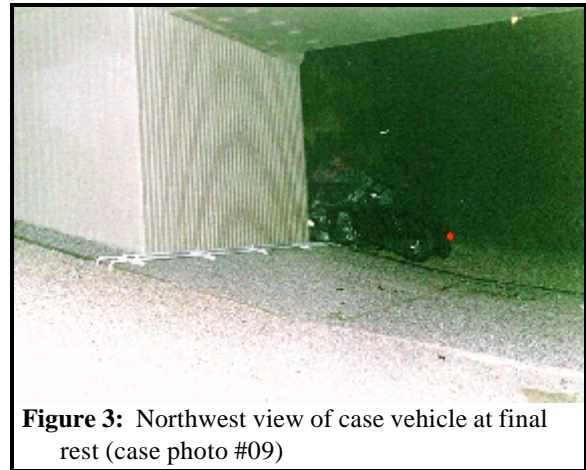
Figure 3: Northwest view of case vehicle at final rest (case photo #09)

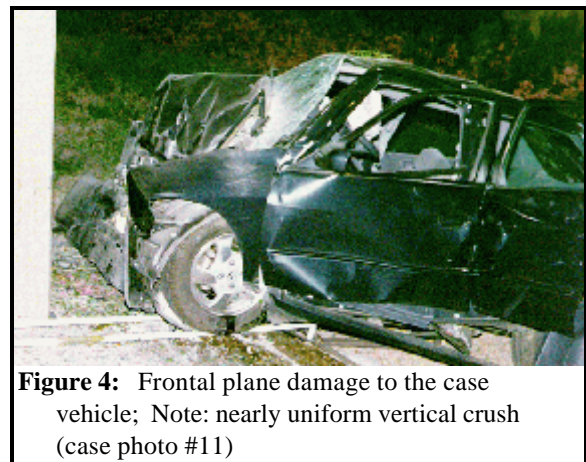
Direct contact damage was sustained to the case vehicle's front plane, beginning slightly to the right of the front left bumper corner (**Figure 4**). The front bumper and fascia, grille, engine compartment brackets, radiator, hood, and right front fender were all displaced rearward and the crush was close to being uniform and vertical (**Figure 5**). Both the left and right headlamp assemblies were shattered. Induced damage included the left front tire pushed into the lower left A-pillar, the left front fender pulled slightly inward, the left upper A-pillar slightly straightened, the left side of the windshield separated from the left A-pillar and splintered, the left front and left rear door panels buckled, the left front door glazing shattered, the left rocker panel molding strip almost totally detached, the left rocker panel buckled, the left rear wheel well and forward portion of the left rear quarterpanel buckled, the left C-pillar buckled, the left roof rail buckled at the B-pillar, the left rear corner of the roof buckled near the back light, the right rear quarter panel over the right rear wheel well and the bottom portion of the right upper C-pillar were buckled, the right rocker panel molding strip was almost totally detached, the right

Figure 4: Frontal plane damage to the case vehicle; Note: nearly uniform vertical crush (case photo #11)

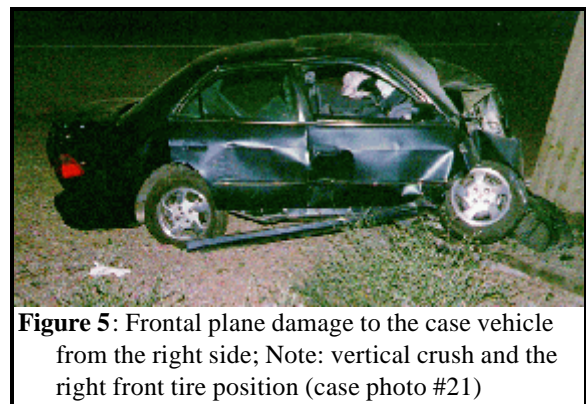
Figure 5: Frontal plane damage to the case vehicle from the right side; Note: vertical crush and the right front tire position (case photo #21)

rocker panel buckled, the right front and right rear door panels buckled, the right roof rail was buckled immediately rearward of the upper B-pillar, the sunroof buckled at its left and right sides, the right front door glazing shattered, the bottom portion of the right upper A-pillar contacted by the rear hood edge, the right front tire pushed into the lower right A-pillar, and the right front tire and wheel laid over at a 45 degree angle, with the top slanted in and the bottom out. Based on police photographs, the CDC for the case vehicle was estimated as **12-FDEW-4** (principal direction of force of 0 degrees). The WinSMASH reconstruction program, CDC-only algorithm, provided a borderline reconstruction, but the results appear reasonable. The case vehicle's estimated Total, Longitudinal, and Lateral Delta Vs are, respectively: 93.3 km.p.h. (58.0 m.p.h.), -93.3 km.p.h. (-58.0 m.p.h.), and 0.0 km.p.h. (0.0 m.p.h.).

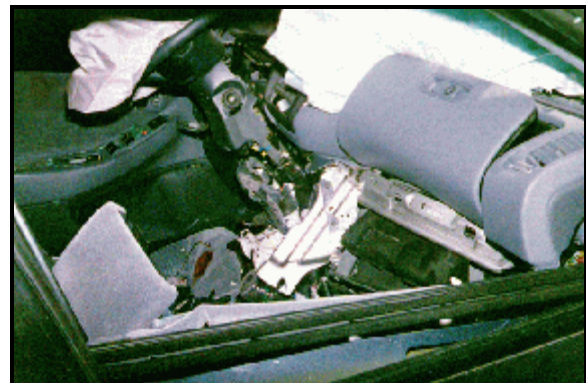
Interior damage to the case vehicle was assessed from the available police photographs. The frontal plane crush was sufficient to displace the engine rearward into the cowl, resulting in the toe pan, foot well, and instrument panel being pushed inward and upward. The intrusion seems deeper at the center and right side of the front seating area. The instrument panel rotated, such that its front surface was facing the roof, post-crash (**Figure 6 and 7**).

Figure 6: Case vehicle's post-impact interior; Note: rotation of instrument panel and position of the steering column (case photo #28)

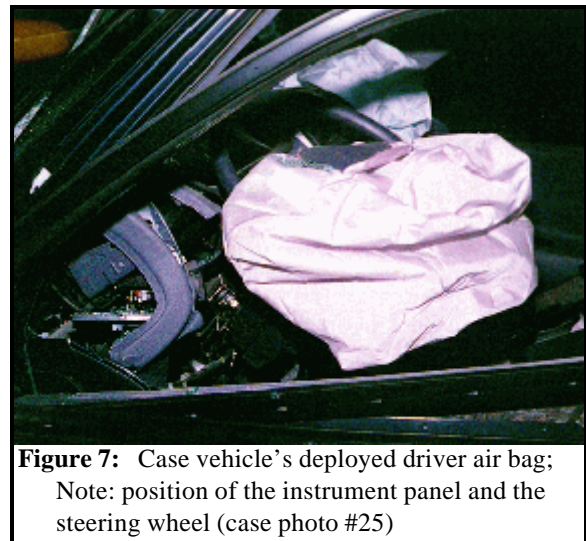
Figure 7: Case vehicle's deployed driver air bag; Note: position of the instrument panel and the steering wheel (case photo #25)
