REMOTE AIR BAG DEPLOYMENT REPORT

CASE NUMBER - IN99-043

VEHICLE - 1998 SUBARU LEGACY WAGON

CRASH DATE - May 1998

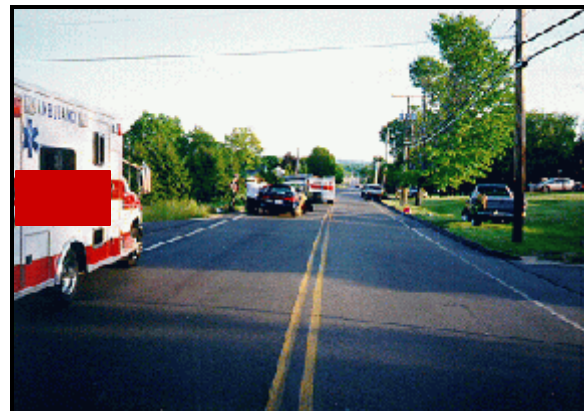
The case vehicle was traveling south in the southbound lane of a two-lane, undivided, state highway (**Figure 1**). Vehicle #2 was traveling north in the northbound lane of the same roadway. It was daylight with clear weather. The roadway was bituminous, dry, straight, level, with no roadway defects and no vision obstructions. The posted speed limit for this roadway was 64 km.p.h. (40 m.p.h.). Traffic control devices present at the crash scene consisted of a double solid yellow (no passing) centerline and single solid white edge lines on the east and west pavement edges. For some unknown reason, the case vehicle drifted left of center into the northbound lane. There was no evidence of pre-impact braking by the case vehicle and a witness following the case vehicle saw no brake lights prior to the crash. Investigating officers did not detect any pre-impact brake marks from vehicle #2, but its driver stated she "slammed" on the brakes immediately prior to impact and a witness noticed the front of vehicle #2 "dip" just prior to the collision.

Figure 1: Southerly view of crash scene; Note: case vehicle at final rest left-of-center (case photo #01)

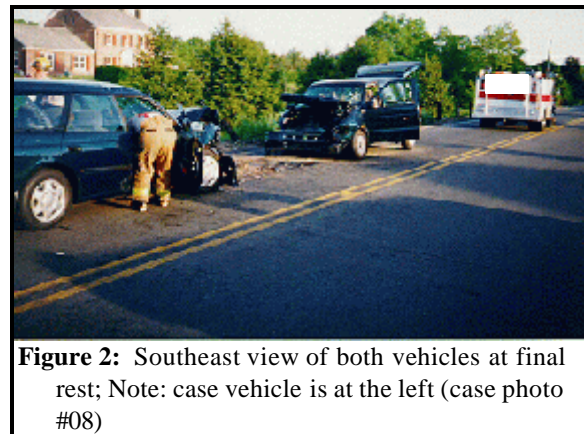
Figure 2: Southeast view of both vehicles at final rest; Note: case vehicle is at the left (case photo #08)

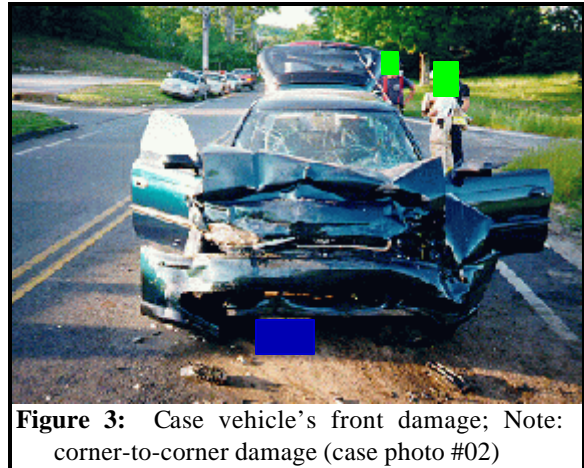
Figure 3: Case vehicle's front damage; Note: corner-to-corner damage (case photo #02)

The case vehicle sustained direct contact across the entire width of its front end (**Figure 3**). All damaged components directly contacted were displaced rearward: the front bumper and fascia, grille, front hood edge, and left and right front fenders. The left headlamp assembly was missing and the right headlamp assembly was smashed but remained in place. Both turn light assemblies were missing. Induced damage included: left front tire and wheel restricted and pushed into left lower A-pillar, windshield splintered, left front door pushed into left lower B-pillar, left roof rail buckled, right front tire and wheel restricted and pushed into right lower A-pillar, right front door pushed into right lower B-pillar, and the right roof rail buckled. Based on police photographs, the CDC for the case vehicle was estimated as: **12-FDEW-2** (principal direction of force 0 degrees). The WinSMASH reconstruction program, with CDC-only estimated crush profile, provided a borderline reconstruction, but the results appear reasonable. The case vehicle's estimated Total, Longitudinal, and Lateral Delta Vs are, respectively: 59.2 km.p.h. (36.8 m.p.h.), -59.2 km.p.h. (-36.8 m.p.h.), and 0.0 km.p.h. (0.0 m.p.h.).

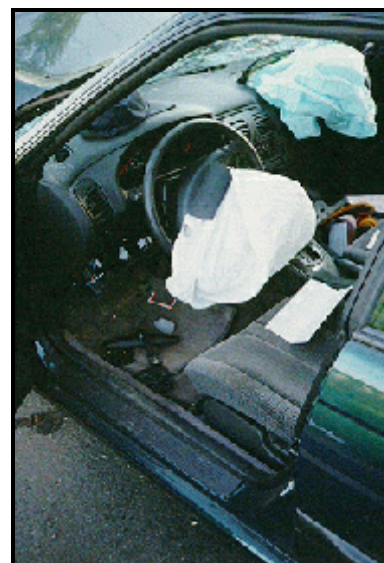
Interior damage to the case vehicle was difficult to assess with a single photograph as the sole view inside. There is a slight indication that the driver's foot well might have sustained a modest upward intrusion, but investigating officers stated in the Police Crash Report's narrative, "The interior of the vehicle was mostly undamaged with only the steering wheel and steering column being pushed forward."

Figure 4: Case vehicle driver’s seat area; Note: no obvious contact marks on air bag or steering wheel (case photo #12)

The case vehicle driver’s injuries resulted in respirator-dependant quadriplegia. A decision was made to discontinue the respirator support and the case vehicle’s driver was pronounced dead approximately five days and 16 hours post-crash. No autopsy was performed. Immediate causes of death listed on his death certificate consisted of, “respiratory failure and multiple blunt force injuries with fracture-dislocation of cervical spine, contusion of the spinal cord, and quadriplegia.” The fracture-dislocation of the cervical spine and contusion of the spinal cord were likely caused by contact with the driver’s air bag. Injuries mentioned in the narrative section of the Police Crash Report consisted of, “several broken ribs and a broken C2 vertebra.” The rib fractures likely resulted from steering wheel contact.

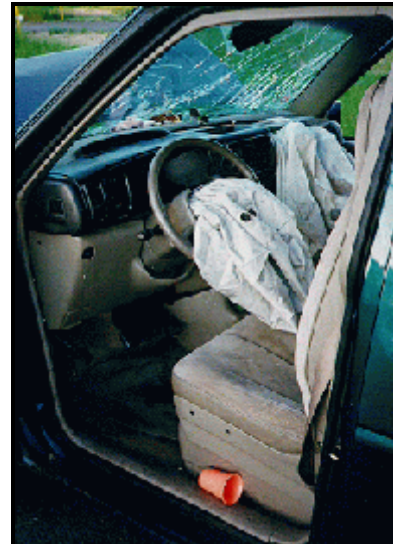
Figure 5: Vehicle #2 driver's seat area; Note: both front air bags deployed (case photo #13)

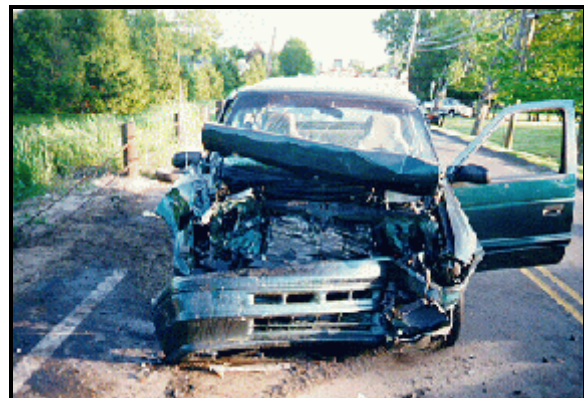
Figure 6: Vehicle #2's front damage; Note: maximum crush just right of the front left corner (case photo #07)
