Remote, Redesigned Air Bag Special Study
FOR NHTSA'S INTERNAL USE ONLY
Dynamic Science, Inc., Case Number (DS99043)
1998 Ford Escort station wagon
Oregon
October/1998

This remote investigation was initiated in response to a possible redesigned air bag deployment. The case was selected from the FARS data files. The redesigned air bag was installed in a 1998 Ford Escort.

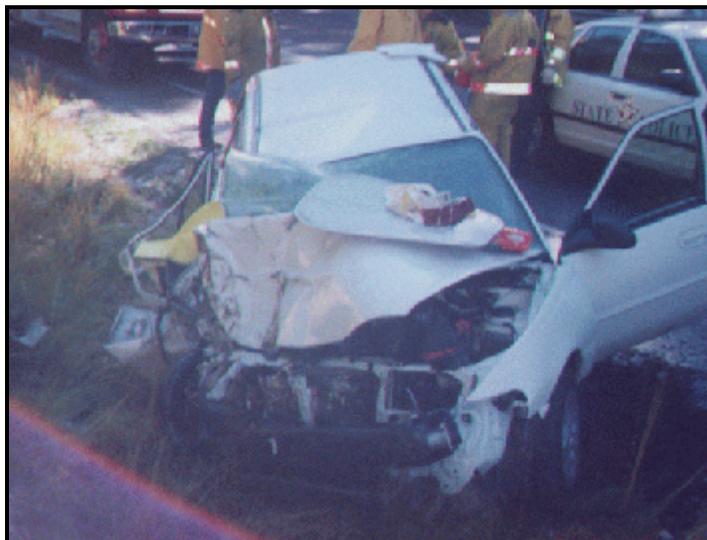
Figure 1. Exterior, case vehicle (1998 Ford Escort)

The case vehicle had sustained heavy front contact damage to the right half of the front end and hood. The right side “A” pillar had been pushed back to a point about half the width of the door opening on the right side. The instrument panel, on the passenger side, was even with the front edge of the front right passenger seat. The vehicle was later towed from the scene due to disabling damage.

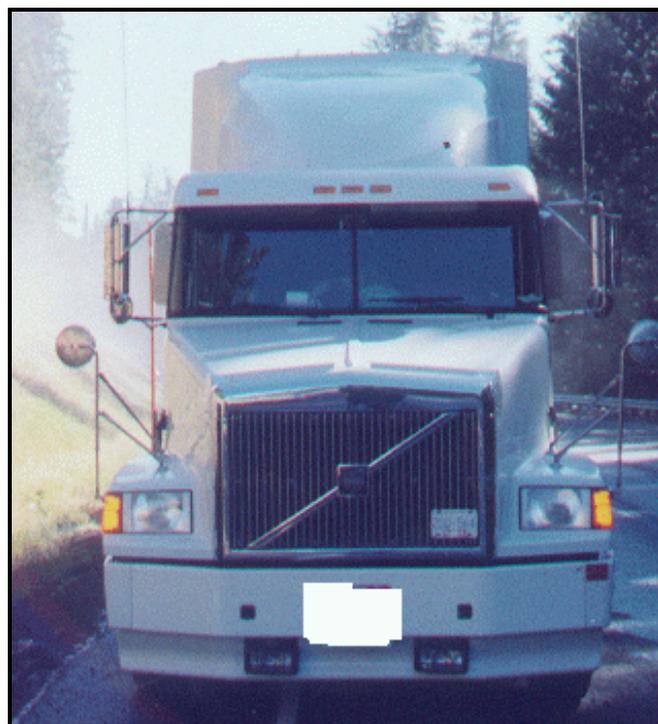
Figure 2. Exterior, other vehicle (1996 Volvo tractor trailer)

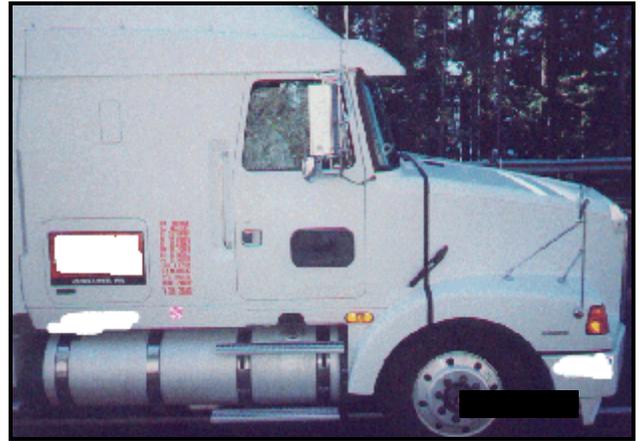
Figure 3. Other vehicle, right side of tractor

The other vehicle sustained light contact damage to the right side of the cab immediately forward of the drive axle. There was contact damage to the right front drive tire and heavy contact damage to the right rear drive tire. There was light contact damage down the frame rail of the trailer and heavy contact damage to the front right trailer tire—the outside tire was torn off the rim, the rim was heavily damaged, and the axle was broken from the frame.

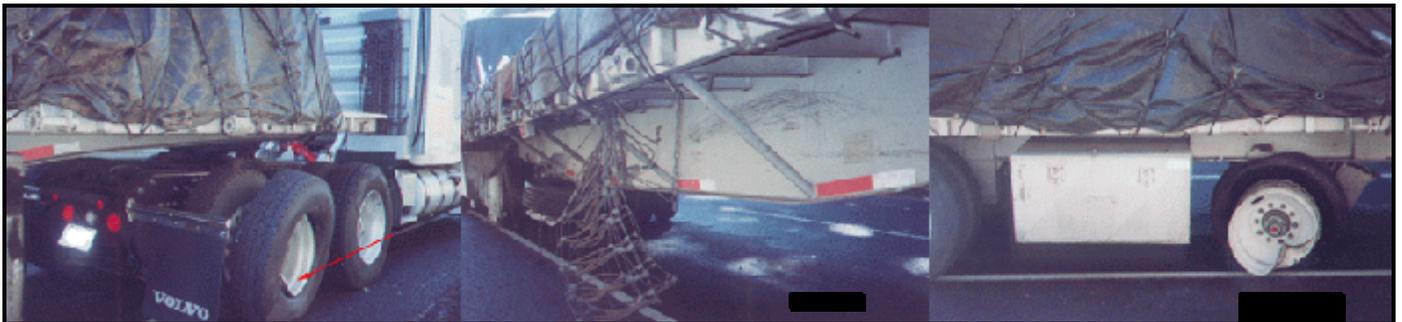
Figure 4. Other vehicle, shows view of damage to rear drive axle, trailer, and front trailer wheel

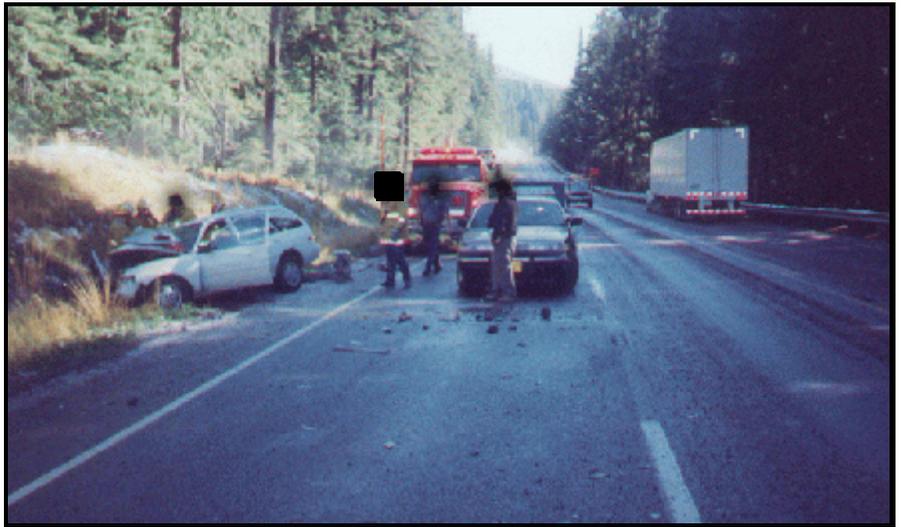
Figure 5. Final rest for case vehicle

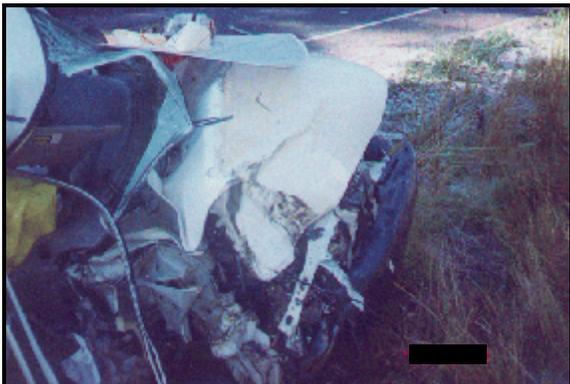
Figure 6. Case vehicle, right side view

The case vehicle sustained substantial longitudinal intrusion of the right instrument panel, toe pan, and A-pillar. There was intrusion along the entire right side. There was integrity loss through the windshield and right front side window.

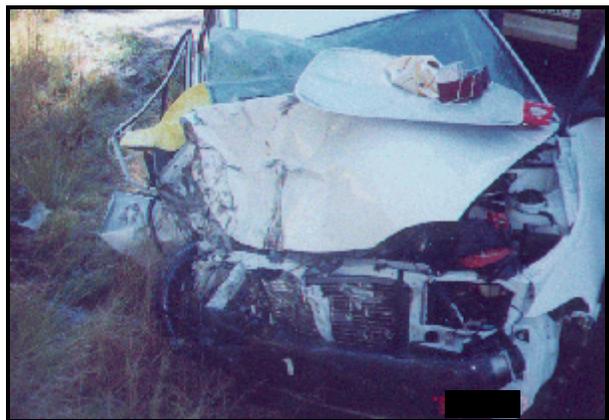
Figure 7. Case vehicle, frontal view

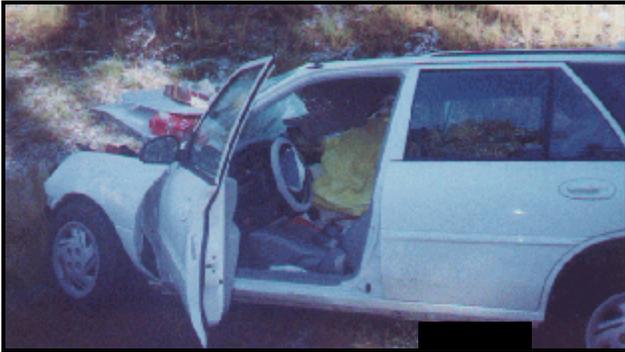
Figure 8. Case vehicle, left side view

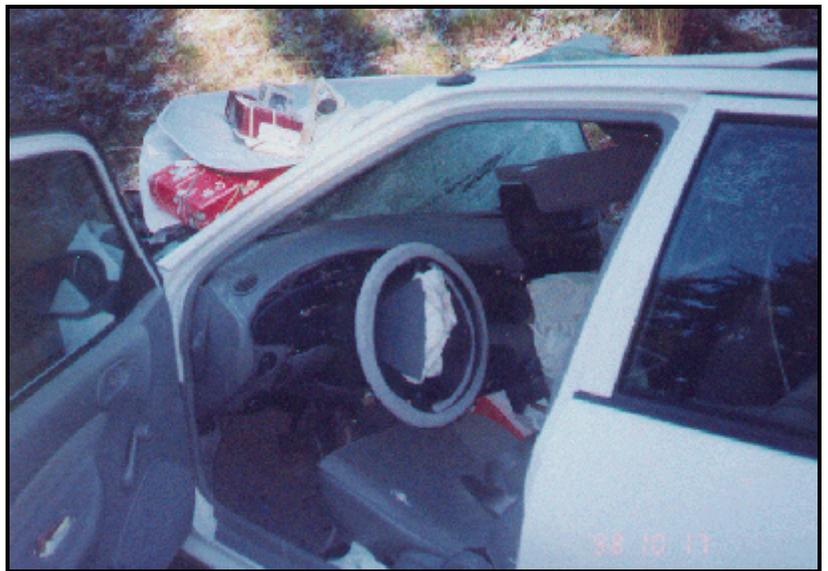
Figure 9. Driver's position, case vehicle
