**TRANSPORTATION SCIENCES
CRASH RESEARCH SECTION**

**VERIDIAN ON-SITE DRIVER AIR BAG FATALITY INVESTIGATION
VERIDIAN CASE NO. CA99-049
VEHICLE: 1991 FORD TAURUS STATION WAGON
LOCATION: NORTH CAROLINA
CRASH DATE: NOVEMBER, 1999**

14. <i>Sponsoring Agency Code</i>	
15. <i>Supplementary Notes</i> On-site investigation of a run-off-road crash that resulted in air bag deployment and the death of the 79 year old female driver.

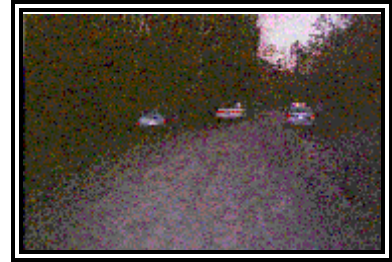
Figure 1. On-scene view of the found position of the Ford Taurus.

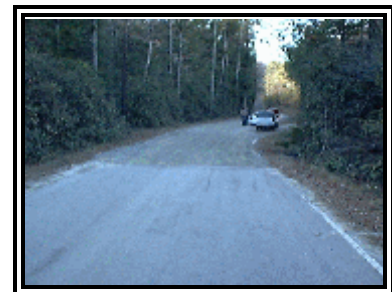
Figure 2. Overall view of the crash site.

At the time of the crash, the conditions were dark with no artificial illumination and the environmental surfaces were dry. The struck tree was 33.0 cm (13.0") in diameter and was located 4.5 m (14.7') outboard of the south (left) road edge. There were no defects or environmental factors contributing to the crash. **Figure 2** is an overall view of the crash site.

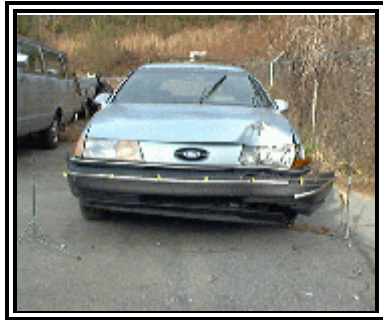
The front left area of the Ford Taurus sustained moderate damage as a result of its impact sequence with the tree. Maximum crush was 26.4 cm (10.4") located on the bumper fascia, 54.6 cm (21.5") left of center. The direct contact damage on the bumper fascia began 34.3 cm (13.5") left of center and extended 33.7 cm (13.25") to the right (**Figure 3**). The narrow impact deformed the full frontal width of the front bumper resulting in a combined induced and direct contact damage length (Field L) of 154.3 cm (60.75"). The crush profile at bumper level was as follows: C1 = 19.1 cm (7.5"), C2 = 19.7 cm (7.75"), C3 = 10.2 cm (4.0"), C4 = 5.7 cm (2.25"), C5 = 3.8 cm (1.5"), C6 = 3.3 cm (1.3").

Figure 3. Frontal damage to the Ford Taurus.

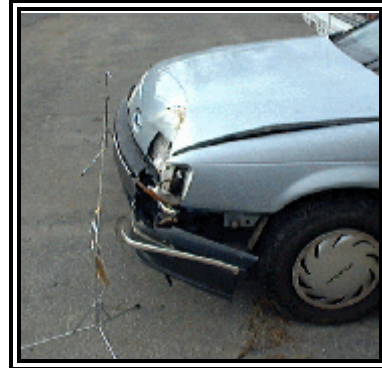
Figure 4 is a profile view of the left frontal area which documents the extent of frontal crush. The Collision Deformation Classification (CDC) for this tree impact was 12-FLEN-1. Components damaged by the tree impact included the front bumper fascia, bumper reinforcement bar, left headlight and turn signal assembly, and the hood.

Figure 4. Profile view documenting the extent of frontal crush.

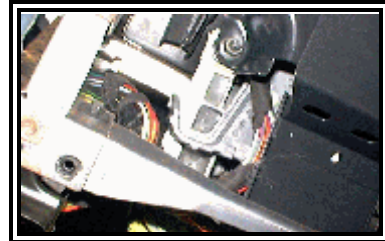
The driver's forward position restricted the deployment of the cover flap and the air bag membrane. This, in combination with her forward trajectory in response to the frontal impact force, compressed the energy absorbing column. Column compression was evidenced by 5.4 cm (2.125") of left shear bracket separation and 4.8 cm (1.875") of right shear bracket separation (**Figure 5**). In addition, the hub of the steering wheel was canted to the left, resulting in approximately 2.5 cm (1.0") of wheel displacement.

Figure 5. Shear bracket separation.

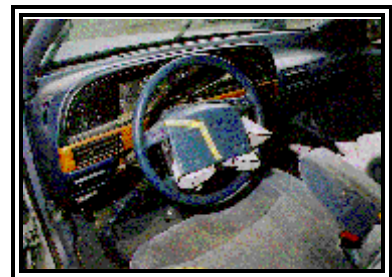
The driver air bag was housed in an H-configuration module cover assembly with asymmetrical cover flaps (**Figure 6**). The upper flap was 20.3 cm (8.0") in width at the horizontal tear seam and 12.7 cm (5.0") in height to the top hinge point. The lower cover flap maintained the same width with a height of 3.8 cm (1.5"). The upper cover flap was scuffed left of center from expansion against the driver’s right chest area. The vertically oriented scuff marks (**Figure 7**) were located 1.3-7.0 cm (0.5-2.75") left of the center line on the cover flap and 0-9.9 cm (0-3.9") vertically, originating at the horizontal tear seam.

Figure 6. Overall view of the deployed front left air bag.

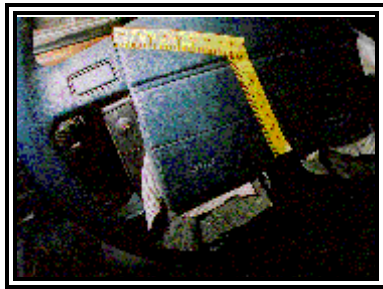
The driver was out-of-position forward against the driver's air bag module at impact and deployment. Vertically oriented scuff marks were present on the upper cover flap from engagement against her clothing and torso. The scuff marks began 1.3 cm (0.5") left of the mid point of the flap and extended 7.0 cm (2.75") to the left. The marks originated at the horizontal tear seam and extended 9.9 cm (3.9") vertically onto the face of the flap.

Figure 7. Vertically oriented scuff marks on the upper cover flap.

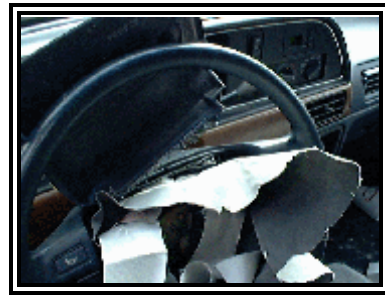
The forward position of the driver against the cover flap at deployment restricted the upward rotation of the flap. Therefore, the subsequent expansion of the air bag membrane against the inner aspect of the restricted flap resulted in an incomplete separation of the flap at the top hinge

point (**Figure 8**). The hinge was 16.2 cm (6.375") in width and was completely separated with the exception of the left 1.3 cm (0.5").

Figure 8. Near separation of the upper hinge point.

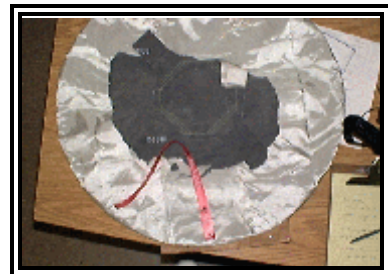
A fabric transfer that was consistent with the color of the blouse worn by the driver was noted to the lower aspect of the air bag at the 5:30 o'clock sector (**Figure 9**). The light blue fabric transfer began 3.8 cm (1.5") forward of the peripheral seam and extended 11.4 cm (4.5") toward the inflator. Based on the known fold pattern for this air bag, the 6 o'clock sector of the bag is the last aspect folded into the module assembly and therefore, is the first to deploy.

Figure 9. Fabric transfer at the 5:30 o'clock position of the bag.

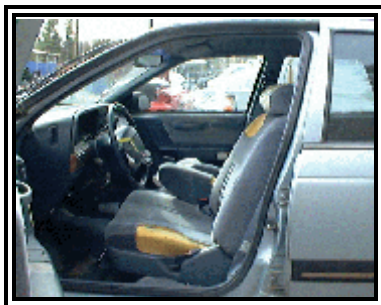
Figure 10. Profile view of the driver's seated position.

The driver was seated in an upright posture with the manual seat track adjusted to forward position, 7.4 cm (2.9") rearward of the full forward, or 15.0 cm (5.9") forward of the full rear position. The seat back angle was reclined to approximately 20 degrees with the tilt steering wheel set to the mid adjustment position (**Figure 10**). In this position, the horizontal distance between the seat back support and the mid point of the air bag module cover was 47.0 cm (18.5"). She was not wearing the manual belt system.

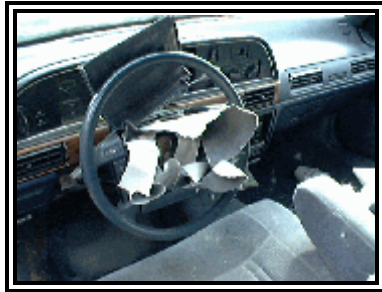
Figure 11. Separation of the upper hinge of the air bag cover flap.

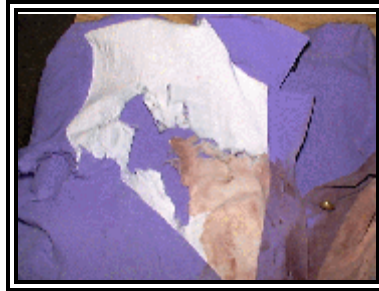
At impact, the driver was out-of-position forward and left with her right upper chest area against the left side of the air bag module cover and her right arm extended rearward. The upward rotational trajectory of the asymmetrical upper cover flap was restricted due to the driver's forward position. As the pressure of the expanding air bag membrane began to build behind the flap, the top hinge of the upper flap separated (**Figure 11**). The flap subsequently gathered the blouse of the driver and torn the polyester fabric over the

right upper chest and shoulder area. A cover flap transfer was noted to the blouse over the shoulder area at the tear site (**Figure 12**). Vertically oriented scuff marks were visible on the left aspect of the upper flap.

Figure 12. Contact and damage to the right upper chest area of the driver's blouse.

The direct contact by the cover flap produced contusions of the right anterior chest and multiple irregular abrasions and contusions of the right anterior shoulder. The cover flap and the expanding air bag compressed the chest of the driver which resulted in multiple bilateral antero-lateral rib fractures with an upper right pulmonary contusion and a sternal fracture at the junction of the 2nd and 3rd ribs.

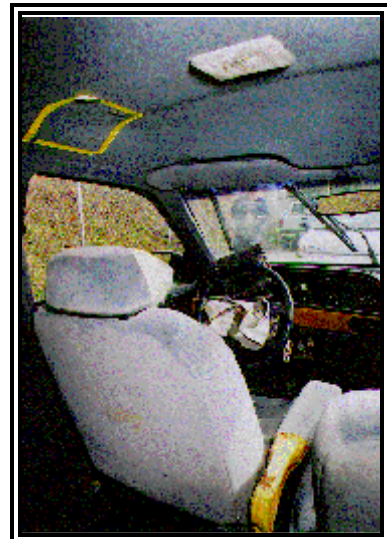
The continued expansion of the frontal air bag against the chest of the driver propelled her in an upward and rearward direction (**Figure 13**). The posterior and superior aspects of the driver's head impacted the roof headliner inboard of the left upper B-pillar. The contact compressed the padded backing and tore the fabric headliner. In addition to the 1.3 cm (0.5") residual depth compression, a scuff mark with dandruff-like deposits evidenced the contact area. The driver sustained subgaleal hemorrhage over the scalp with subarachnoid hemorrhage, and interstitial hemorrhage and perivascular hemorrhage of the brainstem from contact with the headliner.

Figure 13. Overall trajectory of the driver with head strike to the headliner.

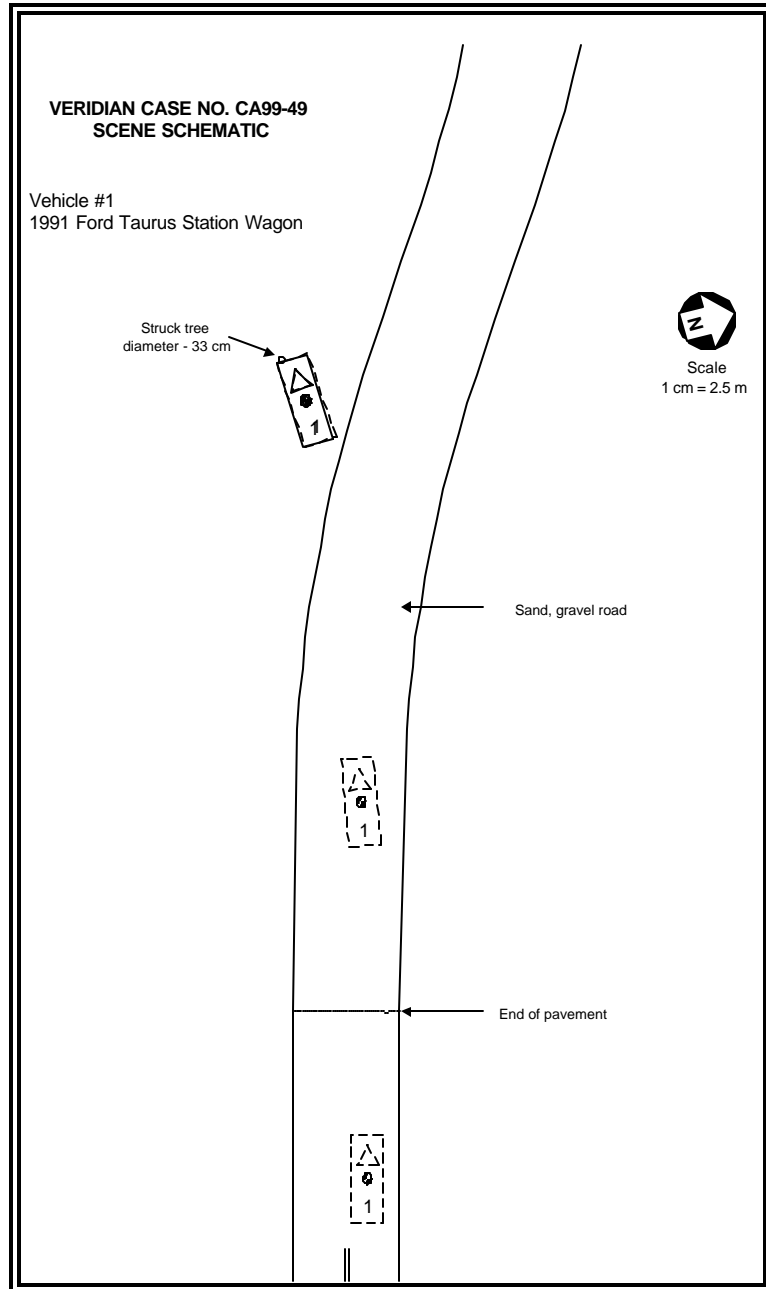
As the vehicle departed the gravel road surface, the front left area of the Ford Taurus impacted a 33.0 cm (13.0") diameter tree. The damage and trajectory algorithm of the WinSMASH program computed an impact speed of 25.5 km/h (15.8 mph). The 12 o'clock direction of force impact resulted in a total velocity change of 20.4 km/h (12.7 mph) with a longitudinal component of -20.4 km/h (-12.7 mph). As a result of the impact induced deceleration, the frontal air bag for the driver's position deployed. The vehicle came to rest against the struck tree. The crash schematic is attached as **Figure 14**, Page 14.

Figure 14. Crash Schematic
