REMOTE AIR BAG DEPLOYMENT REPORT

CASE NUMBER - IN99-050

VEHICLE - 1998 FORD ESCORT SE STATION WAGON

CRASH DATE - March 1998

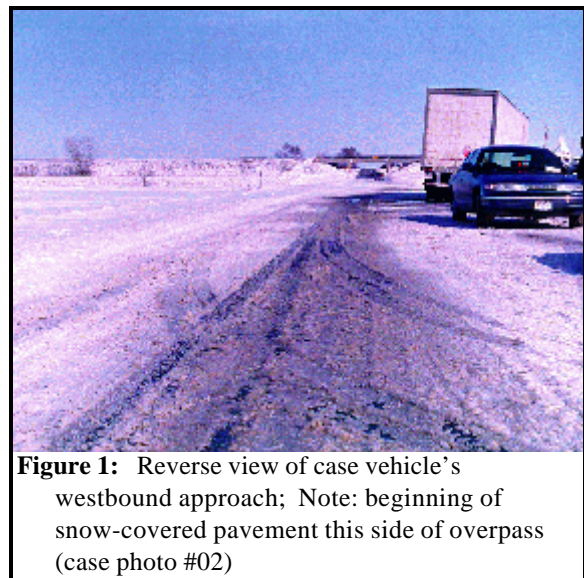
The case vehicle was traveling west in the westbound lane of a two-lane, undivided, state roadway and was intending to continue its westerly travel path. Vehicle #2 was traveling east in the eastbound lane of the same two-lane, undivided, state roadway and intended to continue its easterly travel path (**Figure 1**). It was daylight, clear, no roadway defects, and no view obstructions. The roadway was bituminous, ice- and/or snow-covered in places, straight, and level. The posted speed limit for this stretch of roadway was not reported. The only traffic control devices present were a centerline (snow-covered; thus, type unknown) and single solid white edge lines on the north and south pavement edges. As the case vehicle entered a stretch of ice- and/or snow-covered roadway, it began to fishtail. Its driver may have successfully regained control for a moment but, unfortunately, she lost control and the case vehicle began to rotate clockwise. Vehicle #2's driver estimated that the case vehicle rotated two complete revolutions (720 degrees) pre-crash, but this contractor does not believe there was sufficient distance from the beginning of the ice/snow covering on the pavement to the point of impact for more than one rotation to have occurred. The crash occurred in the eastbound travel lane.

Figure 1: Reverse view of case vehicle's westbound approach; Note: beginning of snow-covered pavement this side of overpass (case photo #02)

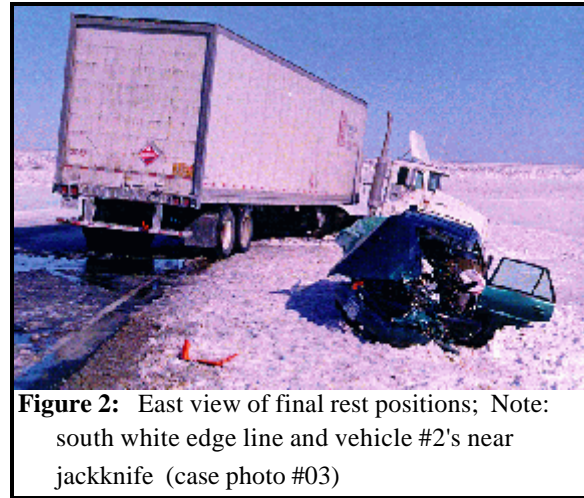
was in a near jackknife position, with the right side dual tires of the trailer's two axles either on the south pavement edge or just off it. The semi-trailer was heading east-southeast at final rest (**Figure 2**). The crash severity for the case vehicle was high [greater than 40 km.p.h. (25 m.p.h.)].

Figure 2: East view of final rest positions; Note: south white edge line and vehicle #2's near jackknife (case photo #03)

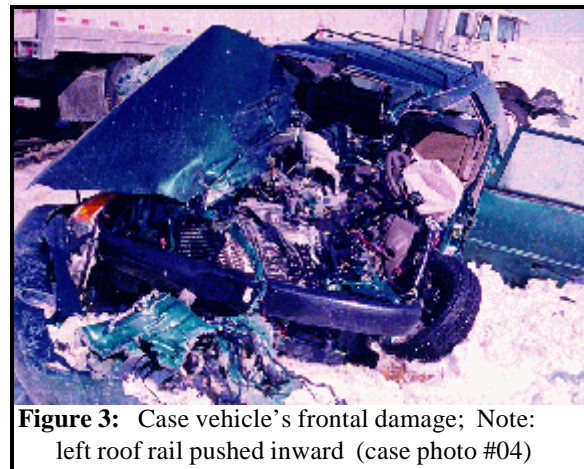
The case vehicle sustained direct contact damage to the left half of the front plane (**Figure 3**). Damaged components included: front fascia pulled off bumper to the right, front bumper pulled to the left, left side of front frame rail depressed downward (on ground), front grille and engine compartment brackets missing, both headlamp assemblies missing, left side of radiator shoved right and rearward, the hood was shoved to the right and tented longitudinally, the left front fender was missing, the left front wheel and tire were laid over at a 45 degree angle (top out, bottom in), left upper A-pillar shoved inward (severed roof rail connection may have been by extrication efforts), the splintered windshield shoved right and folded, front of left side roof rail angled to the right, left B-pillar shoved inward (also damaged by extrication), and the bottom rear corner of left rear door's sheet metal was holed. The left front door may have been torn from the lower A-pillar hinge points, with its top door frame pushed inward and the glazing shattered. The left rocker panel at the lower A-pillar weld may have become separated. Based on police photographs, CDCs for the case vehicle were estimated as: **10-FYAW-6**, with a principal direction of force of 300 (-60) degrees, for the frontal contact and **09-LPEW-2**, with a principal direction of force of 270 (-90) degrees, for the contact of the case vehicle's left rear door with vehicle #2's metal step below the right side fuel tank. This crash is out of scope for the WinSMASH reconstruction program.

Figure 3: Case vehicle's frontal damage; Note: left roof rail pushed inward (case photo #04)

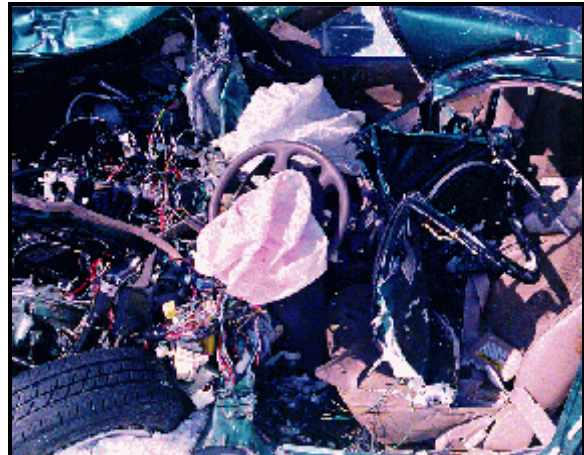
Interior damage to the case vehicle is difficult to assess with available photographs (**Figure 4**). The driver's seating area was reduced by intrusion of the left rocker panel, the left front door, the left end of the instrument panel, the steering column and wheel, the toe pan and floor well. The driver's seat back was reclined, possibly by medical personnel during extrication efforts.

Figure 4: Case vehicle's interior damage; Note: left front door frame placed in driver's seat and position of steering wheel, possibly moved by extrication efforts (case photo #11)

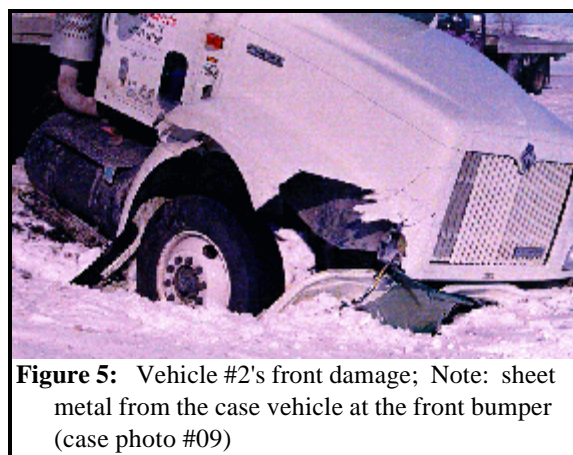
Figure 5: Vehicle #2's front damage; Note: sheet metal from the case vehicle at the front bumper (case photo #09)
