**VERIDIAN ON-SITE AIR BAG RELATED
CHILD PASSENGER FATALITY INVESTIGATION
VERIDIAN CASE NO. CA99-050
VEHICLE: 1998 CHEVROLET TRACKER
LOCATION: MICHIGAN
CRASH DATE: DECEMBER 1999**

1. <i>Report No.</i> CA99-050	2. <i>Government Accession No.</i>	3. <i>Recipient's Catalog No.</i>	
4. <i>Title and Subtitle</i> Veridian On-Site Air Bag Related Child Passenger Fatality Investigation Vehicle: 1998 Chevrolet Tracker Location: Michigan		5. <i>Report Date:</i> June 2002

14. <i>Sponsoring Agency Code</i>	
15. <i>Supplementary Notes</i> On-site investigation of an air bag deployment crash that resulted in the death of a 7 year old female front right passenger of a 1998 Chevrolet Tracker.

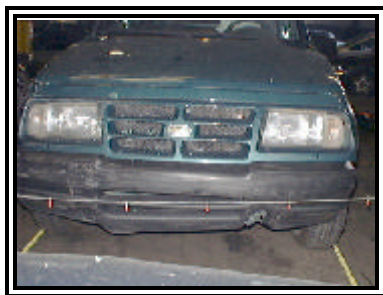
The frontal area of the Tracker sustained moderate damage (**Figure 5**) that was limited to the front bumper, hood, and the right front fender of the vehicle. The maximum crush to the front of the Chevrolet measured 9.2 cm (3.625") located at the right corner of the front bumper (**Figure 6**). The direct contact damage extended across the entire front bumper and measured 149.9 cm (59.0"). The documented crush profile was as follows: C1 = 6.7 cm (2.6"), C2 = 3.5 cm (1.375"), C3 = 6.4 cm (2.5"), C4 = 7.0 cm (2.75"), C5 = 6.0 cm (2.375"), C6 = 9.2 cm (3.625"). The Collision Deformation Classification (CDC) was 11-FDEW-1.

Figure 5. Frontal view of the 1998 Chevrolet Tracker.

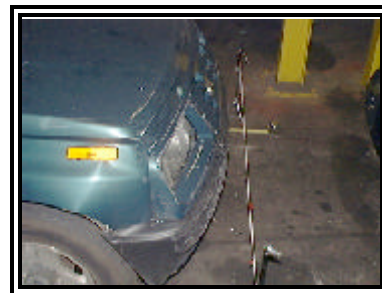
Figure 6. Lateral view of the Chevrolet showing the longitudinal crush profile.

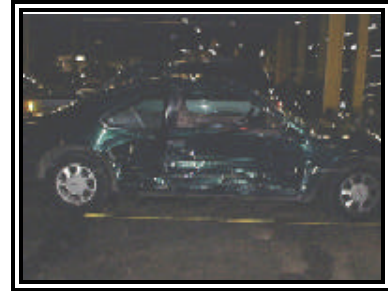
The right side of the Ford Thunderbird sustained moderate damage as a result of the intersection crash with the Chevrolet Tracker. Maximum crush was 31.1 cm (12.25") located on the right door, 116.8 cm (46.0") forward of the right rear axle location. The direct damage began 52.1 cm (20.5") forward of the referenced axle and extended 162.6 cm (64.0") forward to the leading edge of the front door. The combined induced and direct damage length was 203.8 cm (80.25") which began at the leading edge of the door and terminated 24.1 cm (9.5") forward of the right rear axle (**Figure 7**). The crush profile at mid door level was as follows: C1 = 0 cm, C2 = 21.0cm (8.25"), C3 = 29.2 cm (11.5"), C4 = 28.6 cm (11.25"), C5 = 23.2 cm (9.1"), C6 = 0 cm. The CDC for this damage pattern was 02-RPEW-3.

Figure 7. Right side damage to the Ford Thunderbird.

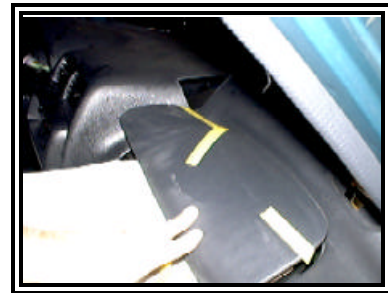
The front right child passenger was positioned forward on the seat cushion and was displaced forward into the path of the air bag module cover and bag membrane. Her lower chin area was struck by the left aspect of the module cover flap. A 5.1 cm (2.0") diameter tissue transfer was surrounded by scuff marks in a 10x13 cm (4x5") area of scuffs and abrasions (**Figure 8**). The full width of the leading edge of the front right cover flap was abraded from windshield contact.

Figure 8. Child passenger contact with the cover flap.

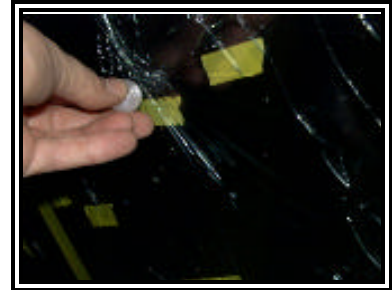
The front right passenger was wearing a series of 1.9 cm (0.75") diameter beads in her hair. As the front right air bag deployed against the forward positioned child, these beads separated from her hair and were thrust against the windshield resulting in a series of isolated fracture points to the glazing. At each site, a transfer was noted that was consistent with color of the beads (**Figure 9**).

Figure 9. Bead and fracture point to the windshield.

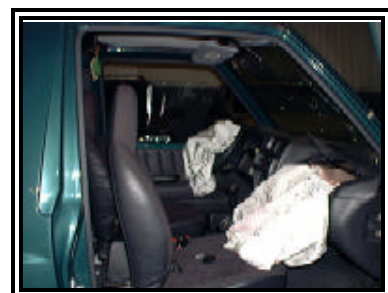
The Chevrolet Tracker was equipped with a frontal air bag system that deployed (**Figure 10**) as a result of the impact sequence with the Ford Thunderbird. The system consisted of a single point Sensing and Diagnostic Module (SDM) that was located on the top of the center transmission tunnel under the center console, an instrument panel mounted air bag indicator lamp, and the driver and front right passenger air bag modules. The SDM measured the severity of the crash, provided a deployment command to the frontal air bag modules, performed diagnostic checks and recorded faults in the system,

Figure 10. Deployed frontal air bags.

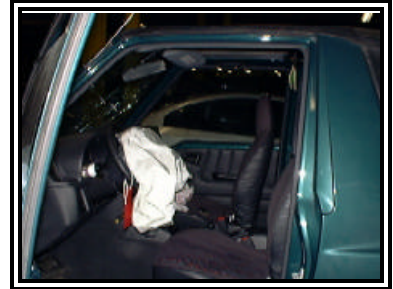
The driver air bag module was located within the four spoke steering wheel rim (**Figure 11**) and concealed by I-configuration module cover flaps. The spokes were located at the 3 and 9 and 5 and 7 o'clock sectors. The flaps were symmetrical in size and measured 7.6 cm (3.0") horizontally and 12.7 cm (5.0") vertically. The thickness of the vinyl flaps was approximately 0.3 cm (0.125"). Two small abrasions were noted to the right cover flap, however, these abrasions were not believed to be crash or occupant related. The driver air bag membrane was approximately 66.0 cm (26.0") in diameter and was vented by two 3.8 cm (1.5") ports located on the back side of the bag at the 10 and 2 o'clock positions. The bag was tethered internally by two straps located at the 12 and 6 o'clock positions. A vinyl transfer was noted to the 1 o'clock sector of the air bag face from expansion within the module cover flaps. There was no loading evidence or damage to the driver's air bag.

Figure 11. Deployed driver's air bag.

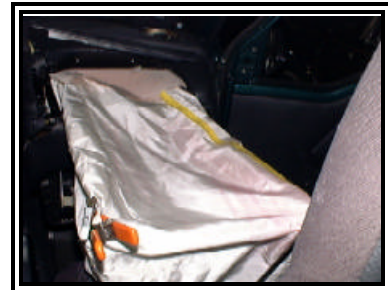
The front right passenger air bag was concealed by a single cover flap in the top of the upper right instrument panel. The cover flap was hinged at the forward aspect and separated from the instrument panel at the designated tear points at both sides and the bottom (leading) edge. The cover flap measured 17.8 cm (7.0") fore and aft and 36.8 cm (14.5") horizontally. A 5.1 cm (2.0") diameter tissue transfer was located on the left aspect of the cover flap. The transfer was centered 10.2 cm (4.0") above the leading edge and adjacent to the left edge. A 12.7 cm (5.0") diameter abrasion pattern extended below the tissue transfer, terminating at the leading edge. The leading edge of the cover flap contacted the windshield which fractured the glazing and abraded the edge of the flap. It should be noted that the cover flap was deformed from contact against the child passenger.

Figure 12. Transfers to the front right passenger air bag.

The front right passenger air bag membrane was rectangular in shape and measured approximately 44.5 cm (17.5") in width and 73.7 cm (29.0") in height. The top aspect of the bag extended approximately 50.8 cm (20.0") rearward from the module assembly. The bag was not tethered, however, two 6.4 cm (2.5") diameter vent ports were located on the side panels of the bag at the 3 and 9 o'clock positions. A narrow black vinyl transfer was noted to the left side of the top panel of the bag membrane from expansion within the module cover. The transfer was 33.0 cm (13.0") in length and originated 17.8 cm (7.0") rearward of the inflator. A large pink fabric transfer from the child's jacket was noted on the right aspect of the top panel (**Figure 12**). The transfer was 15.2 cm (6.0") in width and extended 50.8 cm (20.0") longitudinally on the bag membrane. In addition to the contact evidence, a small 5.1 cm (2.0") tear was located at the

upper left corner of the bag. This tear probably resulted from snagging with the module as the path of the expanding bag was restricted by the forward positioned passenger.

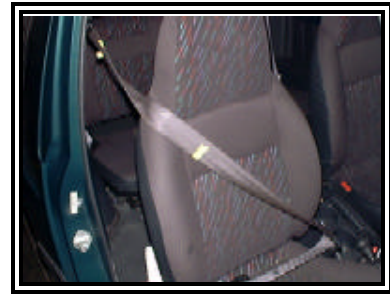
Although the driver was belted in this crash, there was no loading evidence of the belt system. The front right child passenger was improperly restrained with the shoulder belt webbing positioned behind her back. The edges of the belt were frayed from historical use, however, there was no distinct loading evidence. The left rear shoulder belt webbing contained fabric transfers from occupant loading during the crash. The right rear belt system did not yield loading evidence. The lack of contact evidence to the front seat backs supported belt usage.

The front right child passenger was seated in a mid track position with the seat track adjusted 14.0 cm (5.5") rearward of the full forward position and 17.8 cm (7.0") forward of the full rear track position. The seat back support was reclined 10 degrees aft of vertical. She was improperly restrained by the manual belt system. The lap belt was positioned across her hips, however, the shoulder belt webbing was positioned behind her back (**Figure 13**) which produced slack in the belt system. Based on the known seat track position and the improper belt usage, the child was probably positioned forward on the seat cushion, placing her in close proximity to the right instrument panel. She was wearing a pink jacket over a pink sweater with black stretch pants and white athletic shoes.

Figure 13. 3-point lap and shoulder belt system improperly worn by child passenger.

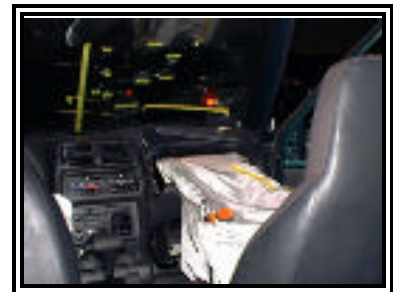
At impact, the frontal air bag system deployed. The top mounted air bag module cover opened in a vertical rotational motion and contacted the child's anterior neck and chin area (**Figure 14**). There was 12.7 cm (5.0") wide abrasion pattern on the surface of the flap which included a 5 cm (2") area of heavy tissue concentration. This correlated with the 17.8 cm (7.0") long and 1.3 cm (0.5") linear abrasion noted by the medical examiner on the undersurface of the chin.

Figure 14. Expansion of the front right air bag into the closely positioned child passenger.

The air bag module cover and the expanding air bag exerted a force under the child's chin which lifted her head upward toward the windshield. The lap belt restricted the vertical motion of the child which probably accentuated the injury to the child's spinal column.
