TRANSPORTATION RESEARCH CENTER

REMOTE AIR BAG DEPLOYMENT REPORT

CASE NUMBER - IN99-070
LOCATION - Louisiana
VEHICLE - 1996 FORD TAURUS
CRASH DATE - January 1997

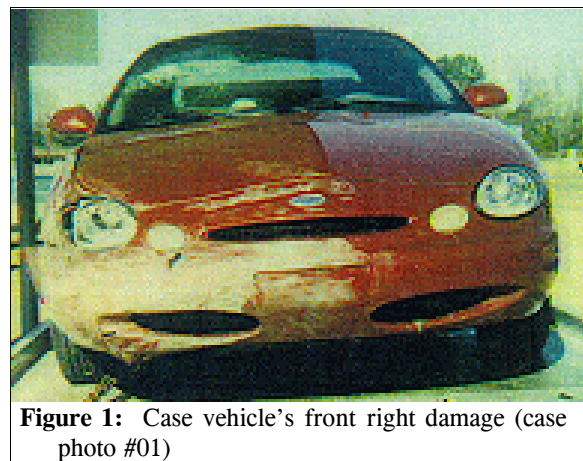
Direct contact extended approximately half way across the case vehicle's front bumper (Figure 1), from the front right bumper corner

Figure 1: Case vehicle's front right damage (case photo #01)

toward the middle. There was also direct damage on the right side with scratches extending to the right front door (**Figure 2**). The right half of the case vehicle's plastic front bumper fascia showed extensive abrading and it was probably compressed and rebounded. The leading edge of the hood and the right headlight assembly show direct contact but only slight deformation. Neither of the front tires appear to be physically restricted from the front end damage.

Based on the available photographs, the case vehicle's CDC was estimated as: **12-FZEW-1 (350)**. The WinSMASH reconstruction program, CDC-only algorithm based on the estimated CDCs for both vehicles, was used. The Total, Longitudinal, and Lateral Delta Vs are, respectively: 20.0 km.p.h. [12.4 m.p.h.], -19.7 km.p.h. [-12.3 m.p.h.], and +4.5 km.p.h. [+2.8 m.p.h.]. This should be regarded as a borderline reconstruction, but the results appear reasonable.

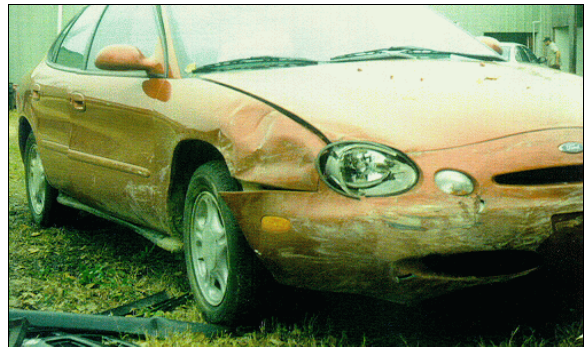
Figure 2: Minor deformation to case vehicle's front right bumper and right fender (case photo #02)

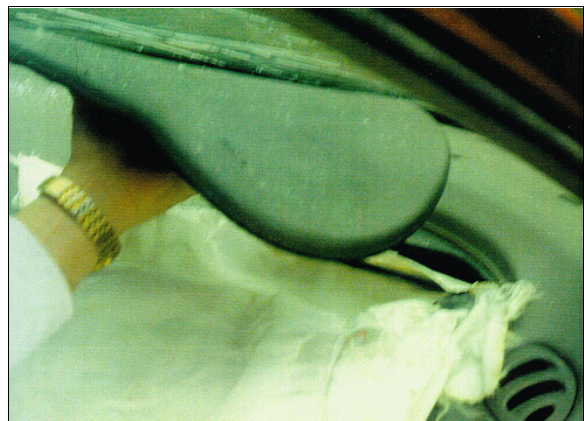
The front right passenger's air bag was located in the top of the instrument panel. The single cover flap appears to have opened at the designated tear points and there was no obvious evidence of damage to the air bag (**Figure 3**). The air bag module's cover flap was bent from contacting and cracking the windshield during deployment (**Figure 4**). The front right passenger had no injuries that could be associated with coming in contact with the cover flap. There was no contact evidence readily visible in the photographs for either the driver or front right passenger air bag.

Figure 3: Close-up of the case vehicle's front right air bag module cover flap (case photo #06)

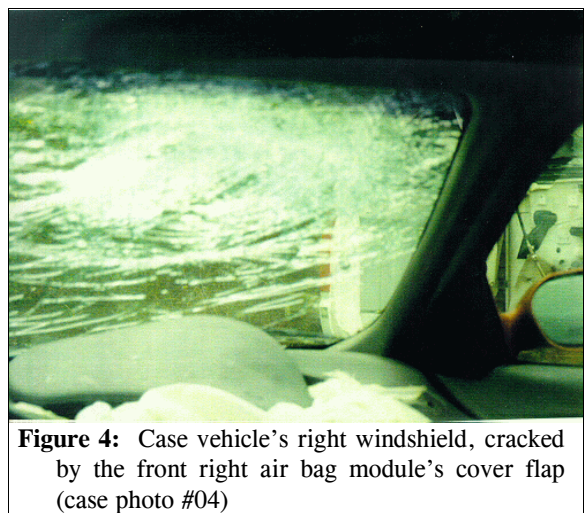
Figure 4: Case vehicle's right windshield, cracked by the front right air bag module's cover flap (case photo #04)

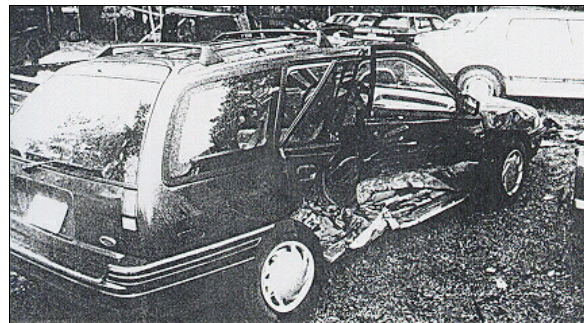
The front of the case vehicle overrode the sill on the other vehicle, engaging the relatively soft side structures on the other vehicle's right side (**Figure 5**), and the case vehicle's air bags probably did not deploy until the case vehicle had reached maximum engagement (i.e., the force pulse from the impact was gradual rather than sudden, sometimes called the "ramp versus spike" phenomenon).

The case vehicle impacted the Escort's right side, with direct damage extending from the right A-pillar to the right C-pillar. The front of the case vehicle overrode the Escort's right sill, resulting in substantial penetration and intrusions into the right side of the Escort's passenger compartment, centered on the right B-pillar. The Escort was towed from the scene due to damage.

Figure 5: Other vehicle's right side damage (case photo #07)

Based on the one available photograph, the CDC was estimated as **02-RPEW-3 (60)** for the Escort. The WinSMASH reconstruction program, CDC-only algorithm based on the estimated CDCs for the two vehicles, was used. The Total, Longitudinal, and Lateral Delta Vs are, respectively: 25.0 km.p.h. [15.5 m.p.h.], -12.5 km.p.h. [-7.8 m.p.h.], and -21.7 km.p.h. [-13.5 m.p.h.]. This should be regarded as a borderline reconstruction, but the results appear reasonable.
