TRANSPORTATION RESEARCH CENTER

REMOTE ALLEGED SAFETY-RELATED DEFECT REPORT

CASE NUMBER - IN99-073
LOCATION - Texas
VEHICLE - 1998 VOLVO S70
INCIDENT DATE - April 1999

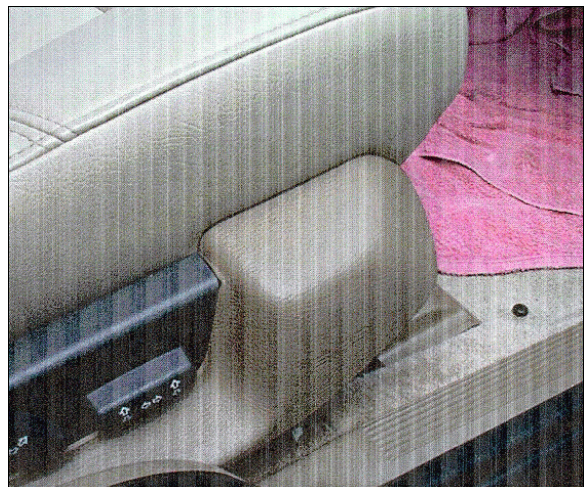
The case vehicle was stopped in a parking lane along a city street and was in the process of picking up two elderly persons from a bus stop. One person got into the front right seating area and became seated. When she closed the front right door, the front right seat back-mounted side air bag deployed. Initial interviews with the case vehicle's driver and the service manager from the repair shop indicated that the front right passenger's purse became wedged between the door and the outside base of the front right seat (i.e., at the side air bag sensor's location). When the door was closed, the purse was compressed against the mechanical sensor, causing the side air bag to deploy (**Figures 1 and 2**).

Subsequent interviews with the case vehicle's driver and the front right passenger have discounted any mention of a purse or any other objects being wedged between the door and outside seat base at the time of the side air bag's deployment. In fact, the case vehicle's front right passenger claims that neither she nor the rear right passenger were carrying a purse at the time of the crash. Based on the insurance company's inspection and the design of the seat-mounted side air bag sensor, this contractor believes the case vehicle's side air bag deployed because some unknown object was wedged between the door panel and sensor plate when the door was pulled closed.

Figure 1: Close-up of outside edge of case vehicle's front right seat showing covering over contacted air bag sensor; Note: sensor is located near seat track adjustment controls (case photo #05)

The service manager also informed this contractor that when the interior of the case vehicle is being serviced for any reason, the mechanic is instructed to place a molded hard cover over the sensor pressure plate to protect the mechanic from inadvertently compressing the sensor pressure plate while working. The necessity for this protective measure indicates the sensitivity of the sensor's pressure plate.

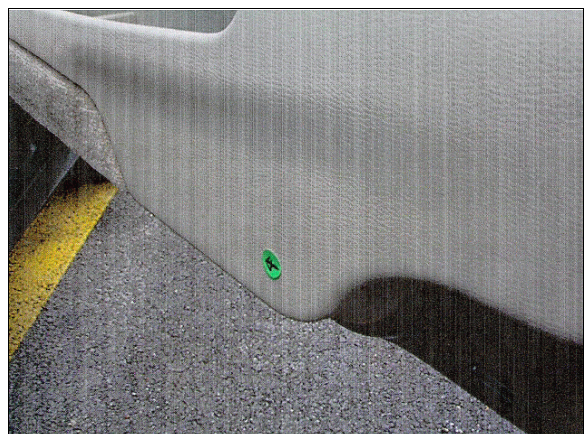
Figure 2: Interior surface of case vehicle's right front door showing area of contact (i.e., green dot) opposite air bag sensor mechanism (case photo #06)

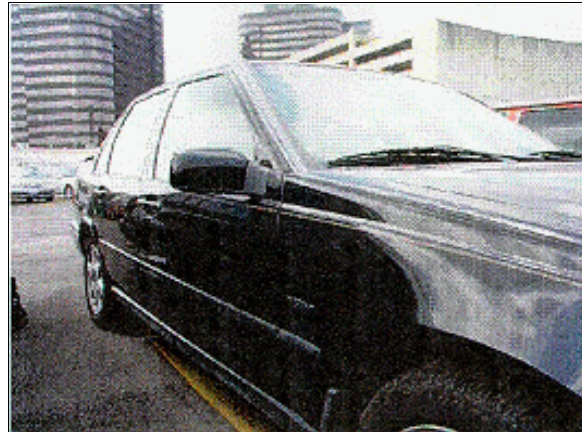
Figure 3: Case vehicle's right side showing no evidence of exterior damage (case photo #01)

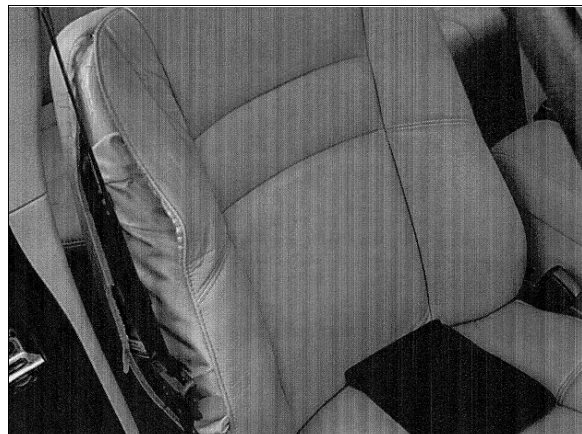
The front right seat back-mounted side air bag was located on the outside edge of the front right seat back along the forward seam line. Photographs show that the air bag opened at the designated tear points along the upholstery seam down the right side of the seat back (Figure 4). There was no evidence of damage to the air bag nor the adjacent components as a result of the deployment. A physical inspection of the air bag was not conducted and the presence of tethers, vent ports, and the air bag's dimensions are not known. According to the manufacturer's service manual (quoted below), the side air bags are designed with a vent through the cushion, so it will collapse slowly enough to act as a brake on the occupant.

Figure 4: Case vehicle's front right passenger seat with deployed air bag exposed along separated upholstery seam (case photo #03)

The case vehicle was a front wheel drive 1998 Volvo S70 GLT, five-passenger, four-door sedan (VIN: YV1LS5676W1-----). The case vehicle was equipped with anti-lock brakes. The case vehicle was driven from the scene. This investigation is based on the available photographs, the insurance company's damage description and the repair invoice. The side air bag sensor cover on the right front seat track along the outside of the base of the seat and the corresponding area opposite the sensor cover on the interior surface of the front right door panel showed impact markings, indicating that something was wedged between the door panel and sensor cover when the door was pulled closed. (Figures 1 and 2). Photographs also document the absence of deformation to the exterior surface of the case vehicle's right front door (Figure 3). The case vehicle's front right bucket seat was replaced along with the side air bag module, seat back padding, and the air bag igniter.

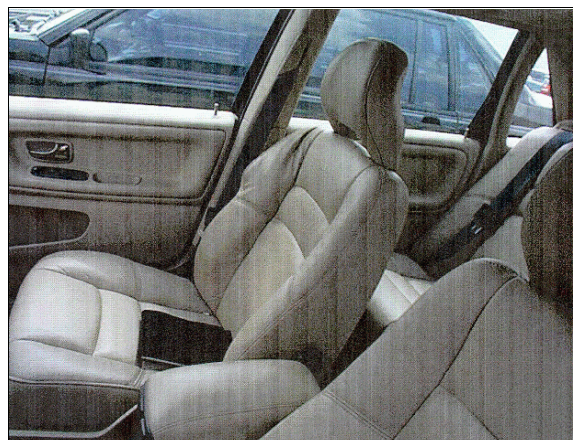
Immediately prior to the incident, the front right passenger had just gotten seated in an upright posture with her back against the seat back, her feet on the floor, and her right arm extended to her right after closing the door. Her seat track was located in its middle position (**Figure 5**). When she pulled the door closed, the seat back-mounted side air bag deployed. The deploying side air bag contacted the front right passenger in her upper right arm. She sustained a minor contusion to her upper right arm but did not seek treatment.

Figure 5: Case vehicle's front right seating area; Note: rippled upholstery along outside of front right seat back (case photo #04)
