INDIANA UNIVERSITY

TRANSPORTATION RESEARCH CENTER

REMOTE AIR BAG REPORT

CASE NUMBER - IN99-079
LOCATION - LOUISIANA
VEHICLE - 1995 TOYOTA COROLLA DX
CRASH DATE - October, 1996

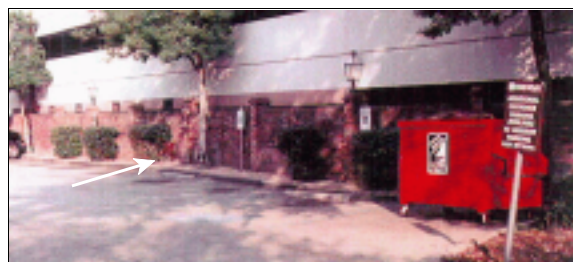
The case vehicle had originally been traveling south in an unknown southbound lane of a one-way, undivided, city street. The case vehicle's driver made a left-hand (eastward) turn into a bank parking lot and traveled eastward for a short distance (**Figure 1**) prior to making a right-hand (southeastward) turn into an angled parking slot. The parking lot driveway was straight and level at the area of impact. The pavement was bituminous. Pavement markings consisted of a diagonal, single, solid yellow, parking slot line on the left side of the parking slot entered by the case vehicle and a diagonal, single, solid blue parking slot line on the right side. Yellow lines indicated regular parking slots and blue lines identified slots for the handicapped. The handicapped parking slots were also identified by signage, and there were no visible traffic

Figure 1: Case vehicle's approach path of travel in bank parking lot; Note: location (arrow) of impact is highlighted (case photo #01)

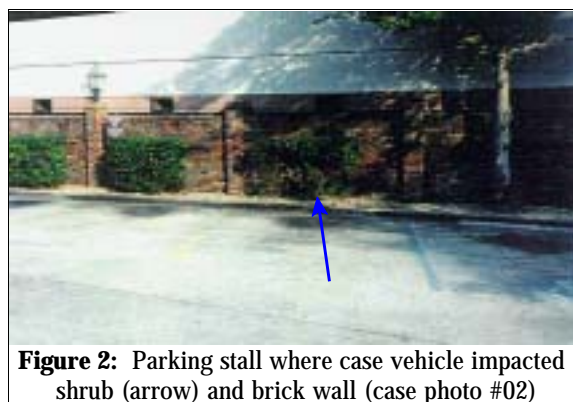
Figure 2: Parking stall where case vehicle impacted shrub (arrow) and brick wall (case photo #02)

At some point during the turning process into the parking slot, the case vehicle's driver reportedly experienced a syncopic episode which resulted in the case vehicle's driver not making any avoidance maneuvers prior to the crash. The crash occurred at the end of the third diagonal parking slot (i.e., east of the two handicapped slots) on the west end of the bank parking lot's south side (**Figure 2** above).

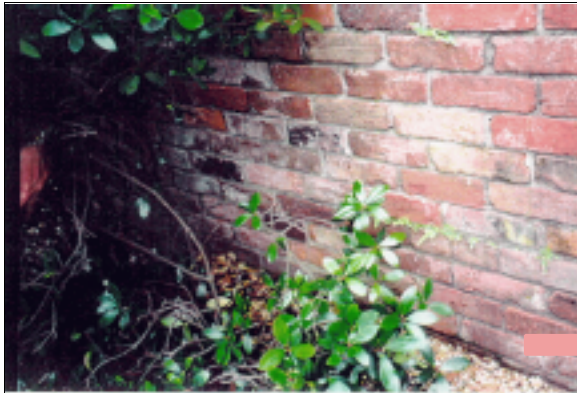
Figure 3: Close-up of case vehicle's impact area with shrub and brick wall (case photo #03)

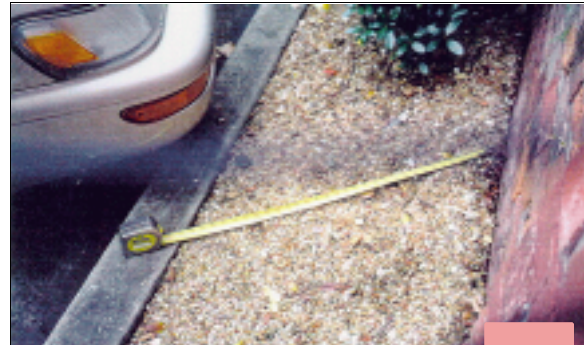
Figure 4: Distance between parking lot's curb and brick wall which enabled case vehicle's front to impact wall at approximately same time as right front tire struck curb (case photo #06)

The exact order of the impact sequence is unknown, but the most likely scenario is that the case vehicle's right front tire contacted and overrode (i.e., without any evidence of wheel damage) a concrete curb, followed by the front left bumper impacting a shrub, and finally, the front right corner impacting the brick wall (**Figures 3, 4, and 5, and Figure 6** below) at the end of the parking slot. The case vehicle's impact with the brick wall caused the case vehicle's driver and front right passenger supplemental restraints (air bags) to deploy. The case vehicle rotated slightly clockwise an unknown number of degrees and rebounded back into the parking lot approximately 0.9 meters (three feet).

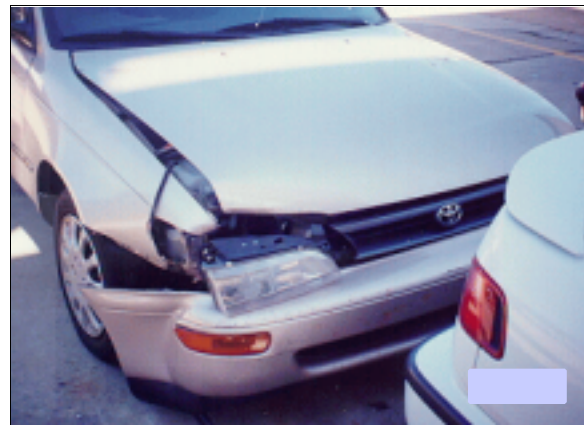
Figure 5: Case vehicle's damaged front showing damage to right hood, headlight assembly, and fender; Note: damage extends across entire front bumper (case photo #07)

Based on available photographs, CDCs were estimated as: **12-FZEW-1 (10)** for the impact with the brick wall [maximum crush was 13.2 centimeters (5.2 inches)] and **12-FLEN-1 (10)** for the shrub impact. The WinSMASH reconstruction program, barrier algorithm, was used on the case vehicle's highest severity impact with the brick wall and provided a borderline reconstruction, but the results appear reasonable. The Total, Longitudinal, and Lateral Delta Vs are, respectively: 24.9 km.p.h. (15.5 m.p.h.), -24.5 km.p.h. (-15.2 m.p.h.), and -4.3 km.p.h. (-2.7 m.p.h.).

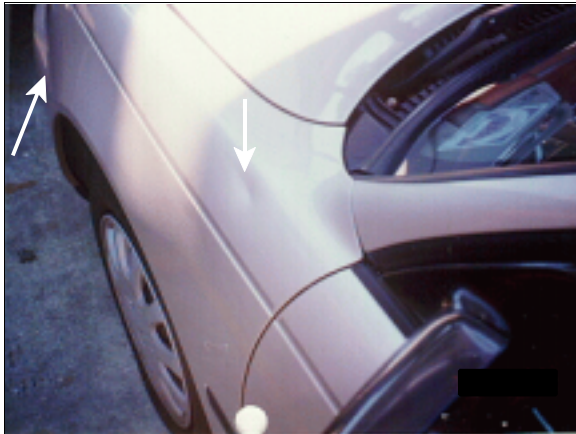
Figure 6: Induced damage to case vehicle's left fender; Note: there was direct damage to the front left bumper (case photo #08)

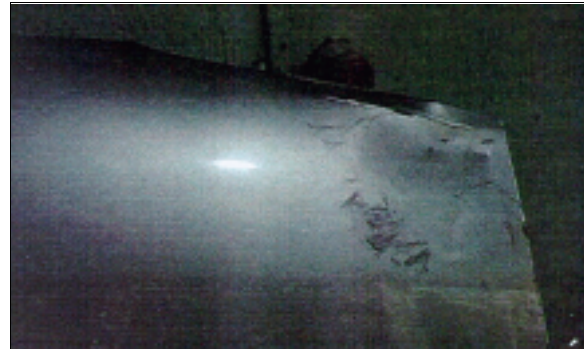
Figure 7: Overhead view of direct damage to front right area of case vehicle's hood; Note: hood has been removed from vehicle (case photo #13)

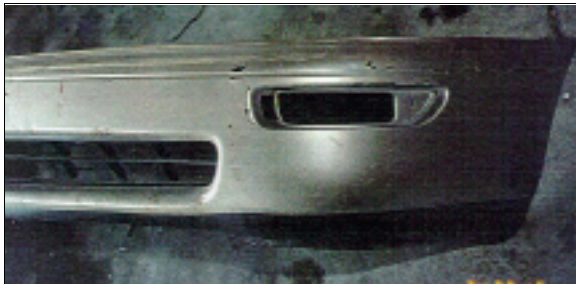
Figure 8: Case vehicle's damaged front bumper showing direct contact laterally across bumper and vertically at front left corner (case photo #20)

The case vehicle was assessed as disabled by the investigating officer, but the Police Crash Report indicated that it was left at the scene. The actual disposition of the case vehicle is not known, but it was repaired by the family. Based on the available photographs, the case vehicle sustained damage from its impact with the brick wall, across approximately two-thirds of the front bumper and to the right headlight assembly, fender, and hood (**Figure 5** above and **Figure 7**). The impact with the shrub caused overlapping damage across the front bumper, but also produced a distinct vertical damage mark on the left bumper (**Figures 8** and **9**).

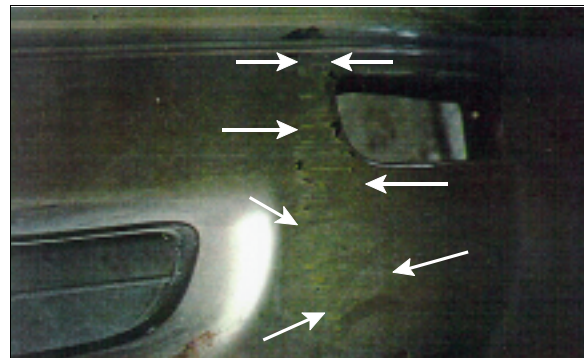
Figure 9: Close-up of vertically oriented direct damage at case vehicle's front left bumper; Note: contact came from shrub (case photo #21)

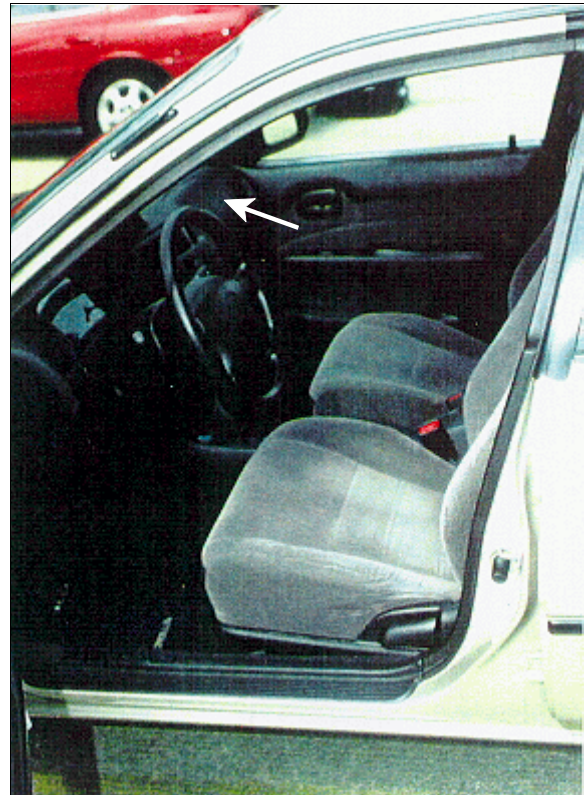
The case vehicle's driver air bag was located in the steering wheel hub (**Figure 10**). Attorney-provided photographs show the driver air bag module's cover flaps and air bag and revealed that the cover flaps opened at the designated tear points and were in a symmetrical "H" configuration. There is inconclusive evidence regarding the possibility of driver contact to the air bag module's cover flaps. On the top cover flap, at the bottom of the manufacturer's logo and just left of center on the horizontal seam, there is possible contact evidence (**Figure 11**). The bottom cover flap also reveals some inconclusive evidence regarding driver contact. Three longitudinal discoloration marks appear to be present in the top left of the flap, with one mark starting near the center of the horizontal seam and the other two located to the left of the first. Another discoloration area is located at the bottom cover flap's lower right corner (**Figure 12**). A combination of available photographs and the depositions provided the following air bag information. The driver's air bag was designed without any tethers. The driver's air bag had two vent ports, approximately 3 centimeters (1.2 inches) in diameter, located at the 11:30 and 12:30 o'clock positions on the back side of the air bag. The deployed driver's air bag was round with a diameter of 67 centimeters (26.4 inches). There was a large bloodstain to the driver air bag's fabric, immediately upward from and to the right of center (**Figures 13 and 14** below).

Figure 10: Case vehicle's front seating area, post repair, showing driver's steering wheel-mounted air bag module and mid instrument panel-mounted (arrow) front right air bag module (case photo #22)

A photograph of the repaired case vehicle (**Figure 10**) shows the replaced front right passenger air bag module to be located in the middle of the instrument panel. The available

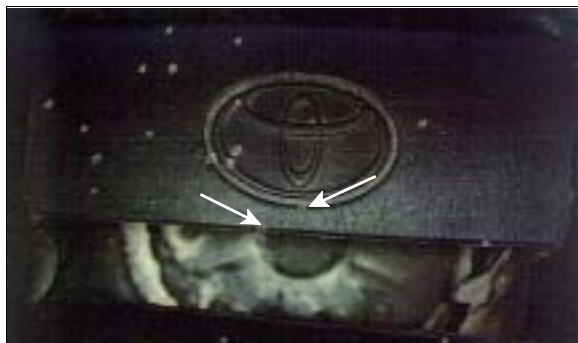
Figure 11: Case vehicle driver air bag module's top cover flap showing two (arrows) areas of possible skin transfer evidence (case photo #27)

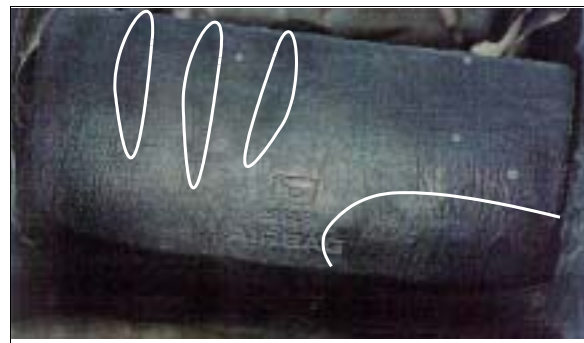
Figure 12: Case vehicle driver air bag module's bottom cover flap showing areas of possible occupant contact (case photo #28)

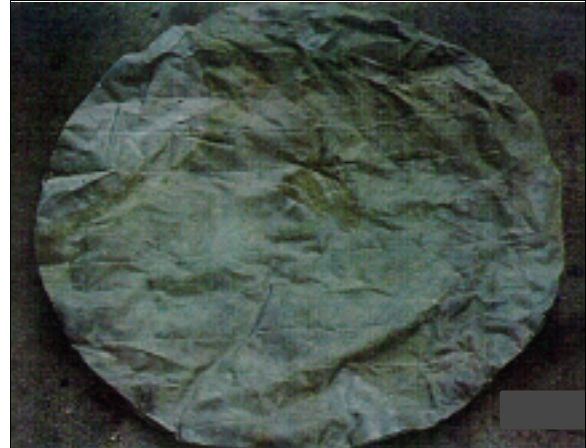
Figure 13: Case vehicle's removed (i.e., cut out) driver air bag showing evidence (i.e., bloodstain) of occupant contact (case photo #23)

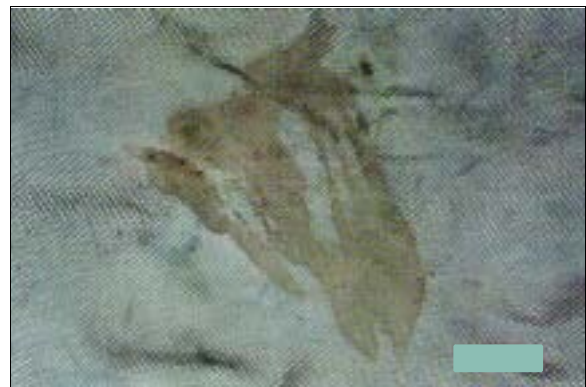
Figure 14: Close-up of occupant contact evidence (i.e., bloodstain) in center of case vehicle's driver air bag (case photo #24)
