INDIANA UNIVERSITY

TRANSPORTATION RESEARCH CENTER

ON-SITE CHILD AIR BAG-RELATED FATALITY INVESTIGATION

CASE NUMBER - IN99-080
LOCATION - MISSISSIPPI
VEHICLE - 1995 DODGE NEON
CRASH DATE - December, 1997

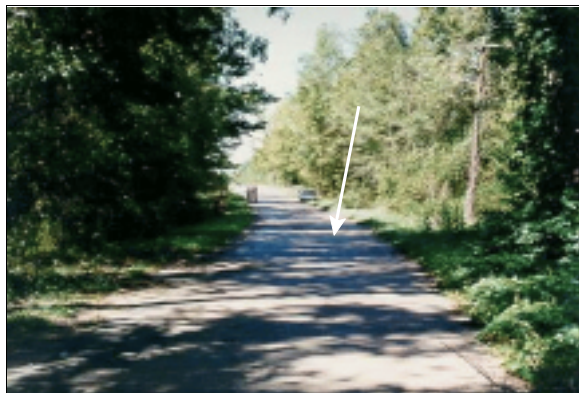
Figure 1: Case vehicle’s westerly travel path in left-hand curve; Note: arrow marks approximate point of impact (case photo #02)

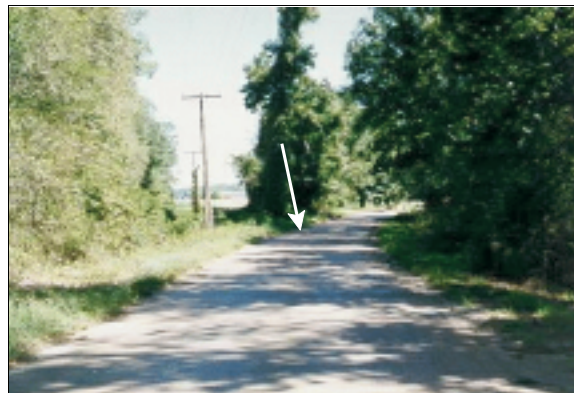
Figure 2: Sunbird’s easterly travel path in right-hand curve; Note: arrow marks approximate point of impact (case photo #06)

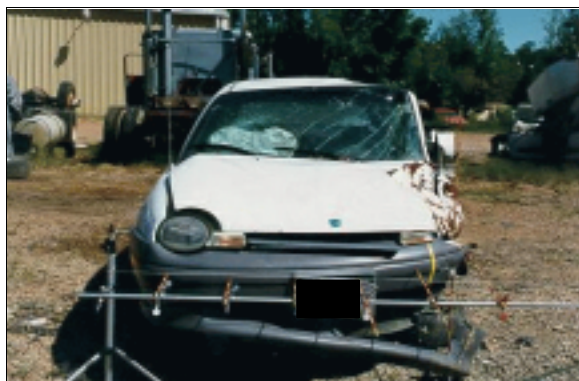
Figure 3: Case vehicle’s very narrow front left corner damage; Note: yellow tape marks rightward extend of direct damage (case photo #09)

The case vehicle's contact with the Pontiac involved its front left corner (**Figures 3 and 4** above). Direct damage began 48 centimeters (18.9 inches) left of center and extended 20 centimeters (7.9 inches) to the front left bumper corner (**Figure 6**). This narrow corner engagement extended down the left side to the left

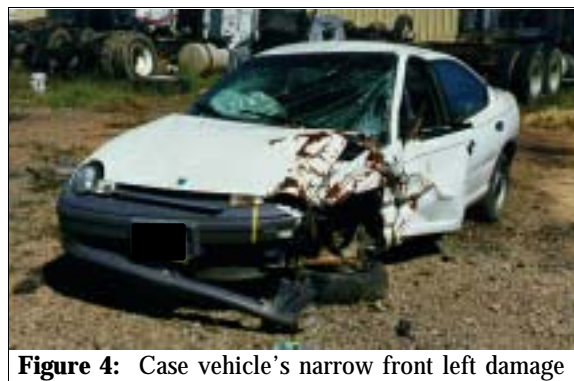
Figure 4: Case vehicle’s narrow front left damage pattern viewed from left of front; Note: direct damage extends to left “A”-pillar and driver’s door (case photo #13)

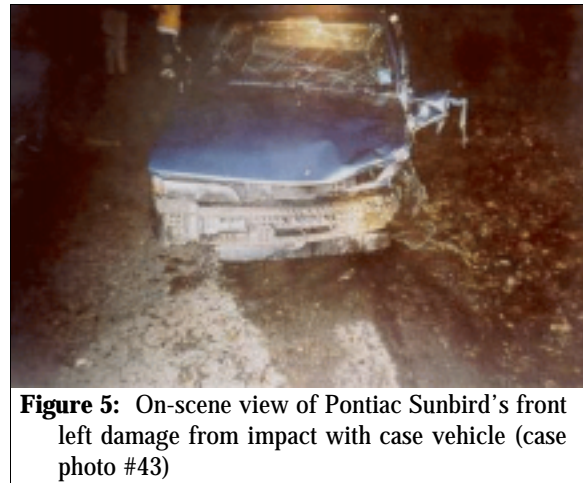
Figure 5: On-scene view of Pontiac Sunbird's front left damage from impact with case vehicle (case photo #43)

Base on the available photograph, the CDC for the Pontiac was estimated as: **12-FLEW-2** (Figure 5 above). The Pontiac was towed due to damage.

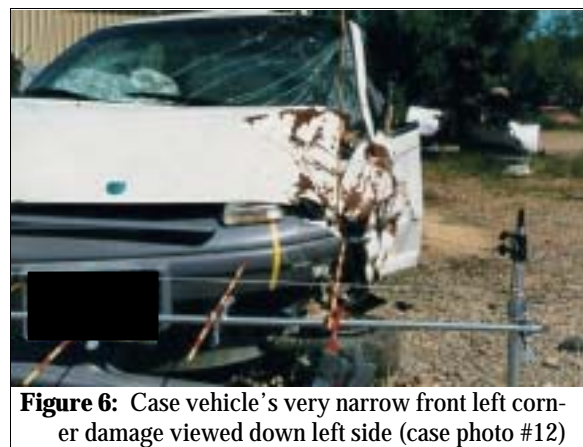
Figure 6: Case vehicle's very narrow front left corner damage viewed down left side (case photo #12)

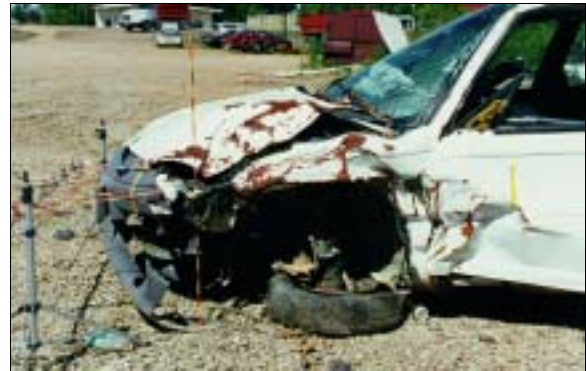
“A”-pillar and driver’s door (**Figure 7**). Direct contact was measured as 175 centimeters (68.9 inches). Residual maximum crush was measured as 32 centimeters (12.6 inches) at C₁. The case vehicle’s left front wheel was torn away from the axle. The wheelbase on the case vehicle’s left side was shortened an estimated 17 centimeters (6.7 inches) while the right side was extended approximately 4 centimeters (1.6 inches). The driver’s window glazing was disintegrated from direct contact to the left “A”-pillar and driver’s door. The case vehicle’s front bumper, bumper fascia, grille, hood, and left headlight and turn signal assemblies, left fender, and left front door were directly damaged and crushed rearward. The case vehicle’s left front tire was also deflated. Both the left front and rear doors sustained induced damage as well the fender. Remote buckling was also found on the left portion of the case vehicle’s roof above the driver’s seating area.

Figure 7: Case vehicle’s very narrow frontal impact showing deformation down left side; Note: yellow tape indicates length of direct contact (case photo #10)

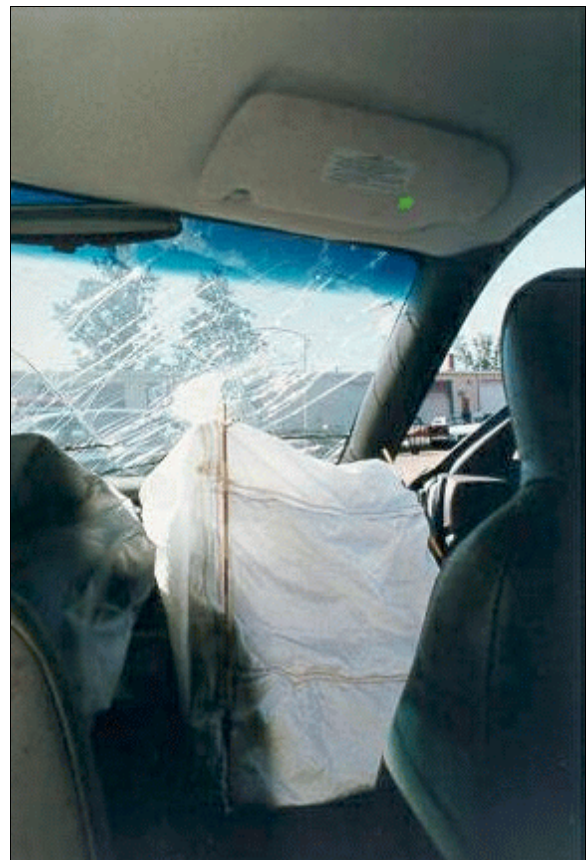
Figure 8: Case vehicle’s front right passenger seating area showing deployed front right passenger air bag, tow yard damage to right windshield’s glazing and either mucous spray or bag exhaust residue on front right sun visor (case photo #26)

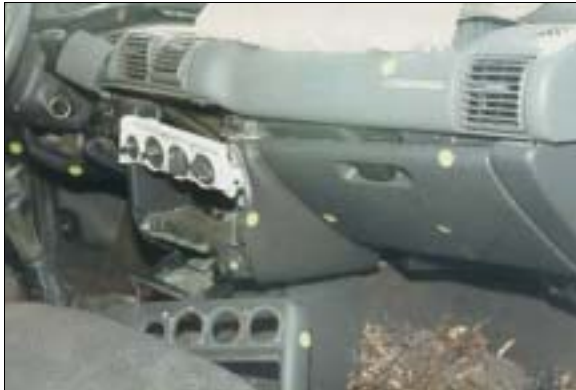
Figure 9: Case vehicle's instrument panel and glove box door showing deployed front right passenger's air bag and contact evidence around steering column, on center instrument panel and right glove box door (case photo #30)

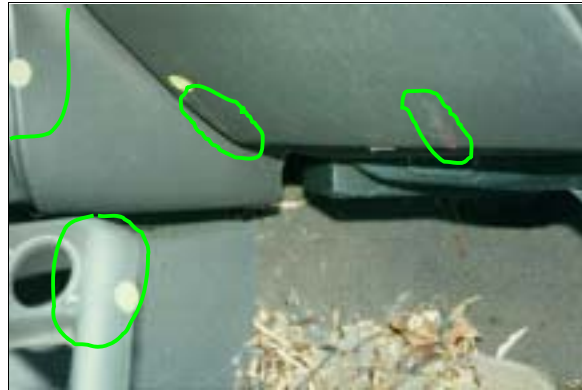
Figure 10: Close-up of cloth transfers to bottom of case vehicle's glove box door; Note: deformation to right side of center instrument panel (case photo #31)

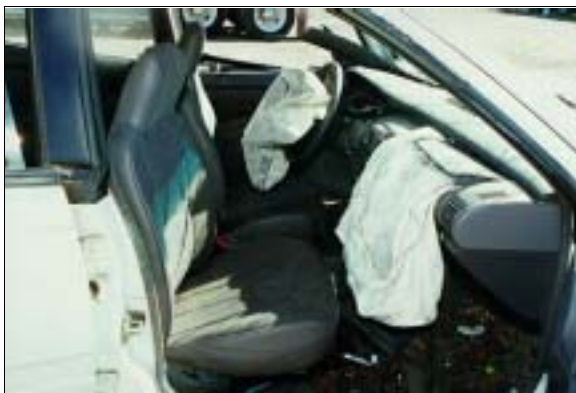
Figure 11: Case vehicle's front seating area showing deployed driver and front right passenger air bags; Note: both front seat backs deformed by passenger impacts from rear (case photo #32)

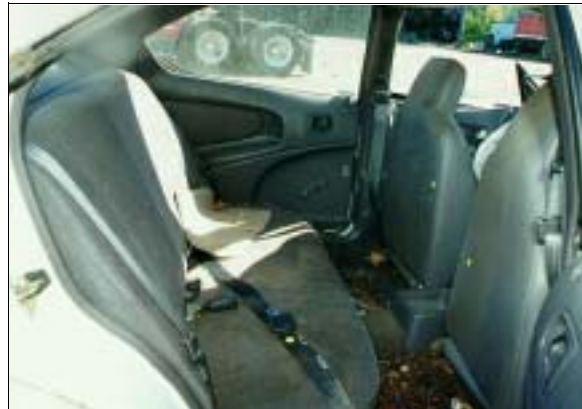
Figure 12: Case vehicle's back seating area; Note: deformed front seat backs from contact by back seat passengers (case photo #32a)

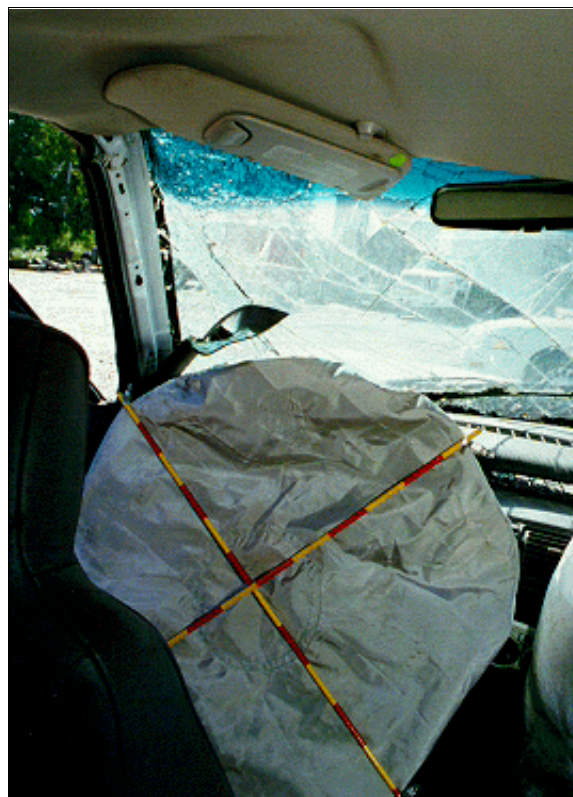
vertically. An inspection of the air bag module's cover flaps and air bag revealed that the cover flaps opened at the designated tear points, and there was no evidence of damage during the deployment to the air bag or the cover flaps. The cover flap, however, was pushed through the steering wheel rim during the deployment, most likely from loading to the air bag's fabric by the driver which caused the air bag to expand towards the left instrument panel. The driver's air bag was designed with four tethers, each approximately 6 centimeters (2.4 inches) in width. The driver's air bag had one vent port, approximately 2.5 centimeters (1.0 inches) in diameter, located at the 12 o'clock position. The deployed driver's air bag was round with a diameter of 59 centimeters (23.2 inches). An inspection of the driver's air bag fabric revealed two areas of skin—a smaller area to the center of the air bag and a larger area in the lower right quadrant. It should be noted that the top of the steering wheel had been rotated to the 5 o'clock position at time of inspection. The small area measured 4 x 2 centimeters (1.6 x 0.8 inches) and the larger area measured 9 x 4 centimeters (3.5 x 1.6 inches). There was also a faint red lipstick mark on the air bag's fabric (**Figure 13**).

Figure 13: Vertical view of case vehicle's driver seating area and deployed air bag showing contact evidence near center of air bag; Note: intrusion to "A"-pillar and air bag exhaust residue on sun visor (case photo #23)

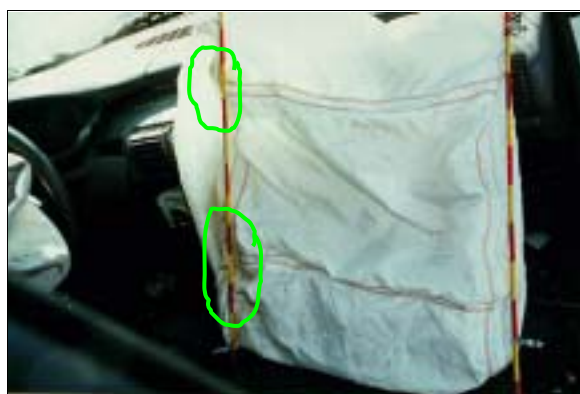
discoloration—most likely dried blood, on the air bag’s fabric along the left edge at the top and bottom corners (**Figure 14** and **Figure 15**). No visible skin transfers were found. The upper area was 8 x 5 centimeter (3.1 x 2.0 inches) and located on the left side surface at upper front corner. The second area was on lower left corner of the front surface and measured approximately 10 x 3 centimeters (3.9 x 1.2 inches). In addition, there was an very small area of unknown substance to the front lower right corner.

Figure 14: Case vehicle’s deployed front right air bag; Note: highlighted discolored areas (case photo #36)

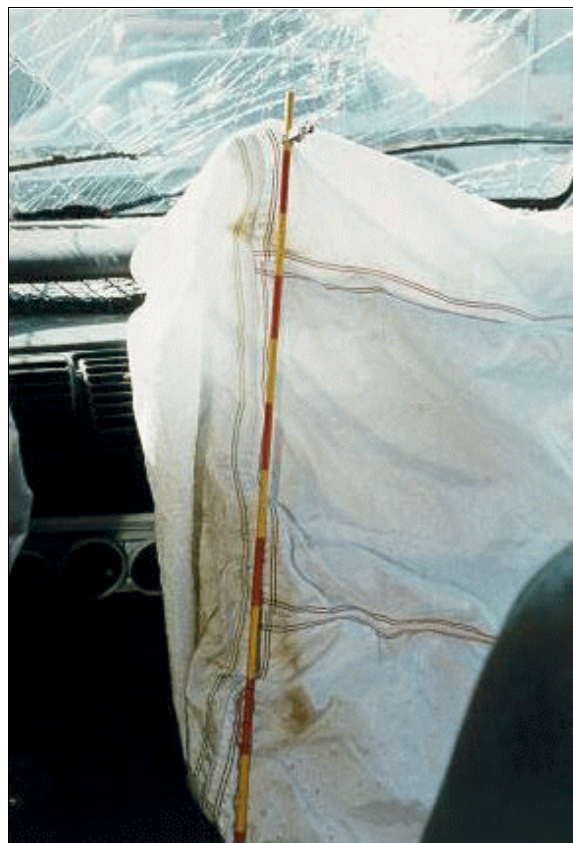
Figure 15: Close-up of case vehicle’s deployed front right passenger air bag showing bloody discoloration along left side surface (case photo #38)

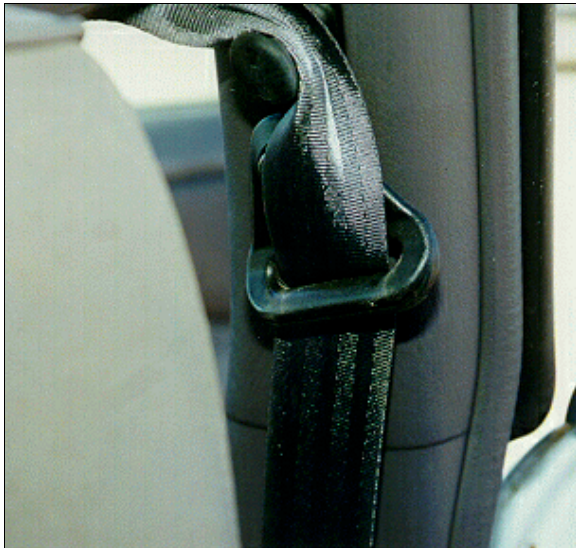
Figure 16: Close-up of "D"-ring from case vehicle's front right safety belt showing trace evidence of loading (case photo #41)

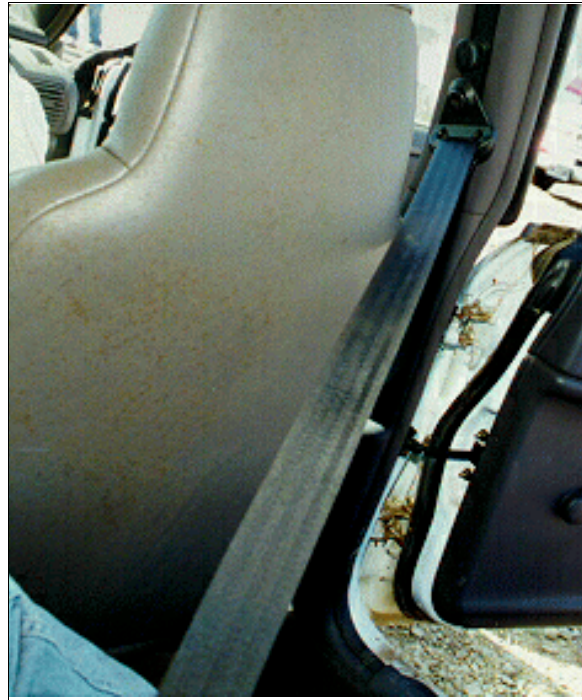
In this contractor's opinion, the case vehicle's front right passenger was not completely restrained by her available, active, three-point, lap-and-shoulder, safety belt system (i.e., the shoulder portion of her restraint was not securely located over her shoulder just prior to impact). There was, however, evidence of lap belt pattern contusions and abrasions to the front right passenger's right lower quadrant and hip, as well as contusions distributed across her lower abdomen. In addition, the inspection of the front right passenger's seat belt webbing, "D"-ring, and latch plate showed some trace evidence of loading on the "D"-ring (**Figure 16**); however, there was no evidence (i.e., loading or blood) on the safety belt's webbing (**Figure 17**).

Figure 17: Vertical view of case vehicle's front right seat belt showing no apparent evidence (i.e., blood or loading) on webbing (case photo #40)
