REMOTE AIR BAG DEPLOYMENT REPORT

CASE NUMBER - IN99-084

LOCATION - LOUISIANA

VEHICLE - 1998 PONTIAC BONNEVILLE SE

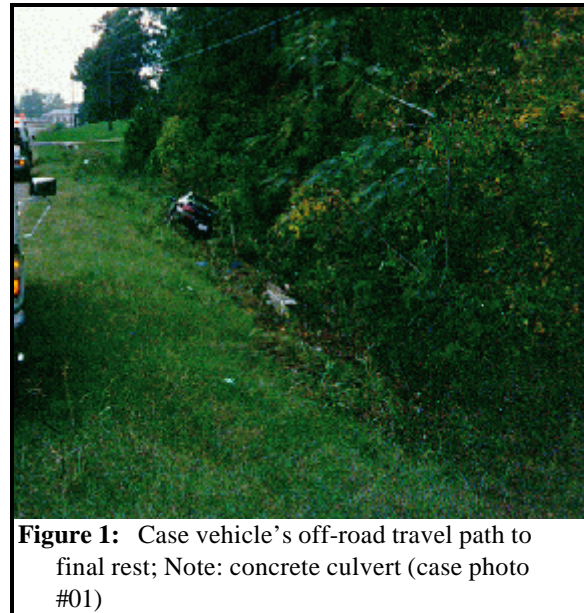
The case vehicle was traveling west in the westbound lane of a two-lane, undivided, state highway and intended to continue its westerly travel path (**Figure 1**). It was daylight and there was no adverse weather. The roadway was bituminous, dry, straight, and level. The posted speed limit was 89 km.p.h. (55 m.p.h.). The only traffic control devices present were a double solid yellow centerline and a single solid white edge line on each side of the roadway. All pavement markings were clearly visible. A witnesses said she had been following the case vehicle and saw it cross the centerline several times and then veer off the road to the right (north). The driver admitted that she had fallen asleep. The investigating officer stated that there was evidence that the case vehicle driver attempted to turn (left) in an attempt to regain the roadway but was unsuccessful. The case vehicle continued its travel path along the embankment and struck a concrete culvert. The crash occurred off the north road edge.

Figure 1: Case vehicle's off-road travel path to final rest; Note: concrete culvert (case photo #01)

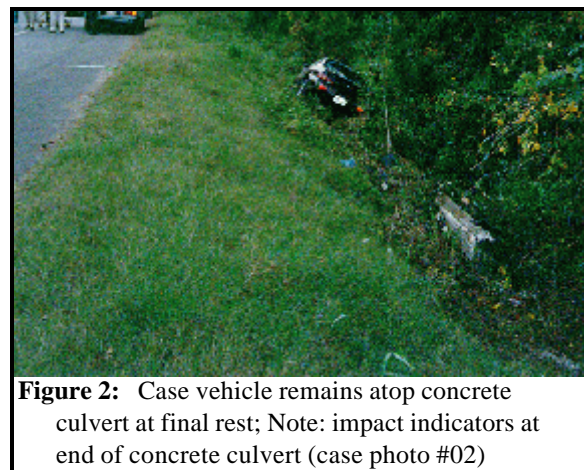
The front right corner of the case vehicle and its right side undercarriage impacted the east end of a concrete culvert, causing the case vehicle's driver and front right passenger air bags to deploy. The case vehicle's right side undercarriage continued in contact with the top of the concrete culvert for an additional 15.2 meters (50 feet) and was facing west at final rest (**Figure 2**). The crash severity for the case vehicle was high [greater than 40 km.p.h. (25 m.p.h.)].

Figure 2: Case vehicle remains atop concrete culvert at final rest; Note: impact indicators at end of concrete culvert (case photo #02)

The case vehicle hit the top of a long, narrow concrete retaining wall that was part of a culvert protruding from the embankment at the bottom of a ditch (**Figure 2**, above). The retaining wall portion of the culvert structure was parallel with the roadway and the case vehicle slid along the top, coming to rest still on top of the culvert. The concrete was abraded, but there is no evidence that it fractured or was otherwise structurally damaged.

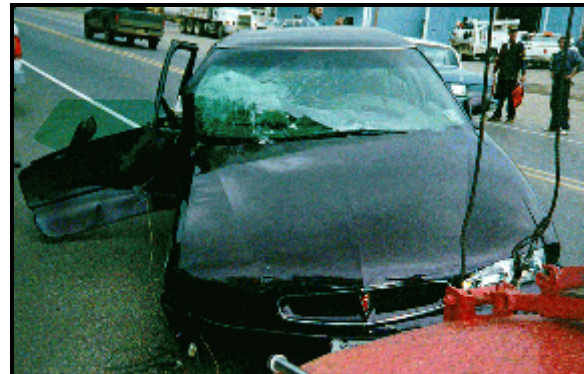
The case vehicle was a front wheel drive, 1998 Pontiac Bonneville SE, six-passenger, four-door sedan (VIN: 1G2HX52K7WH-----) equipped with a 3.8 liter, V-6 gasoline engine and a four-speed automatic transmission with column-mounted transmission selector lever. It was equipped with four-wheel anti-lock brakes. The wheelbase for the case vehicle was 281 centimeters (110.8 inches). No odometer reading was reported. The case vehicle was towed from the scene due to disabling damage (**Figure 3**).

Figure 3: Case vehicle's frontal plane damage; Note: right front door panel position is thought to be a result of removal operations (case photo #05)

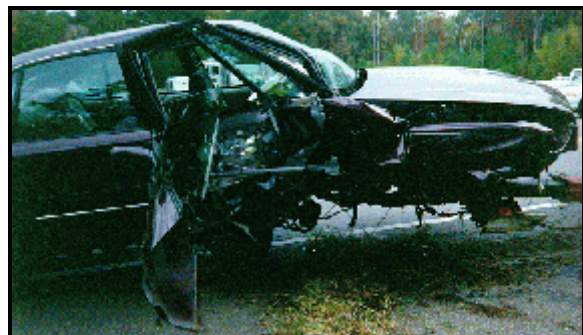
The case vehicle sustained direct contact damage to the front right corner and right side undercarriage. The front right wheel and suspension were displaced rearward almost to the B-pillar. Damaged components included: the air dam's right corner, the front right headlamp assembly, the right front tire and wheel assembly, the right front suspension, and the right side front door sill and rocker panel. Indirect damage included: right front fender, the upper and lower right A-pillar, the right third of the windshield (splintered), the right side roof rail, and the right front door. Based on police photographs, the CDC for the case vehicle was estimated as: **12-FREE-8** (principal direction of force 10 degrees). The WinSMASH reconstruction program, with CDC-only estimated crush profile, provided a borderline reconstruction. The calculated results appear to be somewhat high but are reasonable. The case vehicle's estimated Total, Longitudinal, and Lateral Delta Vs are, respectively: 65.9 km.p.h. (40.9 m.p.h.), -64.9 km.p.h. (-40.3 m.p.h.), and -11.4 km.p.h. (-7.1 m.p.h.).

There are no photographs available to assess damage to the interior. It is apparent that there was substantial intrusion in the right front passenger area, including the toe pan, the floor, the right lower A-pillar and the right instrument panel. The front right seating area was probably moved upward as a result of the floor intrusion. The right instrument panel appears to have been moved upward and rearward. The interior rearview mirror was dislodged and laying atop the instrument panel in front of the driver's position. It is likely that the left side of the instrument panel was also displaced upwards.

Figure 4: Case vehicle's undercarriage damage to right side; Note: right front wheel assembly and suspension under passenger's seat (case photo #07)
