REMOTE AIR BAG DEPLOYMENT REPORT

CASE NUMBER - IN99-085

LOCATION - MISSOURI

VEHICLE - 1998 DODGE DURANGO

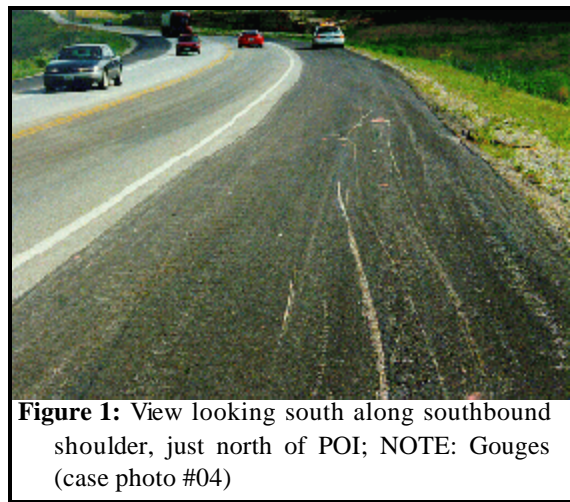
The case vehicle was traveling south in the southbound lane of a two-lane, undivided, U.S. route and was approaching a curve left. Vehicle #1 was traveling north in northbound lane of the same roadway and was negotiating a curve right. The roadway was wet and the driver of vehicle #1 was traveling at excessive speed based on the roadway conditions (i.e., rate of curve and wet conditions). Vehicle #1's trailing unit began to slide across the centerline into the southbound lanes, eventually blocking the entire southbound lane and shoulder. The case vehicle's driver steered to the right and braked, attempting to avoid the crash. The crash occurred in the southbound shoulder of the roadway (**Figure 1**).

Figure 1: View looking south along southbound shoulder, just north of POI; NOTE: Gouges (case photo #04)

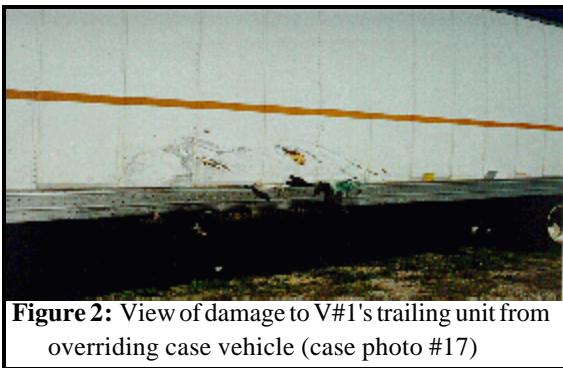
Figure 2: View of damage to V#1's trailing unit from overriding case vehicle (case photo #17)

The front left of the case vehicle was impacted by and subsequently underrode the left side of vehicle #1's trailer (**Figures 2 and 3**), causing the case vehicle's driver and front right passenger supplemental restraints (air bags) to deploy. Vehicle #1's trailing unit passed almost entirely over the case

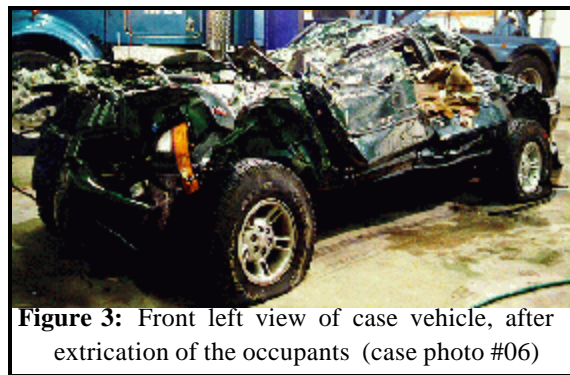
Figure 3: Front left view of case vehicle, after extrication of the occupants (case photo #06)

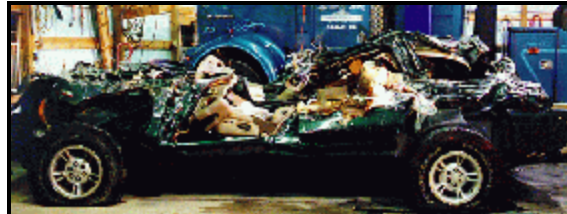
The case vehicle steered to the right and braked trying to avoid the trailer. The impact with vehicle #1's trailer resulted in the case vehicle going completely under the trailer bed prior to being dragged while underneath for approximately 76 meters (250 feet). The case vehicle's entire roof and green house area were crushed downward on top of the seat backs (**Figures 4-5**). The roof was cut and peeled off the case vehicle in order to extricate the injured occupants. Direct contact with vehicle #1's trailer extended across the entire front bumper and top of the case vehicle. The case vehicle's front end above the bumper contacted the right leaf spring and brake actuator of the trailer, probably preventing the vehicle from going completely under and out the other side of vehicle #1's trailing unit. Vehicle #1's brake actuator cover was embedded into the case vehicle's right front fender (**Figure 6**). As the case vehicle rotated clockwise under the trailer, the tops of the case vehicle's left side doors were also crushed inward and down. The left back side of the case vehicle was also crushed inward and flattened with all four tires being aired out as well. The case vehicle's right side was shifted outward. The vehicle's

Figure 4: Left side of case vehicle after extrication; NOTE: inward deformation (case photo #07)

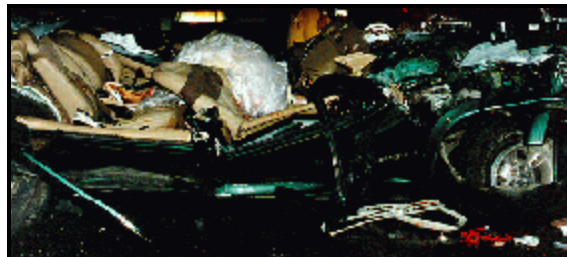
Figure 5: Right side of case vehicle after extrication; NOTE: outward deformation (case photo #12)

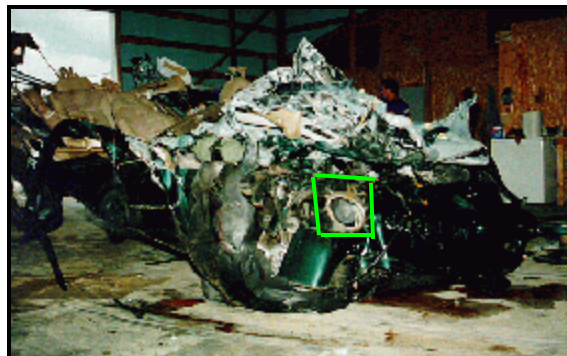
Figure 6: Angle view from front right of case vehicle; NOTE: V#1's brake actuator cover embedded into fender and right side components deformed outward (case photo #14)

instrument panel was also compressed downward. The CDC, estimated from police photographs is **11-FDHA-9** [principal direction of force of 330 (-30) degrees]. Because of the severe underride and vehicle #1 being out of scope, the WinSMASH reconstruction algorithm could not be executed. The crash severity for the case vehicle was high [greater than 40 km.p.h. (25 m.p.h.)]. The case vehicle was towed due to damage.

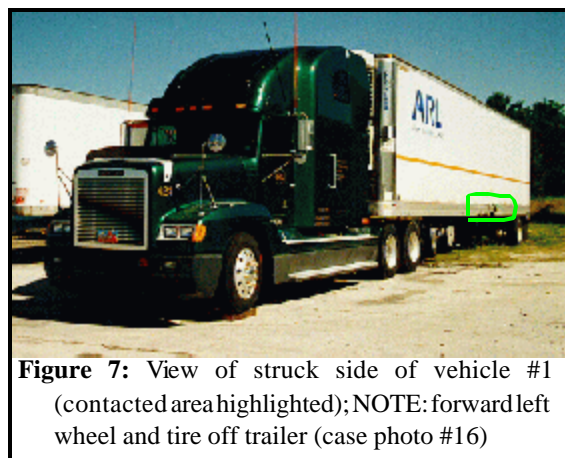
Figure 7: View of struck side of vehicle #1 (contacted area highlighted); NOTE: forward left wheel and tire off trailer (case photo #16)

The case vehicle's impact with the left side of vehicle #1's trailer caused damage to the left wall of the trailer (**Figure 7**, above), the frame, right leaf spring and brake actuator, and the forward axle, including left and right forward tandem wheels and tires (**Figures 8 & 9**). The right side wall of the trailer sustained induced damage and was bowed outward.

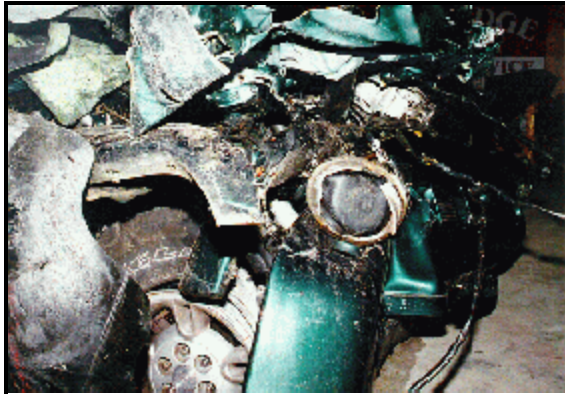
Figure 8: Close-up of vehicle #1 trailer's right brake actuator cover embedded into the case vehicle's right front fender (case photo #15)

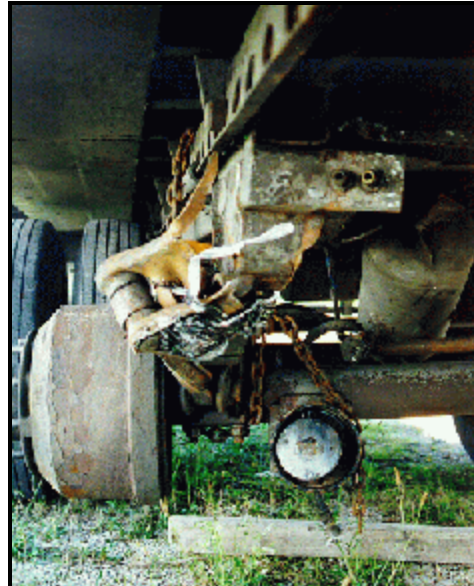
Figure 9: Close-up of vehicle #1 trailer's undercarriage showing struck right main spring and brake actuator (case photo #19)
