ON-SITE AIR BAG INVESTIGATION

CASE NUMBER - IN99-087
LOCATION - MISSISSIPPI
VEHICLE - 1996 HYUNDAI ACCENT L
CRASH DATE - August, 1999

1. <i>Report No.</i> IN99-087		2. <i>Government Accession No.</i>		3. <i>Recipient's Catalog No.</i>	
4. <i>Title and Subtitle</i> On-Site Air Bag Fatality Investigation Vehicle - 1996 Hyundai Accent L Location - Mississippi			5. <i>Report Date:</i> October 26, 2001; July 30, 2002

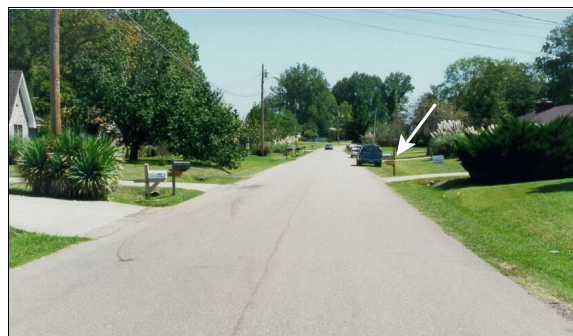
The case vehicle was traveling east in the eastbound lane of a two-lane, undivided, city street and intended to continue traveling eastbound (**Figure 1**). According to the case vehicle's driver, a noncontact truck was westbound, driving in her eastbound lane of travel, and she swerved to the right to avoid it. The case vehicle's driver subsequently drove into a brick mailbox post, located along of the south edge of the road (**Figure 2**). The case vehicle's driver made no avoidance maneuvers just prior to striking the mailbox post. The crash occurred on the south roadside (see **CRASH DIAGRAM** below). The case vehicle's driver was unable to give any description of the oncoming noncontact truck. Based on police follow-up interviews with surrounding neighbors and other motorist, this account was dismissed. This contractor believes that the driver became distracted while interacting (i.e., bottle feeding) with her infant daughter and inadvertently steered off the south edge of the roadway into the brick mailbox post.

Figure 1: Case vehicle's eastward travel path on residential street; Note: arrow indicates location of replacement mailbox (case photo #01)

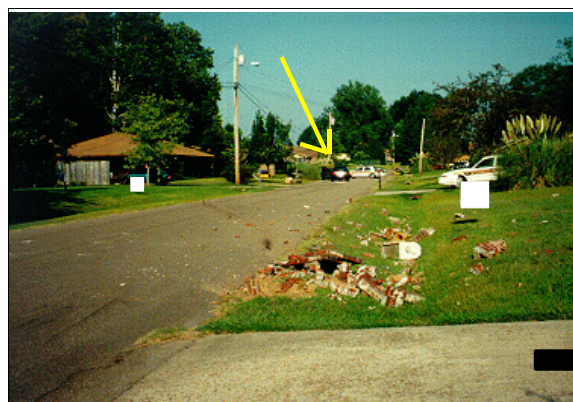
Figure 2: On-scene view looking east-northeast from in front of point of impact (POI) with brick mailbox post; Note: case vehicle's final rest position (arrow), fluid trail, and front right tire mark leading from POI (case photo #49)

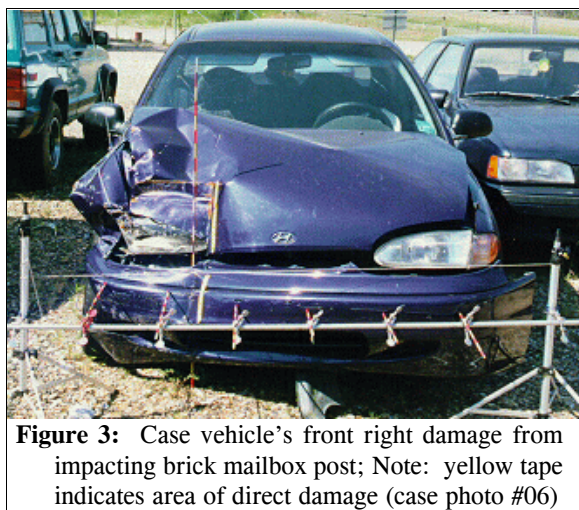
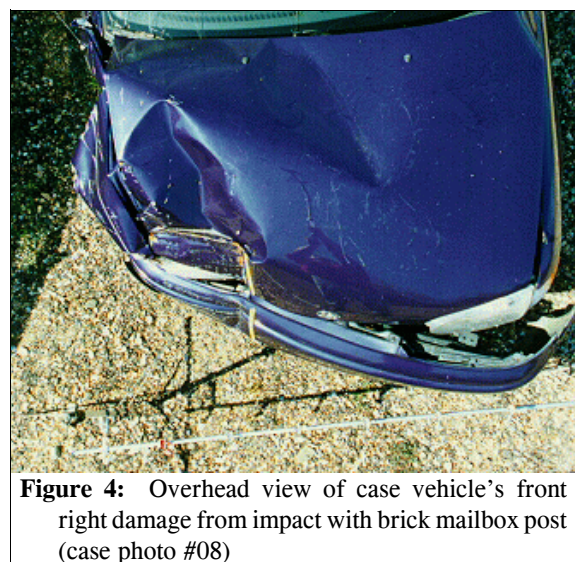
The front right (**Figures 3 and 4**) of the case vehicle impacted the brick mailbox post, causing the case vehicle's driver and front right passenger supplemental restraints (air bags) to deploy. The case vehicle directly impacted only three-fourths of the brick post's width. The case vehicle was going fast enough that after the initial impact, the case vehicle continued primarily eastward, sideswiping a portion of the crumbling mailbox post with its right quarter panel before swerving back across the street where its left wheels went off the north edge of the roadway. The case vehicle re-entered the roadway and came to rest in the westbound lane, heading east (**Figure 1** above), 67.1 meters (220 feet) further east of the point of impact. The driver stated she was only traveling 32 km.p.h. (20 m.p.h.) when she swerved to the right to avoid the unknown truck. Based on the extent of damage and distance it traveled post crash, it is this contractor's opinion that the case vehicle was traveling in excess of 56 km.p.h. (35 m.p.h.).

The case vehicle's initial contact with the brick mailbox post involved the front right corner (Figure 3 above). Direct damage began at the right bumper corner and extended, a measured distance of 41 centimeters (16.1 inches), inwards along the front bumper (Figure 4 above). The induced damage (i.e., field L) extended across the case vehicle's entire front bumper a distance of 119 centimeters (46.9 inches); the undeformed end width was determined to be 134 centimeters (52.8 inches). Maximum crush was measured as 29 centimeters (11.4 inches) at C₆. The case vehicle's front right bumper corner and right fender were crushed rearward restricting the right front wheel (Figure 5) and shortening the wheelbase on the right side 2 centimeters (0.8 inches). The wheelbase on the case vehicle's left side was unchanged. In addition, the continuation of the case vehicle through the brick mailbox post resulted in a portion of the brick structure swiping down the right side of the case vehicle directly contacting the right outside rearview mirror and right quarter panel near the flare of the right rear wheel well. Furthermore, there was direct contact to the right rear wheel's rim and the rear edge of the right rear door just below the "C"-pillar (Figure 6). The direct damage width was 31 centimeters (12.2 inches). The case vehicle's front bumper, bumper fascia, grille, hood, right headlight and turn signal assemblies, and right

Based on the vehicle inspection, the CDCs for the case vehicle were determined to be: **12-FREW-2 (0)** and **12-RBMS-1 (0)**. The WinSMASH reconstruction program, barrier algorithm, was used on the case vehicle's highest severity impact. The Total, Longitudinal, and Lateral Delta Vs are, respectively: 21.2 m.p.h. (13.2 m.p.h.), -21.2 km.p.h. (-13.2 m.p.h.), and 0.0 km.p.h. (0.0 m.p.h.). Although these results should be considered borderline because the NASS, CDS, WinSMASH protocol requires that the struck object be immovable, this contractor's believes the estimate is reasonable. The case vehicle was towed due to damage.

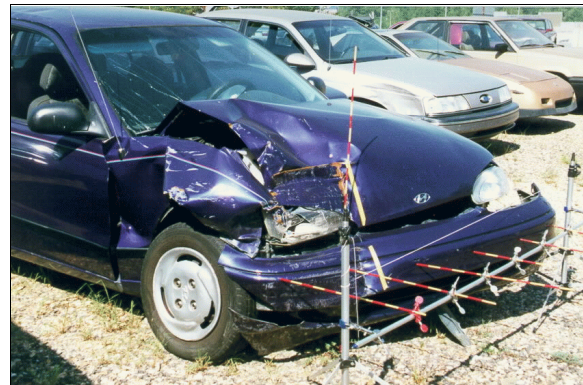
Figure 5: Case vehicle's front right impact showing restricted right front tire and induced damage to right fender and windshield (case photo #17)

fender were directly damaged and crushed rearward. The case vehicle's right front tire was physically restricted but not deflated. The left headlight and turn signal assemblies as well as both the right and left fenders sustained induced damage from the vehicle's frontal impact with the brick mailbox. The right windshield's glazing sustained several stress cracks to the lower right corner near the "A"-pillar, and the glazing in the right front door was disintegrated from the frontal impact. Additionally, the roof above the right "B"-pillar was buckled.

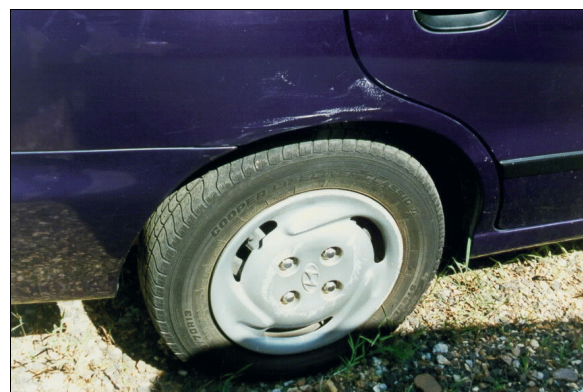
Figure 6: Damage to case vehicle's right quarter panel from sideswiping mailbox (case photo #14)

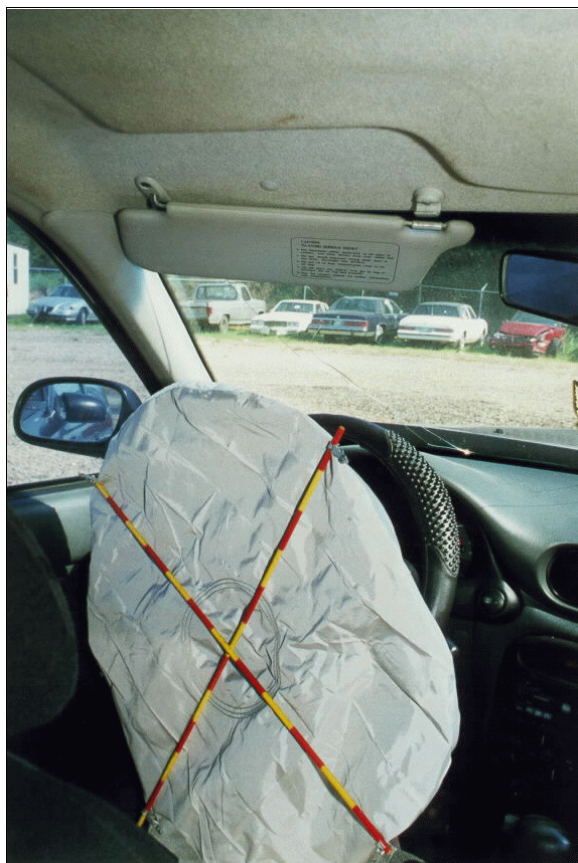
Figure 7: Vertical view of case vehicle's driver seating area showing no apparent visible contact evidence on deployed air bag or to greenhouse areas (case photo #26)

Inspection of the case vehicle's interior revealed that there was no other discernable evidence of occupant contact on the interior surfaces of the case vehicle (**Figures 7 and 8**). In addition, the

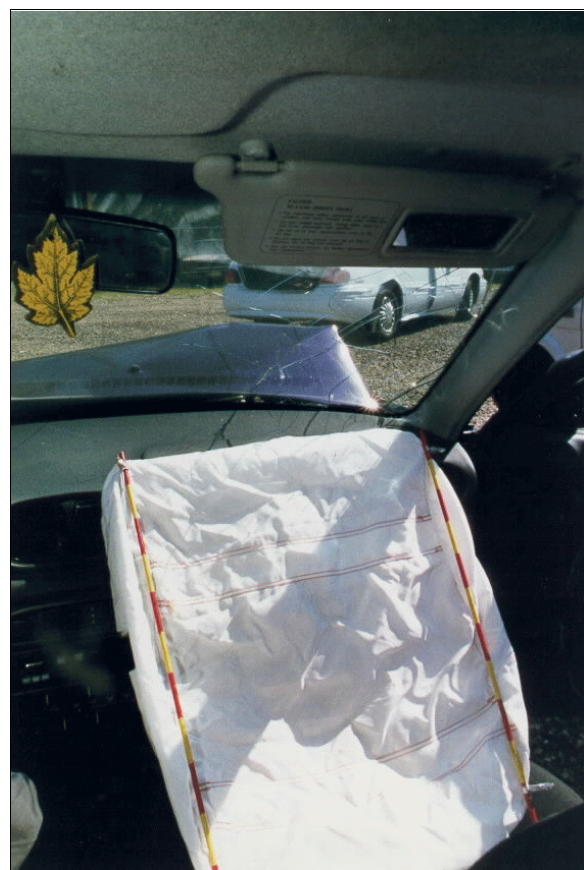
Figure 8: Case vehicle's front right passenger seating area showing no apparent visible contact evidence on deployed air bag's front surface and greenhouse areas, except for stress fractures to right windshield's glazing (case photo #29)

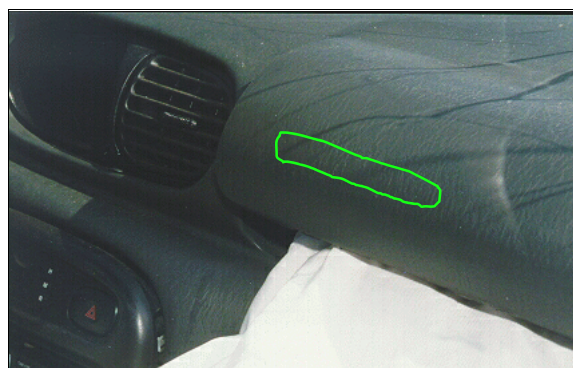
The front right passenger's air bag was located in the top of the instrument panel. There was a single, curvilinear, essentially rectangular, modular cover flap. The cover flap was made of a thick vinyl over a thick cardboard type frame. The flap's dimensions were 35 centimeters (13.8 inches) at the forward horizontal seam, and 20 centimeters (7.9 inches) along both vertically-oriented seams. The flap was curved approximately 90 degrees and the apex of the curve was located approximately 15 centimeters (5.9 inches) from the rear horizontal seam (i.e., toward the windshield) while only 5 centimeters (2.0 inches) from the forward horizontal seam. The profile of the case vehicle's instrument panel resulted in a 3 centimeter (1.2 inch) setback of the leading edge of the cover flap relative to the protruding right instrument panel. An inspection

Figure 10: Case vehicle's front right air bag module's cover flap showing slight impression/scuff (highlighted) from contact with top, back edge of Rear Facing Child Safety Seat (case photo #33)

The front right occupant was transported by a passing neighbor to the hospital. She sustained critical brain injuries and was pronounced dead three hours and twenty minutes post-crash. According to her medical records, the case vehicle's front right passenger sustained: a critical nonanatomic brain injury accompanied by intracerebral petechial hemorrhages, fractures to her left and right temporal and parietal bones, and contusions over her left and right scalp at the fracture sites. This occupant's head injuries were caused by contact with the back surface of her RFCSS (**Figure 13** above) which was directly contacted by the front right air bag module's cover flap (**Figure 10** above) and subsequently by the deploying front right passenger air bag.

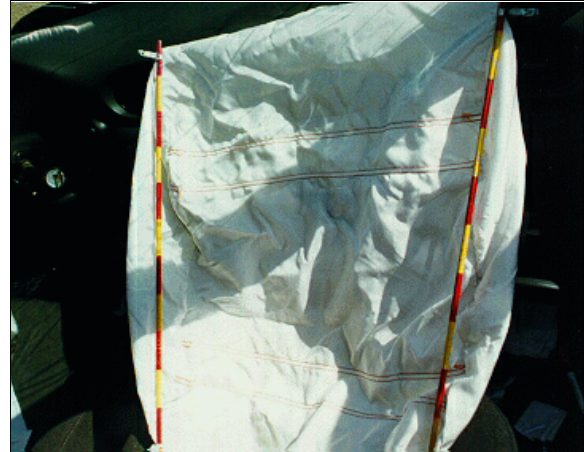
of the front right air bag module's cover flap and air bag revealed that the cover flap opened at the designated tear points and the front right air bag module's cover flap had a 12 centimeter (4.7 inch) wide horizontal scuff as a direct result of contacting the top, back edge of the front right passenger's rear facing child safety seat (**Figure 10** above). Furthermore, the back surface of the front right air bag had a dark black flap transfer. The front right passenger's air bag was designed with two tethers, each 42 centimeters (16.5 inches) in width. The top tether was sewn to the interior face of the air bag at a point that was 13 centimeters (5.1 inches) below the top edge while the second tether was sewn 26 centimeters (10.2 inches) below the top tether. The front right air bag had two vent ports, approximately 5 centimeters (2.0 inches) in diameter, located at the 9:30 and 2:30 o'clock positions. The deployed front right air bag was rectangular with a height of approximately 57 centimeters (22.4 inches) and a width of approximately 47 centimeters (18.5 inches). Because of the contact with the back of the child safety seat, there was no visible contact evidence readily apparent on the front surface of the front right air bag (**Figure 11**).

Figure 11: Case vehicle's front right air bag; Note: no apparent physical evidence of contact was found (case photo #36)

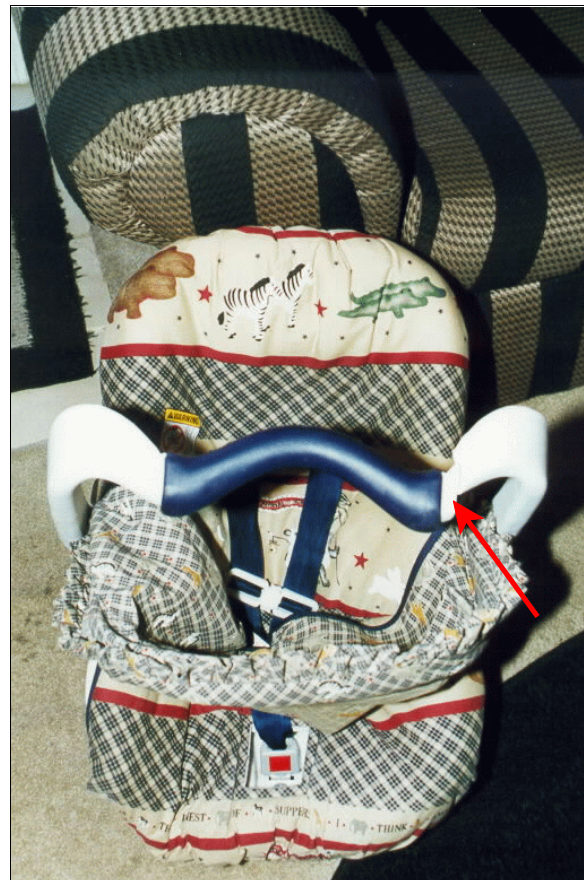
The rear facing child safety seat (RFCSS) was manufactured by Century on February 2, 1999 and was identified by "Prosport 4/1" Model number 11650CN0 (**Figure 12**). The involved child safety seat was improperly used at the time of the crash (i.e., based upon the on-scene police photographs the infant was not properly restrained by the seat's available harness, and the RFCSS was not properly secured by the available three-point, lap-and-shoulder, safety belt system). The RFCSS was designed to be used only as a rearward facing infant restraint. The RFCSS consisted of a plastic one-piece shell with a pivoting carrying handle attached to the sides at the mid-point of the shell. The child safety seat was manufactured with a three-point harness, which was attached to the shell, but was improperly attached at the time of the crash. In addition, the RFCSS was equipped with two slots

Figure 12: Rear Facing Child Safety Seat (RFCSS) used by case vehicle's front right passenger; Note: broken carry handle (case photo #40)

Examination of the RFCSS revealed several anomalies to the structure as a result of the impact from the deploying front right passenger air bag module's cover flap and air bag. The top back edge of the seat back portion which rested against the front right air bag module's cover flap was cracked in two places approximately 12 centimeters (4.7 inches) apart (**Figure 13**). In addition, the carry handle, towards the outboard side, was cracked from contact with the seat back (**Figure 12** above).

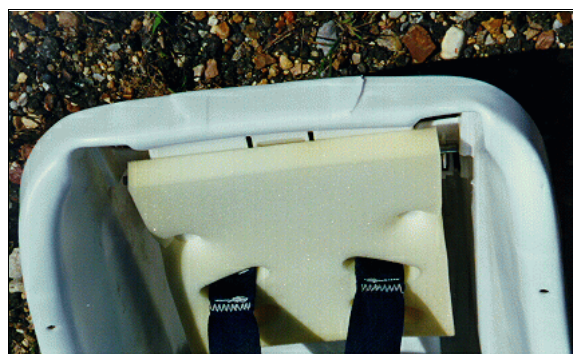
Figure 13: Overhead view of case vehicle's RFCSS showing cracks to top of back support from contact with front right air bag module's cover flap (case photo #43)

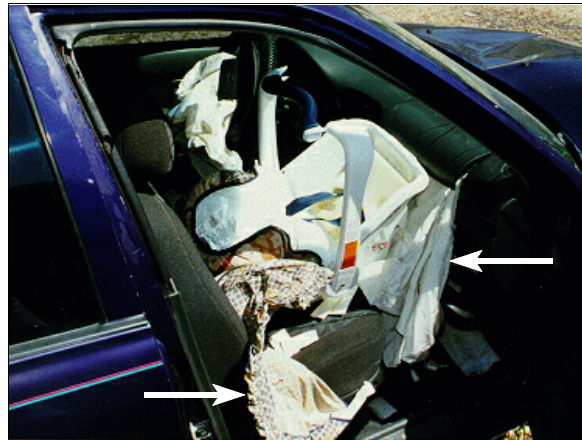
Figure 14: On-scene view of position of case vehicle's front right, **rear facing child safety seat (RFCSS)** in vehicle; Note: front right air bag module's cover flap contacted back of seat's shell and seat cover and sun umbrella have been pulled away from shell (case photo #54)

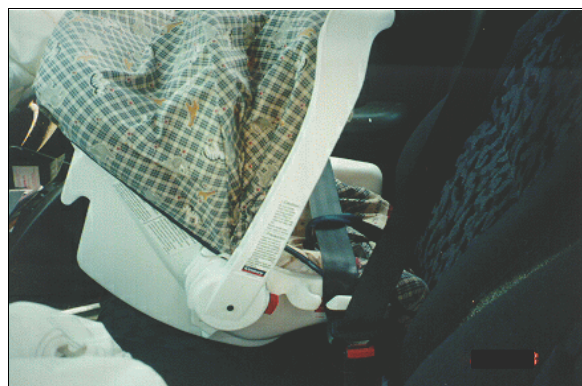
The case vehicle's front right passenger was incorrectly restrained in her **rear facing child safety seat (RFCSS)**. First, the child seat was improperly secured to the vehicle by the available, active, three-point, lap-and-shoulder, safety belt system. On-scene photographs taken by the police showed only the lap portion was attached of the three-point belt system (**Figure 15**). The inspection of the front right passenger's seat belt webbing, "D"-ring, and latch plate showed no evidence of loading. Second, the RFCSS was improperly located in the front right seat position by having its forward edge placed against the front right passenger air bag module (**Figure 14**). Third, this contractor found a few additional child safety restraint flaws.

Figure 15: On-scene view of case vehicle's, improperly secured (i.e., by lap belt only), front right rear facing child safety seat (RFCSS); Note: carry handle is in up position (case photo #59)

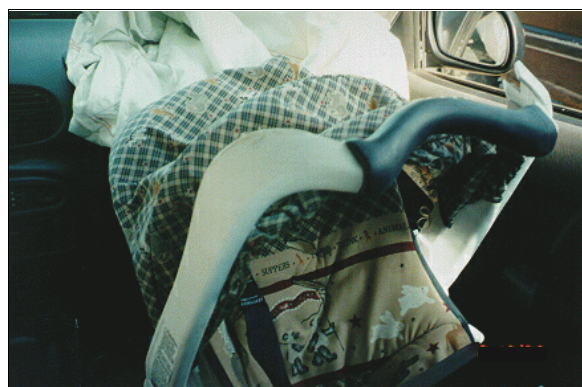
The case vehicle is equipped with a switchable retractor system. There was a patch sewn near the floor end of the front right belt webbing, instructing the user to totally extend the webbing until the retractor switches into the locking mode when used with a child. The case vehicle's driver had no knowledge about having to switch the retractor into the Automatic Locking Retractor (ALR) mode. Based on this contractor's inspection and the interview with the case vehicle's driver, the case vehicle's front right seat belt retractor was not switched to the locking mode at the time of the crash. Additionally, the metal rod used to retain the harness on the back of the RFCSS's was not secured properly allowing the harness webbing to pull out through the slot. The carry handle attached to the RFCSS was found post-crash in the upwards position contrary to instruction labels attached to the outboard side of handle (**Figure 16**).

Figure 16: On-scene view of case vehicle's rear facing child safety seat at final rest; Note: carrying handle is in up position and sun umbrella is extended (case photo #55)

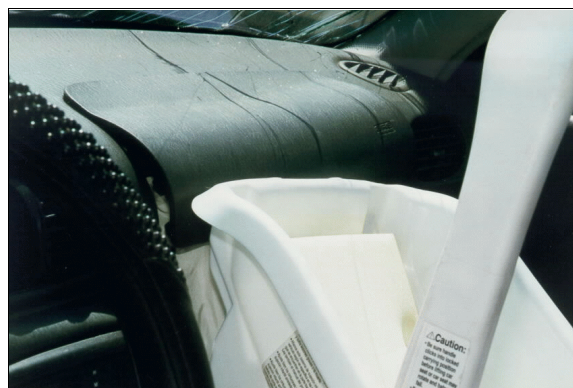
Figure 17: On-scene view showing proximity of case vehicle front right air bag module's cover flap and cracked back edge of RFCSS (case photo #58)
