ON-SITE REDESIGNED AIR BAG INVESTIGATION

CASE NUMBER - IN99-089
LOCATION - TEXAS
VEHICLE - 1998 FORD MUSTANG
CRASH DATE - September, 1999

1. <i>Report No.</i> IN99-089		2. <i>Government Accession No.</i>		3. <i>Recipient's Catalog No.</i>	
4. <i>Title and Subtitle</i> On-Site Redesigned Air Bag Investigation Vehicle - 1998 Ford Mustang Location - Texas			5. <i>Report Date:</i> August 21, 2002

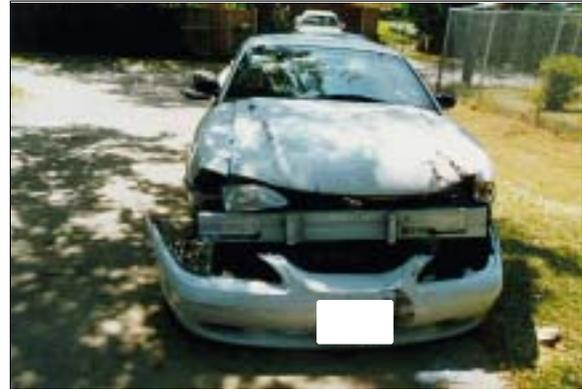
The front (**Figure 2**) of the case vehicle impacted and underrode the right rear of the Ford truck (**Figures 3 and 4**), causing the case vehicle's driver and front right passenger supplemental restraints (air bags) to deploy. The two vehicles essentially came to rest at the point of impact.

Figure 2: Case vehicle's frontal damage; Note: torn-off front bumper fascia and reinforcement bar (case photo #13)

Residual maximum crush was measured as 13 centimeters (5.1 inches) at C₄. The case vehicle's wheelbase was unaltered from the crash. The case vehicle's front bumper, bumper fascia, grille, hood, and left headlight and turn signal assemblies were directly damaged and crushed rearward (**Figure 2** above and **Figure 5**). None of the case vehicle's tires were damaged, deflated, or physically restricted. The right headlight and turn signal assemblies sustained induced damage as well as the hood and both the right and left fenders.

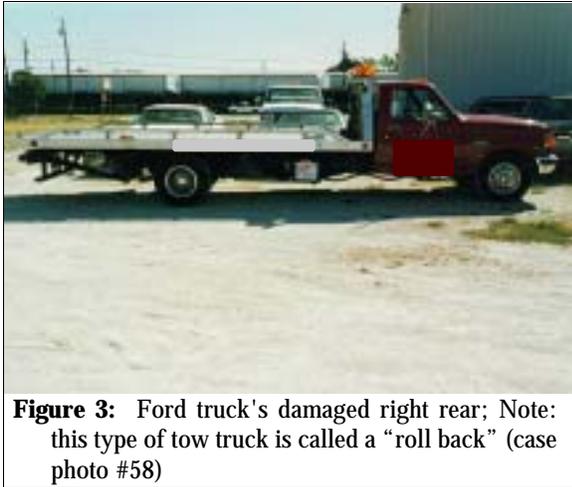
Figure 3: Ford truck's damaged right rear; Note: this type of tow truck is called a "roll back" (case photo #58)

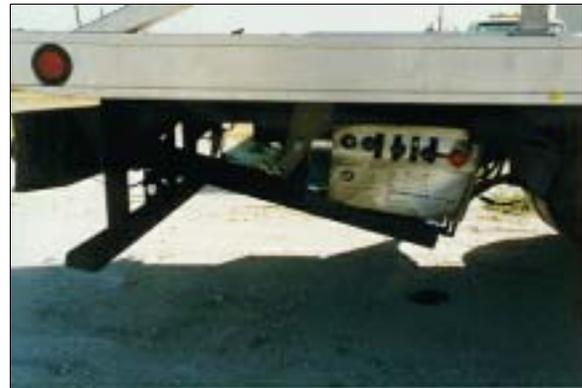
Figure 4: Close-up of Ford truck's damaged right rear showing primary damage to undercarriage; Note: yellow dot indicates forward-most point of direct damage (case photo #60)

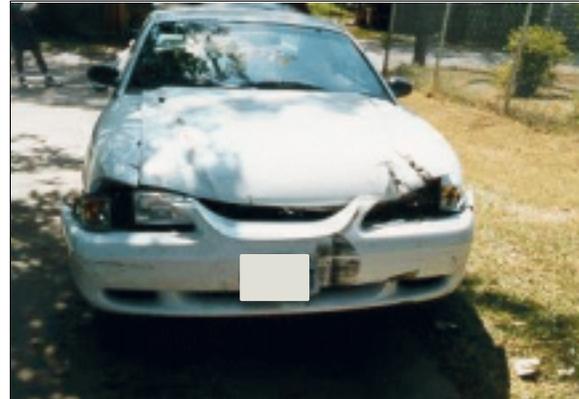
The case vehicle's contact with the Ford truck involved its entire front (**Figure 5** below). Direct damage began at the front left bumper corner and extended, a measured distance of distance of 142 centimeters (55.9 inches), along the front bumper to the front right bumper corner.

Figure 5: Case vehicle's damaged front end showing torn off bumper fascia placed back onto reinforcement bar (case photo #16)

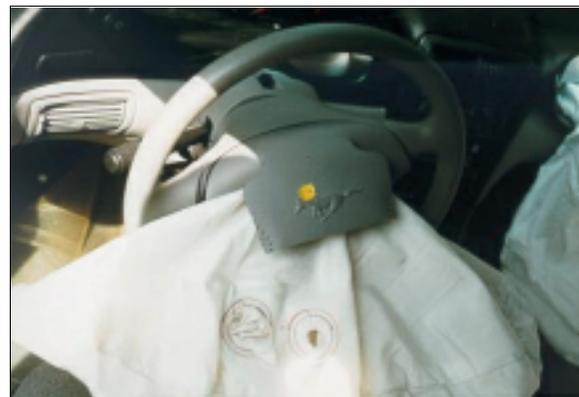
Figure 6: Case vehicle driver air bag module's top cover flap showing (i.e., yellow tape) scratch near flap's logo and vent ports (case photo #46)

deployment to the air bag. Furthermore, there appeared to be a scratch immediately above the horse image (i.e., Mustang) at the center of the driver air bag module's top cover flap (**Figure 6** above). The driver's air bag was designed with two tethers, each approximately 10 centimeters (3.9 inches) in width. The driver's air bag had two vent ports, approximately 2 centimeters (0.8 inches) in diameter, located at the 11:30 and 12:30 o'clock positions. The deployed driver's air bag was rectangular, with a height of 50 centimeters (19.7 inches) and a width of 62 centimeters (24.4 inches). An inspection of the driver's air bag fabric revealed a body fluid stain and slight scratching toward the top left quadrant near the center of the air bag's fabric (**Figure 7** above).

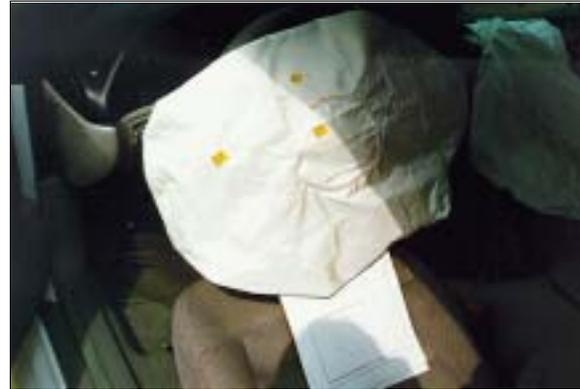
Figure 7: Case vehicle's deployed driver air bag; Note: yellow tape indicates occupant contact points (case photo #47)

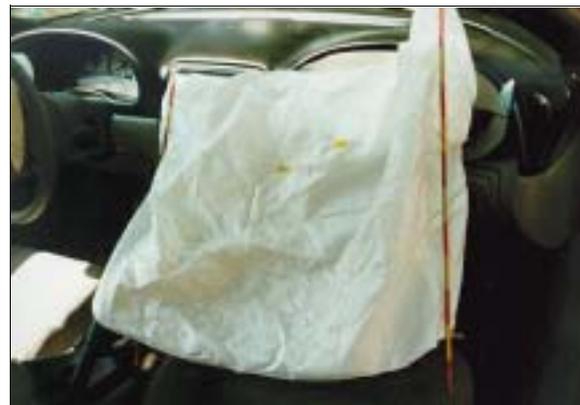
The front right passenger's air bag was located in the middle of the instrument panel. There were two, essentially symmetrical, quarter moon shaped modular cover flaps. The cover flaps were made of a thick vinyl over a thick cardboard type frame. Each dimensions were 45 centimeters (17.7 inches) at the horizontal seam and 7.5 centimeters (3.0 inches) vertically at the flap's apex. An inspection of the front right air bag module's cover flaps and air bag revealed that the cover flaps opened at the designated tear points, and there was no evidence of damage during the deployment to the air bag or the cover flaps. The front right passenger's air bag was designed without any tethers. The front right air bag had no vent ports. The deployed front right air bag was rectangular with a height of 52 centimeters (20.5 inches) and a width of 79 centimeters (31.1 inches). An inspection of the front right passenger's air bag fabric revealed that the front right passenger contacted his air bag, depositing some slight scratching on the top left quadrant near the center of the fabric and a body fluid stain just above the bag's horizontal midline about a quarter of the way to the right outside seam (**Figure 8**).

Figure 8: Case vehicle's deployed front right passenger air bag; Note: yellow tape indicates occupant contact points (case photo #50)
