# INDIANA UNIVERSITY

## ON-SITE AIR BAG INVESTIGATION

CASE NUMBER - IN99-091  
LOCATION - NORTH DAKOTA  
VEHICLE - 1990 GEO STORM  
CRASH DATE - April, 1999

1. <i>Report No.</i> IN99-091		2. <i>Government Accession No.</i>		3. <i>Recipient's Catalog No.</i>	
4. <i>Title and Subtitle</i> On-Site Air Bag Fatality Investigation Vehicle - 1990 Geo Storm Location - North Dakota			5. <i>Report Date:</i> 9/30/2001; 2/27/2002; 3/06/2002

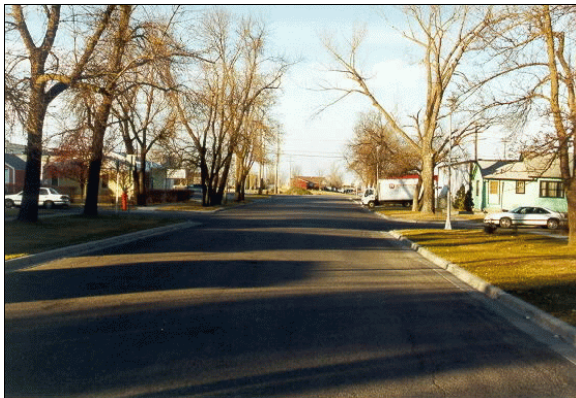
**Figure 1:** Case vehicle's northward travel path into four-leg intersection; Note: fire hydrant on left and white car (i.e., approximate position of noncontact vehicle) approaching from east leg (case photo #01)

The north/south city roadway was straight and level at the area of impact (**Figure 1**). The pavement was bituminous, and the width on the south leg of the intersection was 9.6 meters (31.5 feet), with legal parking on the east side only. The north leg of the intersection was 12.2 meters (40.0 feet) wide, with legal parking along both the east and west sides. The shoulders for the

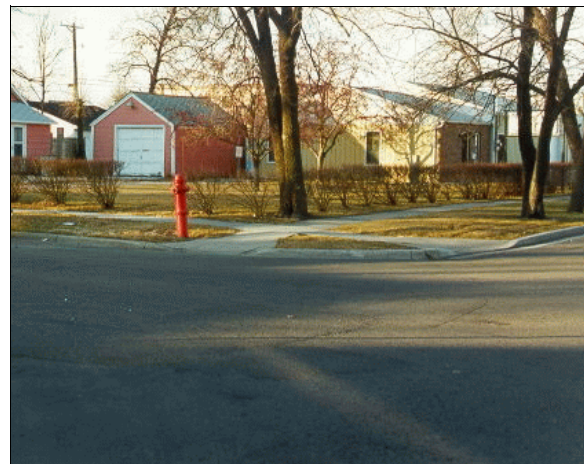
**Figure 2:** Northwest corner of intersection toward which case vehicle's driver steered sharply in response to encroaching noncontact vehicle (case photo #03)

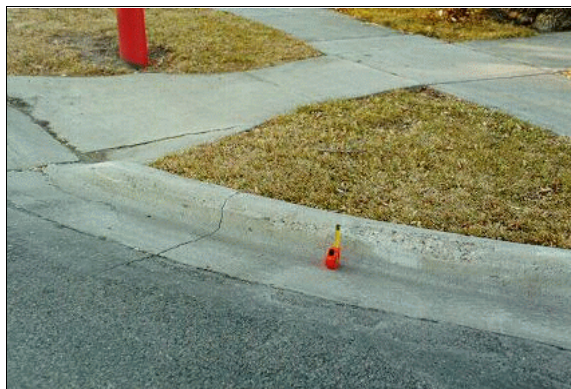
The right front tire of the case vehicle impacted the barrier curb [11.4 centimeters high (4.5 inches)–**Figure 3**], causing the case vehicle's driver (only) supplemental restraint (air bag) to deploy. The case vehicle continued in a west-northwesterly direction, and its front left bumper corner (**Figure 4**) impacted a fire hydrant (**Figure 3**). The narrow end engagement with the fire hydrant traveled down the case vehicle's left side and snagged on the left front wheel (**Figure 5**), causing the case vehicle to rotate approximately 100 degrees counterclockwise. The case vehicle came to rest on the sidewalk, off the northwest corner of the intersection, heading in a southwesterly direction.

**Figure 3:** Case vehicle traveled off northwest corner of four-leg intersection striking first the curb (near tape measure) with its right front wheel and then the fire hydrant (case photo #04)

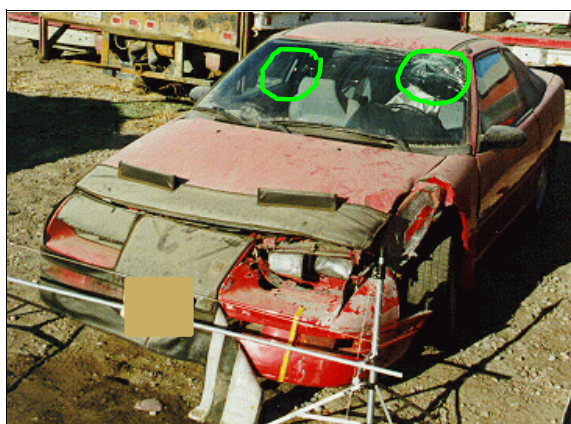
**Figure 4:** Case vehicle's front left damage viewed from left of front showing deformation from fire hydrant impact; Note: head contacts to windshield (case photo #09)

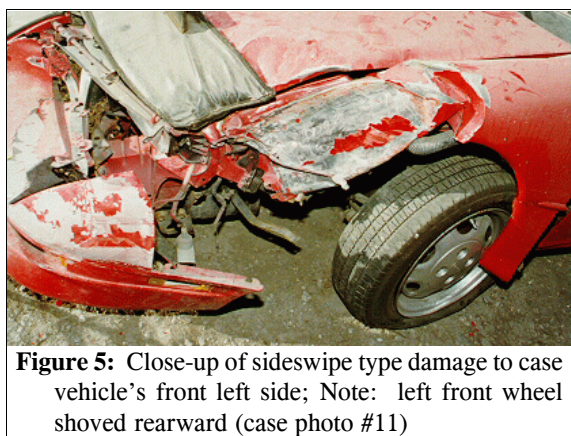
**Figure 5:** Close-up of sideswipe type damage to case vehicle's front left side; Note: left front wheel shoved rearward (case photo #11)

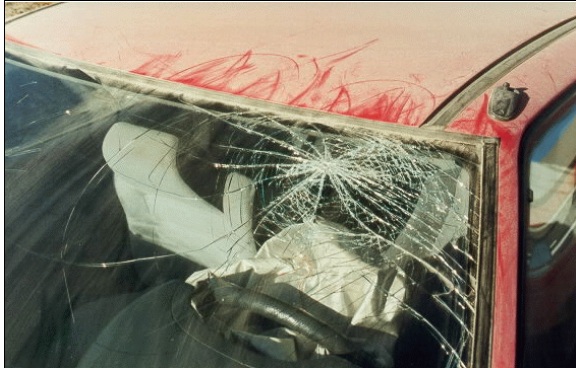
**Figure 6:** Exterior view of driver's contact to case vehicle's upper left windshield (case photo #14)

The inspection of the case vehicle's interior revealed a spider web crack on the left side of the windshield's glazing (**Figure 6**) from the driver's head and a crack on the passenger side (**Figure 7**) from contact by the front right passenger (also **Figure 4** above). In addition, the case vehicle's driver loaded the steering wheel causing the energy absorbing steering column to show significant evidence of compression (**Figure 8**). The shear capsules had become completely separated with the separation measured at 3.5 centimeters (1.4 inches). The bottom half of the steering wheel rim had blood splatter over it. Furthermore, the driver contacted the sun visor (**Figure 9** below) and the knee bolster—to the left of the steering column, was scuffed and deformed (**Figure 10** below). The front right passenger contacted, in addition to the windshield's glazing, the right and center instrument panel (i.e., deformed and scuffed) and the rearview mirror. The roof near the left side rail showed what appeared to be a mucous smear. There was no readily visible evidence of intrusion to the case vehicle's interior.

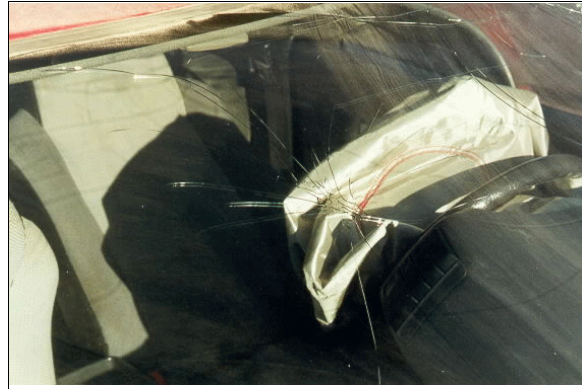
**Figure 7:** Exterior view of front right passenger's contact to case vehicle's right center windshield (case photo #19)

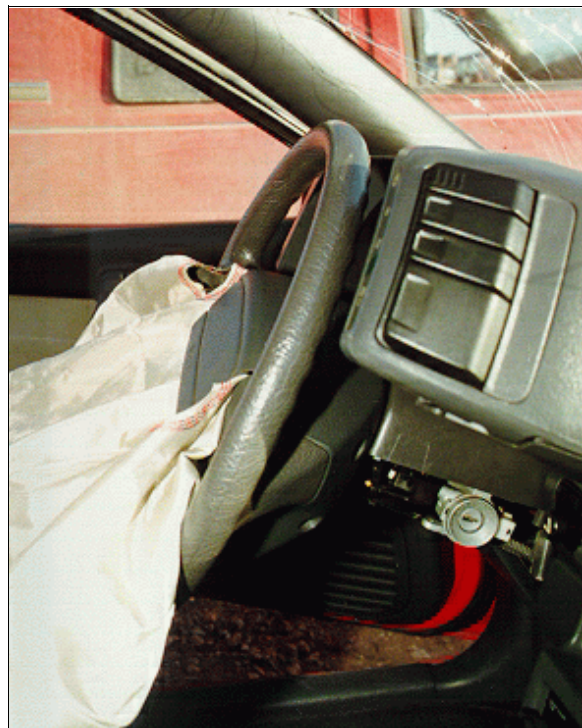
**Figure 8:** Side view of case vehicle's steering wheel and column pushed forward into instrument panel from driver loading (case photo #29)

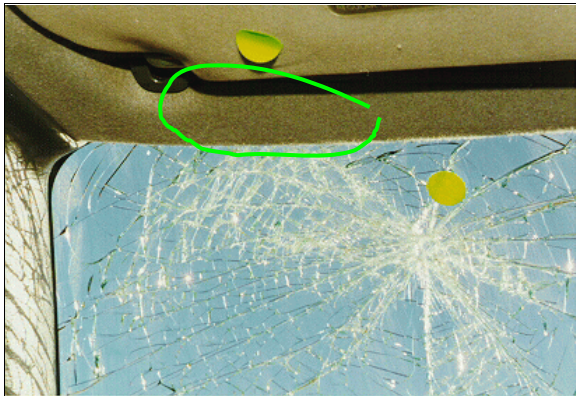
**Figure 9:** Close-up of case vehicle's front left header area showing driver's head strike to windshield, header, and sun visor; Note: hair hanging down (case photo #30)

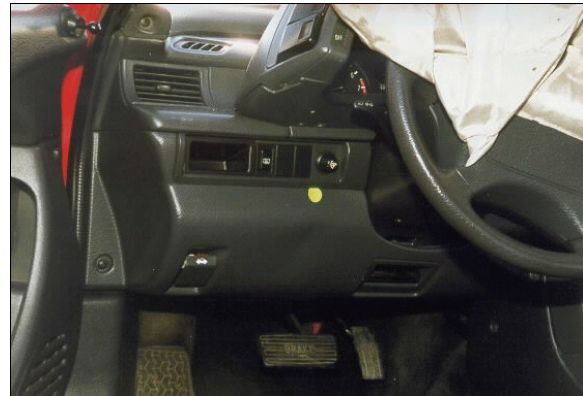
**Figure 10:** Contact evidence on case vehicle's driver knee bolster, left of steering column (case photo #23)

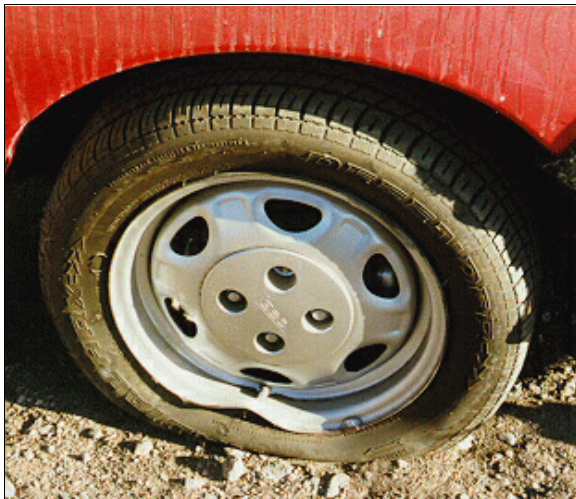
**Figure 11:** Close-up view of case vehicle's right front wheel showing rim and tire damage from curb impact (case photo #18)

The case vehicle's initial contact with the curb involved the front right tire, causing the rim to be deformed (**Figure 11**) and the wheelbase to be shortened. The case vehicle's initial contact with the fire hydrant was to the front left bumper corner (**Figure 12**). Direct damage began at the front left bumper corner (**Figure 4** above) and extended inward, a measured distance of 15 centimeters (5.9 inches), along the front bumper. The case vehicle's left EAD (i.e., Energy Absorption Device) on the front bumper was fully stroked a measured distance of 4.5 centimeters (1.8 inches). The crush to the case vehicle's bumper was approximately 4 centimeters (1.6 inches). The case vehicle's narrow corner engagement with the fire hydrant continued down the left side directly contacting and subsequently snagging and deforming (i.e., rim bent) the left front wheel (**Figure 13** below). The length of direct contact extended a measured distance of 93

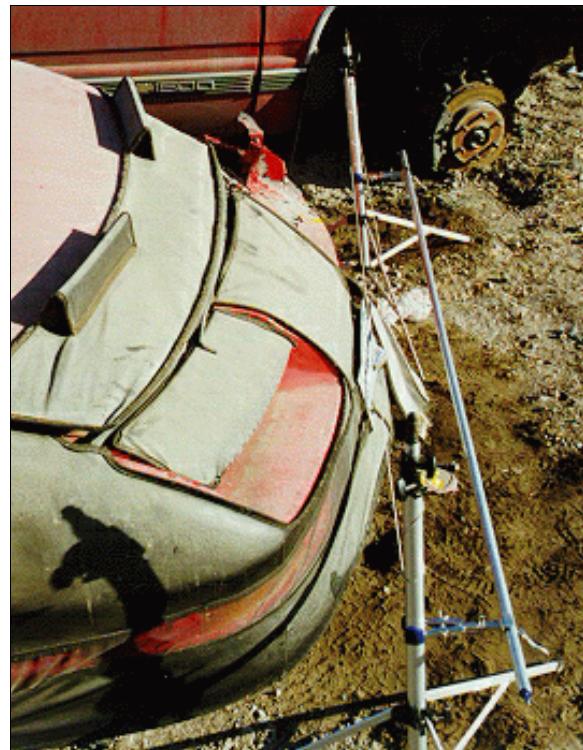
**Figure 12:** Case vehicle's minimally deformed front viewed along front reference line from right (case photo #20)

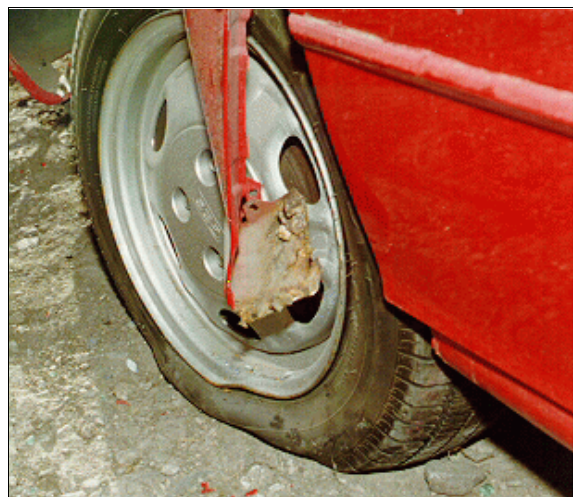
centimeters (36.6 inches) down the left side. The wheel base on the left side was shortened 17 centimeters (6.7 inches) while the right side was shortened 4 centimeters (1.6 inches). The case vehicle's front bumper, bumper fascia, grille, hood, left headlight and turn signal assemblies, and left fender were directly damaged and crushed rearward. The front right tire had been deflated during the curb impact (**Figure 11** above), and the front left tire was deflated from impacting the fire hydrant (**Figure 13**).

**Figure 13:** Close-up of case vehicle's left front wheel, viewed from rear of left, showing rim damage from fire hydrant impact (case photo #13)

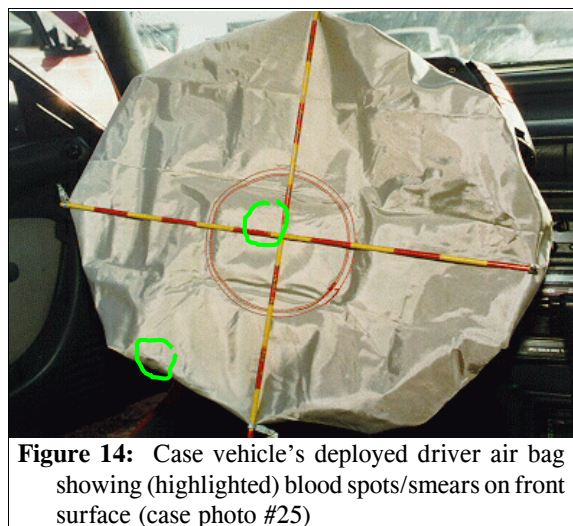
The case vehicle was equipped with a Supplemental Restraint System (SRS) that consisted of a frontal air bag at the driver (only) position. The driver's air bag deployed as a result of the right front tire impact with the curb. The case vehicle's driver air bag was located in the steering wheel hub. An inspection of the air bag module's cover flaps and air bag revealed that the cover flaps opened at the designated tear points, and there was no evidence of damage during the deployment to the air bag or the cover flaps. The driver's air bag was designed with six tethers, each 5 centimeters (2.0 inches) wide, located at the 1, 3, 5, 7, 9, and 11 o'clock positions, respectively. The driver's air bag had two vent ports, approximately 4.5 centimeters (1.8 inches) in diameter, located at the 10 and 2 o'clock positions. The deployed driver's air bag was round with diameter 60 centimeters (23.6 inches). The examination of the air bag revealed there were a few scattered blood spots on the front surface near the center and 7 o'clock positions (**Figure 14**). In addition, there was a 27 x 10 centimeter (10.6 x 3.9 inch) area of contact evidence (i.e., blood with small, very short, dark

**Figure 14:** Case vehicle's deployed driver air bag showing (highlighted) blood spots/smears on front surface (case photo #25)

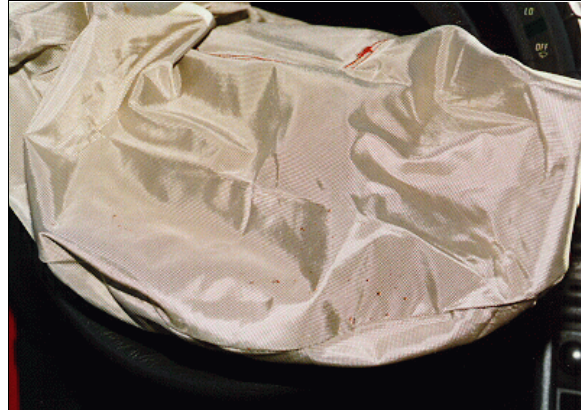
hairs) readily apparent to the very bottom back surface of the driver's air bag, in the 5-8 o'clock area (**Figure 15**). Furthermore there were two blood spots on the backside around the 3 o'clock area. It should be noted that because of the left steering maneuver, the top of the steering wheel was inverted at time of deployment. It should also be noted that the case vehicle had been involved in a previous crash, but it is unknown if the air bag deployed in that crash.

**Figure 15:** Case vehicle's deployed driver air bag showing hair and blood spray from driver towards bottom of air bag; Note: steering wheel inverted at time of deployment (case photo #26)

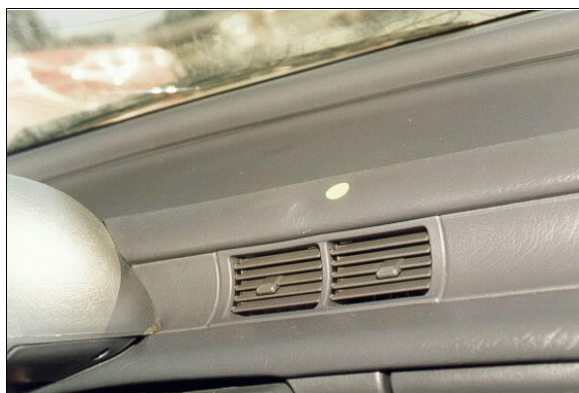
**Figure 16:** Contact evidence on case vehicle's center instrument panel from front right passenger (case photo #35)

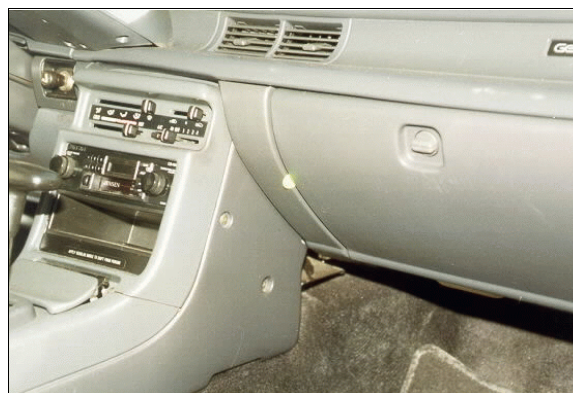
**Figure 17:** Contact evidence to case vehicle's lower right instrument panel from front right passenger (case photo #34)
