REMOTE AIR BAG DEPLOYMENT REPORT

CASE NUMBER - IN99-096

VEHICLE - 1998 DODGE RAM 1500 PICKUP TRUCK

CRASH DATE - June 1998

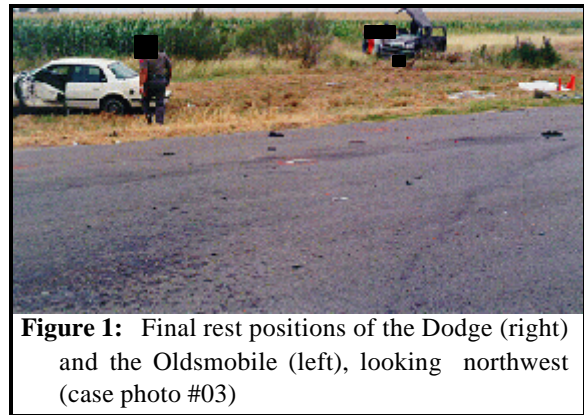
Figure 1: Final rest positions of the Dodge (right) and the Oldsmobile (left), looking northwest (case photo #03)

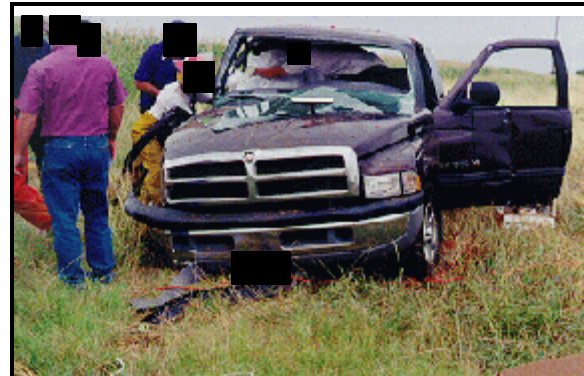
From the impact with the Oldsmobile, the Dodge sustained direct contact damage to its right side. Incomplete photographic coverage and extensive cutting during extrication precludes a definitive description of the Dodge's crash damage (**Figures 2 and 3**). The right front tire was deflated and the wheel rim damaged. The lower right A-pillar was crushed inward, as were the right rocker panel, the right front door, the lower right B-pillar, the right extended cab panel, the lower right C-pillar, and the right front corner of the cargo bed (**Figure 3**). Rescue workers snipped the upper A, B, and C pillars and raised the roof to remove the front right passenger. The right front door, right extended cab, and back light glazing are missing (some may be from extrication efforts). An impact with a metal sign pole resulted in a vertical impression on the left front door panel that likely shattered the glazing (**Figure 4**). Induced damage included the right hood edge, the front right bumper fascia corner, the front right air dam corner, the front right black rubber corner, left front fender buckling, buckling of the left front door panel's forward third, and the deflation of the left rear tire. A CDC for the Dodge's impact with the Oldsmobile was estimated from police photographs as: **01-RDEW-3 (040)**. The WinSMASH reconstruction program, with CDC-only estimated crush profile, provided a borderline reconstruction, and the results appear reasonable. The Dodge's estimated Total, Longitudinal, and Lateral Delta Vs are, respectively: 16.3 km.p.h. [10.1 m.p.h.], -12.5 km.p.h. [-7.8 m.p.h.], and -10.4 km.p.h. [-6.5 m.p.h.].

Figure 2: Induced damage to Dodge's front right corner (case photo #06)

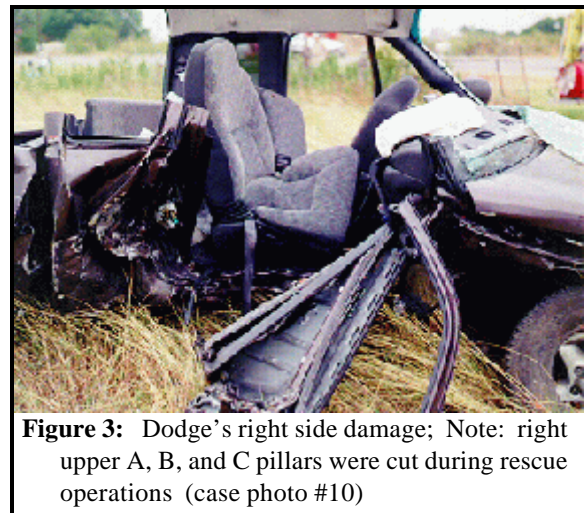
Figure 3: Dodge's right side damage; Note: right upper A, B, and C pillars were cut during rescue operations (case photo #10)

Intrusion to the Dodge's front right passenger seating area was severe (**Figure 3**). The lower right A-pillar was displaced inward, buckling the toe pan and floorboard areas of the front right seat position. Although the right front door panel was removed during rescue operations post-crash, the inward movement of the right rocker panel and the right front door also reduced available space in the front right seat position. Those intruding components resulted in the front right passenger's seat being deformed and displaced.

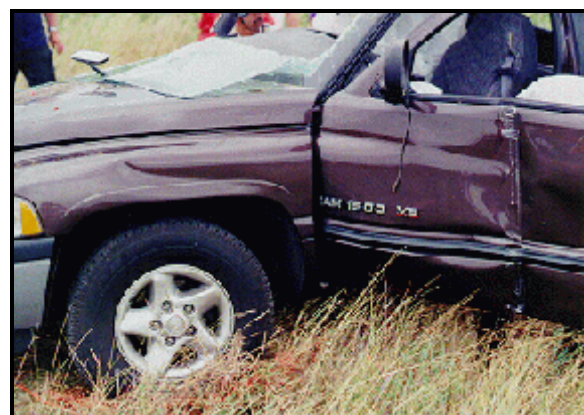
Figure 4: Road sign post impact to Dodge's left front door; Note: damage extended to top of door window frame (case photo #07)

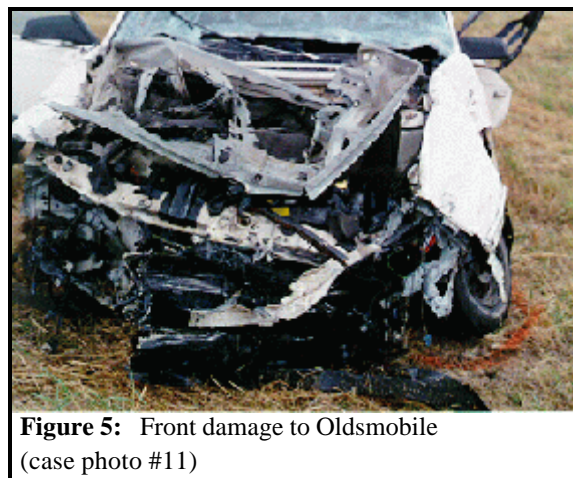
From the collision with the Dodge, direct contact damage to the Oldsmobile included: the front bumper fascia and the front reinforcement bar were displaced rearward; the grille and headlamp assemblies shattered and missing; the engine compartment's forward top radiator bracket was pushed rearward and downward; the top hood panel torn off and missing; the metal hood frame was shifted right and buckled; and both front fenders pushed rearward and buckled (**Figure 5**). A second impact, with at least one wooden fencepost, resulted in a vertical line of crush from the bottom of the left front door panel to the upper A-pillar (**Figure 6**). Induced damage to the Oldsmobile included: the left front tire and wheel, the forward seam of the left front door, the right front tire and wheel, the forward seam of the right front door panel, and the splintering of the windshield. A combination of the fencepost impact, a violent clockwise

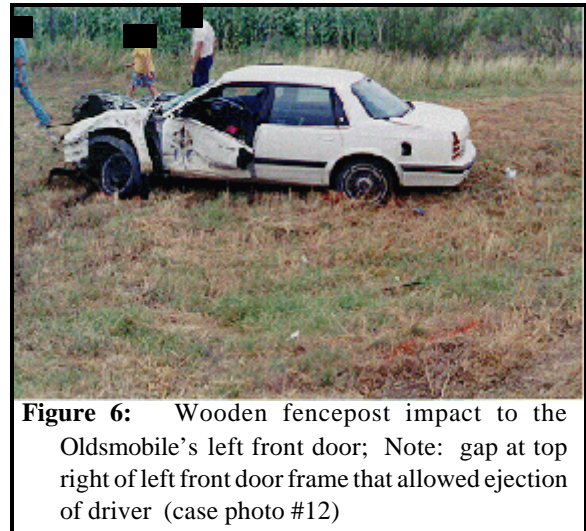
rotation from the vehicle-to-vehicle collision, and the unrestrained driver contacting the interior panel of the left front door resulted in the top of the door frame pulling away from the left roof rail a sufficient distance to allow the driver's body to be completely ejected through that opening. Based on police photographs, a CDC for the Oldsmobile was estimated as: **11-FDEW-1 (320)**. The WinSMASH reconstruction program, with CDC-only estimated crush profile, provided a borderline reconstruction, and the results appear reasonable. The Oldsmobile's estimated Total, Longitudinal, and Lateral Delta Vs are, respectively: 25.2 km.p.h. [15.7 m.p.h.], -19.3 km.p.h. [-12.0 m.p.h.], and 16.2 km.p.h. [10.1 m.p.h.].

Figure 6: Wooden fencepost impact to the Oldsmobile's left front door; Note: gap at top right of left front door frame that allowed ejection of driver (case photo #12)
