## REMOTE AIR BAG DEPLOYMENT REPORT

CASE NUMBER - IN99-104

VEHICLE - 1998 CHEVROLET CAVALIER Z24

CRASH DATE - July 1998

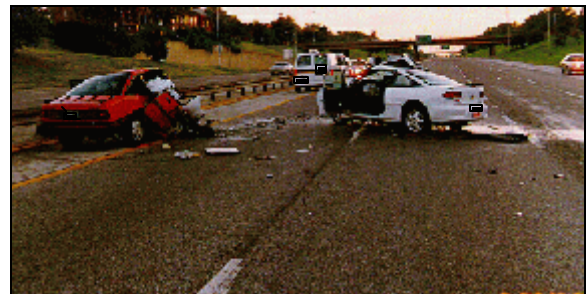
The case vehicle was traveling south in the inside northbound lane (i.e., traveling in the wrong direction) of a four-lane roadway that was part of an eight-lane, divided, urban interstate highway (**Figure 1**). Vehicle #2 was traveling north in the same inside, northbound lane (i.e., traveling in the proper direction) of the same four-lane roadway of the same urban interstate highway. It was dark, with street lights, clear weather, and no vision obstructions noted. The roadway was bituminous, dry, straight, and level. Impact occurred immediately north of the exiting tangent point for a northbound, right-hand curve. The posted speed limit was 97 km.p.h. (60 m.p.h.). The crash occurred in the inside northbound lane. Investigating officers noted there were no pre-impact skidmarks and none were visible in the police on-scene photographs.

**Figure 1:** Northbound view of impact and final rest areas; Note: case vehicle is white (case photo #03)

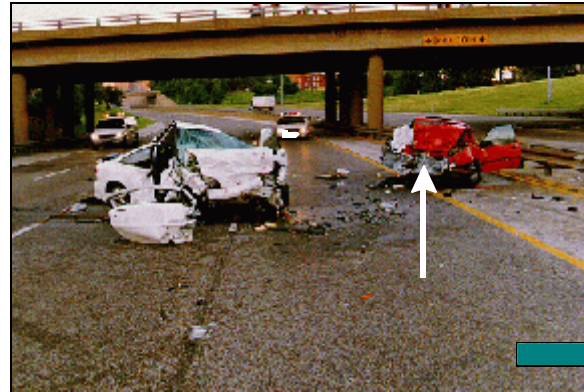
The case vehicle sustained direct contact damage across its entire front plane. The front bumper fascia separated from the case vehicle and was embedded in the front plane of vehicle #2 (**Figure 2**). The other damaged case vehicle front components were displaced rearward, including: front bumper reinforcement bar, front grille, left and right headlamp assemblies, front hood edge, left front fender, right front fender, and the left and right stub frame front bumper extensions. Induced damage included the engine pushed into the front cowl, the left front fender bowed out, left front wheel and tire pushed into the lower left A-pillar, left rocker panel cover distorted, the right front wheel and tire pushed into and under the right lower A-pillar, the right lower A-pillar detached from the right rocker panel and displaced rearward into the right front door opening, the right rocker panel deformed and its cover nearly separated, the right upper A-pillar straightened to nearly vertical, the right front roof rail slanted upwards (front high), right front door severely deformed, the sunroof deformed, the right side of the roof pushed upwards, and the windshield splintered. The CDC for the case vehicle, estimated from police photographs is: **12-FDEW-5** (principal direction of force 10 degrees). The WinSMASH reconstruction program, with CDC-only estimated crush profile, provided a borderline reconstruction, but the results appear reasonable. The case vehicle's estimated Total, Longitudinal, and Lateral Delta Vs are, respectively: 93.5 km.p.h. (58.1 m.p.h.), -92.1 km.p.h. (-57.2 m.p.h.), and -16.2 km.p.h. (-10.1 m.p.h.).

**Figure 2:** Case vehicle's front damage; Note: arrow points to case vehicle's front bumper fascia embedded in vehicle #2's front bumper (case photo #02)

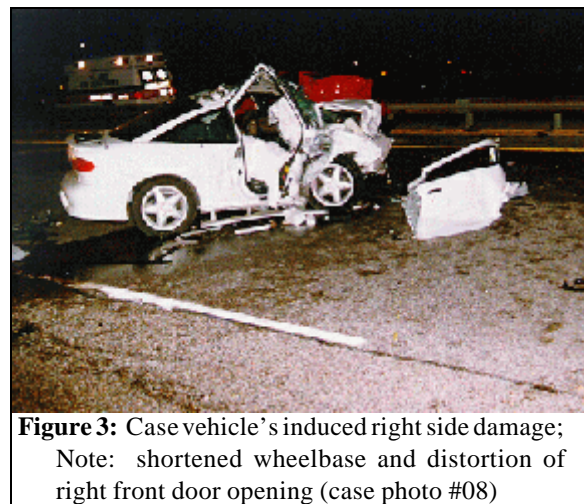
Intrusion to the front right passenger's seating area was severe (**Figure 3**). The right upper A-pillar was displaced rearward, along with the right side of the windshield, and was nearly vertical. The right front corner, where the windshield header and the right roof rail meet, was buckled upwards, and actually increased the available vertical head room as the horizontal distance was decreased. The right lower A-pillar was pushed rearward and the passenger's toe pan and foot well areas were pushed up and rearward. The toe pan was nearly touching the forward edge of the front right passenger's seat cushion. The

**Figure 3:** Case vehicle's induced right side damage; Note: shortened wheelbase and distortion of right front door opening (case photo #08)

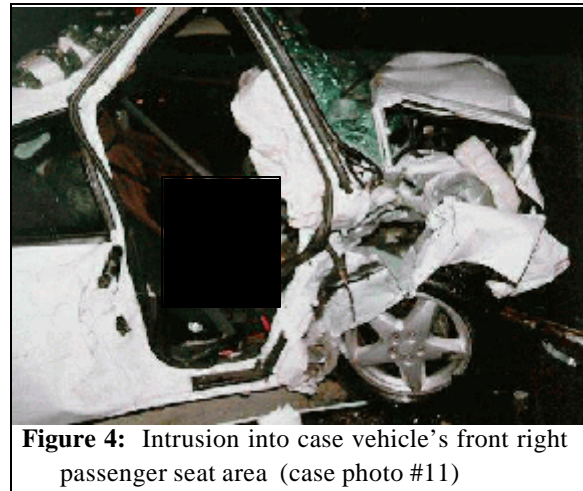
right front door opening was reduced by half. The instrument panel in front of the passenger's seat was displaced rearward and its leading edge projected over the seat cushion. The glove compartment door's lower left corner was shattered and contents spilled onto the legs of the passenger. The cover flap of the top-mounted front right passenger's air bag contacted and splintered the right lower portion of the windshield when the module was activated by the crash forces.

Figure 4: Intrusion into case vehicle's front right passenger seat area (case photo #11)

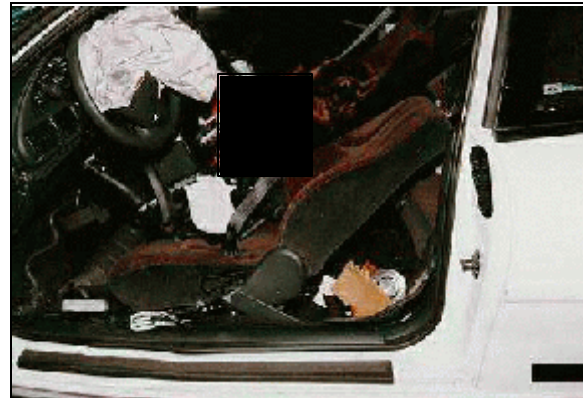
The case vehicle’s driver (21-year-old male, unknown race/ethnicity, unknown height and weight) was wearing his available, active, three-point, lap-and-shoulder, safety belt system (**Figure 5**). His pre-crash seat adjustments, steering wheel position, and posture are not known. He was transported from the scene by ambulance to a medical facility. Police assessed his injuries as “evident-not disabling.” It is suspected that his body kinematics would mirror those of the front right passenger. Police detected a “strong odor of an intoxicating liquor” while interviewing the case vehicle’s driver (recall that the front right passenger had a BAC of 0.278).

**Figure 5:** Case vehicle driver’s seat area; Note: cut end of driver’s seat belt (case photo #10)

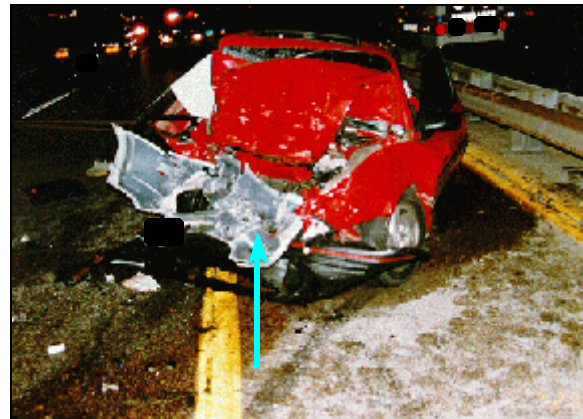
**Figure 6:** Vehicle #2’s front damage; Note: arrow denotes case vehicle’s front bumper fascia embedded in vehicle #2’s front bumper (case photo #15)

From the collision with the case vehicle, direct contact damage to vehicle #2 included: the front bumper, the front reinforcement bar, and fascia displaced rearward, with the front right corner pushed past the cowl and into the lower right A-pillar; the grille pushed rearward; the front hood edge shoved rearward, causing a buckling at its middle and the rear edge contacting the lower edge of the windshield; the right front fender pushed rearward into and past the lower

A-pillar; the upper right A-pillar virtually straightened; and the right front wheel and tire shoved to a position under the front right passenger's bucket seat (**Figure 6** above). Induced damage included the left front fender pulled to the right and buckled at its rear seam; the left rear quarterpanel's sheet metal buckled forward and rearward of the left rear wheel well; the right rear quarterpanel bent downward; the right front door buckled, with a downward "V" at the mid-sill area; the right front door and right rear glazing shattered (kernelized); the right side rocker panel shortened and pushed downward; the windshield splintered, most severely at the right side; and the right roof rail pushed upward at the front and buckled at the B-pillar (**Figure 7**). Intrusion into the greenhouse area consisted of the instrument panel, toe pan, and foot wells being shoved rearward, most severely at the front right passenger's position.

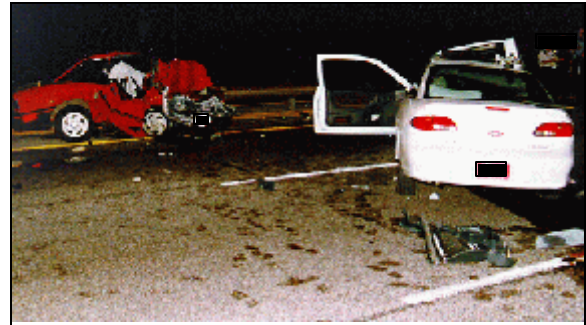
**Figure 7:** Vehicle #2's induced right side damage; Note: shortened right wheelbase (case photo #19)

Based on police photographs, a CDC for vehicle #2 was estimated as: **12-FDEW-6** (principal direction of force 10 degrees). The WinSMASH reconstruction program, with CDC-only estimated crush profile, provided a borderline reconstruction, but the results appear reasonable. Vehicle #2's estimated Total, Longitudinal, and Lateral Delta Vs are, respectively: 109.0 km.p.h. (67.7 m.p.h.), -107.3 km.p.h. (-66.7 m.p.h.), and -18.9 km.p.h. (-11.7 m.p.h.). Vehicle #2's driver [18-year-old, White (unknown if Hispanic) female; unknown height and weight] was not wearing her available, active, three-point, lap-and-shoulder, safety belt system. Her pre-crash seat adjustments, steering wheel position, and posture are not known. She was transported from the scene by ambulance and was pronounced dead on arrival at a medical facility. Vehicle #2's front right passenger [19-year-old, White (unknown if Hispanic) male; unknown height and weight] was not wearing his available, manual, three-point, lap-and-shoulder, safety belt system. His pre-crash seat adjustments and posture are not known. He was pronounced dead at the scene.
