# INDIANA UNIVERSITY

## REMOTE AIR BAG DEPLOYMENT REPORT

CASE NUMBER - IN99-105

VEHICLE - 1998 FORD ESCORT ZX2

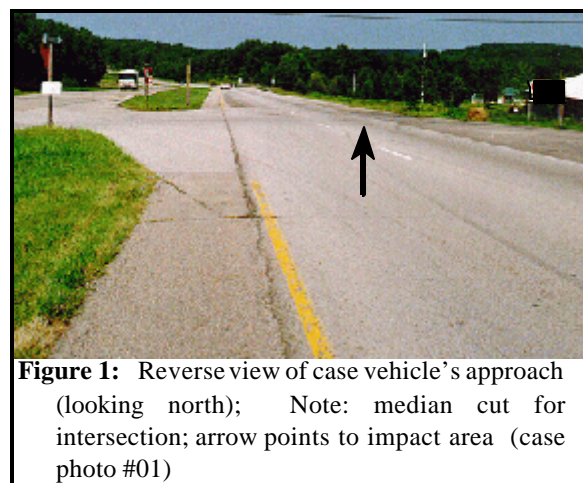
**Figure 1:** Reverse view of case vehicle's approach (looking north); Note: median cut for intersection; arrow points to impact area (case photo #01)

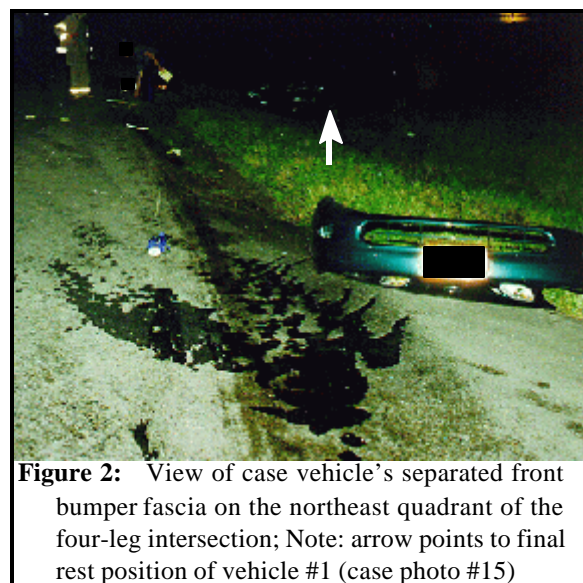
**Figure 2:** View of case vehicle's separated front bumper fascia on the northeast quadrant of the four-leg intersection; Note: arrow points to final rest position of vehicle #1 (case photo #15)

The right front of the case vehicle (vehicle #2) was impacted by the front left of vehicle #1, causing the case vehicle's driver and front right passenger air bags to deploy. Pavement gouge marks and post-impact tire marks show that the case vehicle rotated approximately 360 degrees counterclockwise and traveled approximately 23 meters (75 feet) in a north-northwest direction, coming to rest straddling the northbound lanes' (west) yellow edge line and facing east. During its counterclockwise rotation, the case vehicle's right rear quarterpanel impacted the left front fender of vehicle #1 in a sideslap, second impact. Vehicle #1 also rotated counterclockwise nearly 240 degrees, but traveled in a northeasterly direction for approximately 29 meters (95 feet). Vehicle #1 came to rest off the northbound travel lanes' east side, facing southwest (**Figure 2** above). The crash severity for the case vehicle was moderate [24-40 km.p.h. (15 to 25 m.p.h.)].

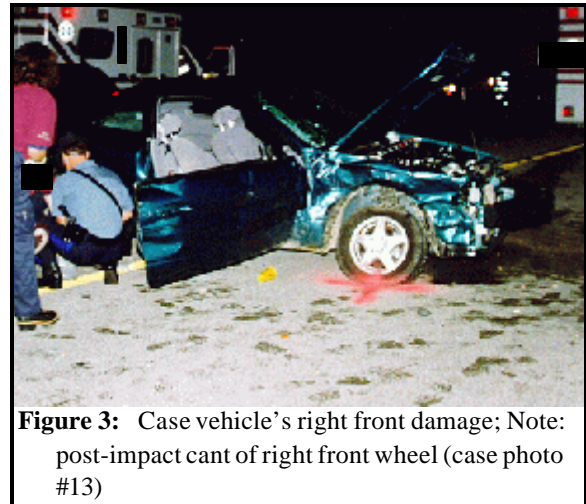
The case vehicle (vehicle #2) sustained direct contact damage along its entire right front fender from the initial impact with vehicle #1 (**Figure 3**). Damaged components included: the front bumper fascia separated from the bumper reinforcement bar; the front right corner of the bumper reinforcement bar pushed inward, bowing the bar outward at its center; the sheet metal of the right front fender was displaced inward; the right front wheel and tire were tilted inward; and the front right suspension was displaced inward. There were no direct views of the case vehicle's front plane

**Figure 3:** Case vehicle's right front damage; Note: post-impact cant of right front wheel (case photo #13)

The CDC for the case vehicle's first (most severe) impact, estimated from police photographs, is **02-RYEW-3** (principal direction of force 60 degrees). The WinSMASH reconstruction program, with a CDC-only estimated crush profile, provided a borderline reconstruction, but the results appear reasonable. The estimated Total, Longitudinal, and Lateral Delta Vs are, respectively: 27.0 km.p.h. (16.7 m.p.h.), -13.5 km.p.h. (-8.4 m.p.h.), and -23.4 km.p.h. (-14.5 m.p.h.).

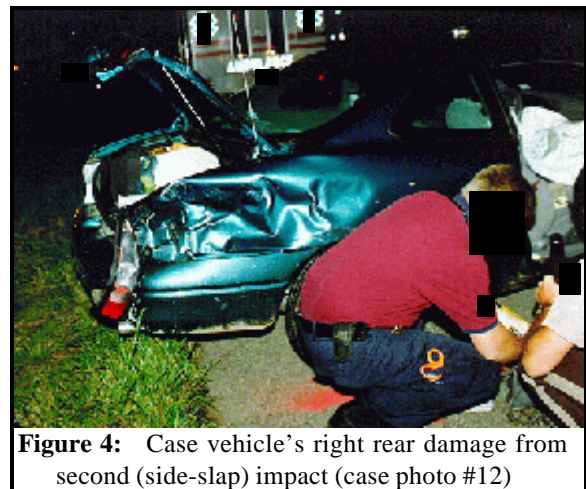
**Figure 4:** Case vehicle's right rear damage from second (side-slap) impact (case photo #12)

but indirect damage probably included: the front grille, both front headlamp assemblies, the front engine compartment brackets, the right seam edge of the hood, the right edge of the windshield (splintered), and the right front door glazing (possibly broken out by the front right passenger's head). No view of the case vehicle's interior was sufficient to detect the existence of intrusion. The second impact, a sideslap involving the case vehicle's right rear with the left side of vehicle #1, damaged the case vehicle's right rear quarterpanel, the right rear taillight assembly, the back right bumper corner, and the right seam edge of the trunk (**Figure 4** above).

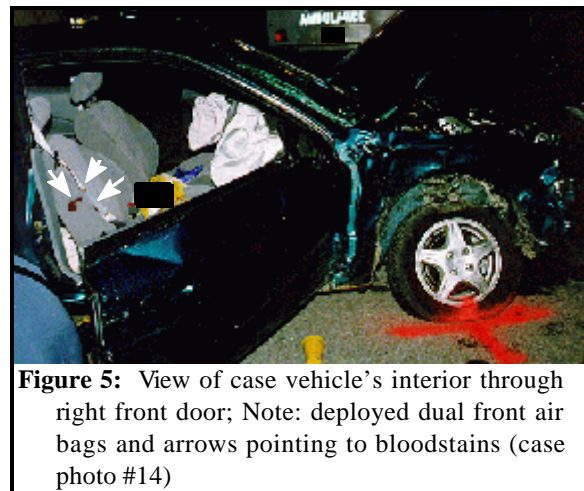
The case vehicle's front right passenger (73-year-old female, White (non-Hispanic), height and weight not known) was restrained by her available, manual, three-point, lap-and-shoulder safety belt system. Her pre-crash seat adjustments and posture are not known. She was pronounced dead at the crash scene. No autopsy was performed. The front right passenger's injuries and kinematics are based on her Certificate of Death, on-scene police photographs (all photographs were exterior vehicle views, with interior details unclearly depicted; **Figure 5**), and the principles of occupant kinematics.

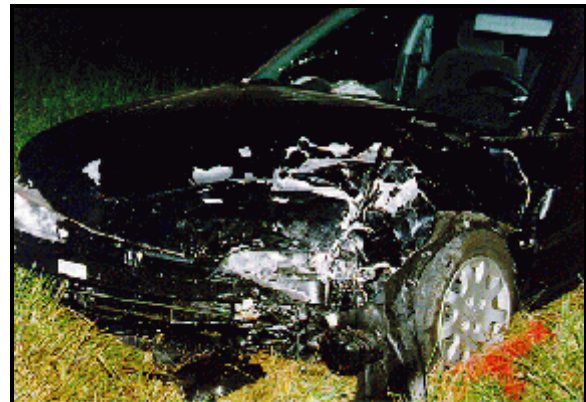
**Figure 6:** Vehicle #1's front left damage; Note: missing front bumper fascia and deployed dual front air bags (case photo #19)

Vehicle #1 sustained direct contact damage to the left half of its front plane from the first impact with the case vehicle (**Figure 6**). Damaged components included: the front bumper fascia separated from the vehicle; the left side of the grille, the left side of the reinforcement bar and the left lower corner of the radiator displaced rearward; the left headlight assembly smashed; the left front hood corner displaced rearward, buckling the left hood seam upward at its mid-point; the left front fender was pushed back and buckled at the front half of the wheel well; and the left front tire and wheel pushed into the lower left A-pillar. Visible induced damage to vehicle #1 included the forward seam of the left front door and cracked glazing on the windshield's right side (passenger air bag module cover flap struck windshield). There may have been some slight intrusion to vehicle #1's left toe pan or foot well, but there were no photographs of the interior. Based on police photographs, the CDC for vehicle #1's first impact was: **11-FYEW-2** (principal direction of force 330 (-30) degrees). The WinSMASH reconstruction program, with a CDC-only estimated crush profile, provided a borderline reconstruction, but the results appear reasonable. The Total, Longitudinal and Lateral Delta Vs for vehicle #1's most severe (first) impact are, respectively: 24.9 km.p.h. (15.5 m.p.h.), -21.5 km.p.h. (13.4 m.p.h.) and 12.4 km.p.h (7.7 m.p.h.).
