## ON-SITE AIR BAG FATALITY INVESTIGATION

CASE NUMBER - IN99-113

LOCATION - Wisconsin

VEHICLE - 1995 CHEVROLET CAVALIER

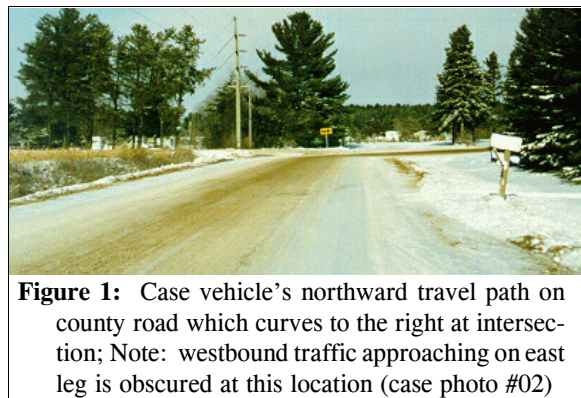
**Figure 1:** Case vehicle's northward travel path on county road which curves to the right at intersection; Note: westbound traffic approaching on east leg is obscured at this location (case photo #02)

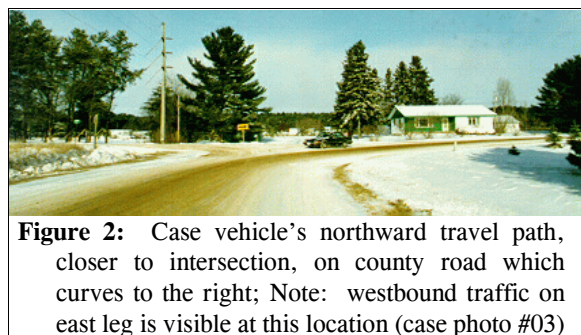
**Figure 2:** Case vehicle's northward travel path, closer to intersection, on county road which curves to the right; Note: westbound traffic on east leg is visible at this location (case photo #03)

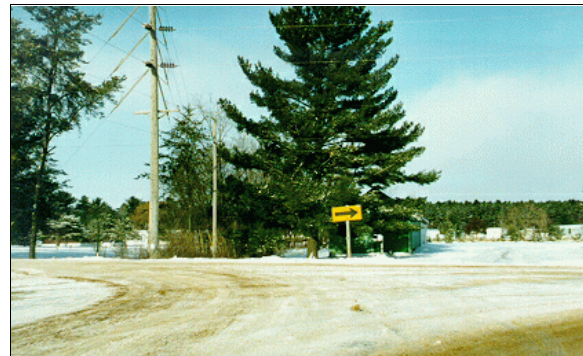
**Figure 3:** Case vehicle's northward approach to four-leg intersection just prior to impact; Note: case vehicle intended to turn left and travel west on an intersecting county roadway (case photo #05)

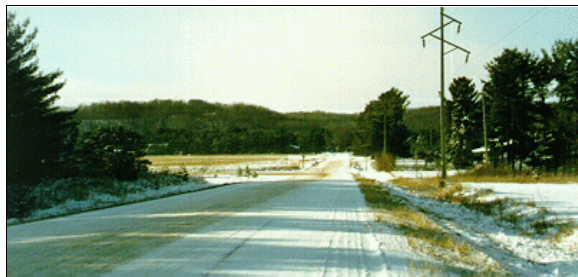
**Figure 4:** Ford's westward travel path on county road that curves to the south at intersection; Note: northbound traffic is not visible at this location (case photo #07)

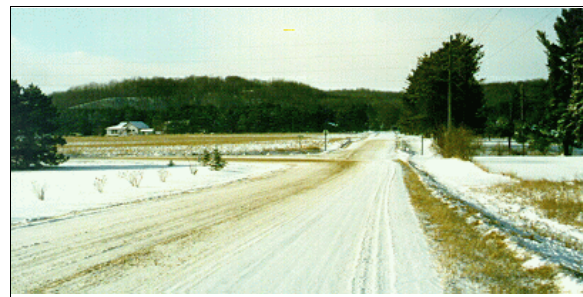
**Figure 5:** Ford's westward travel path, closer to intersection, on county road that curves to the south at intersection; Note: northbound traffic is visible at this location (case photo #08)

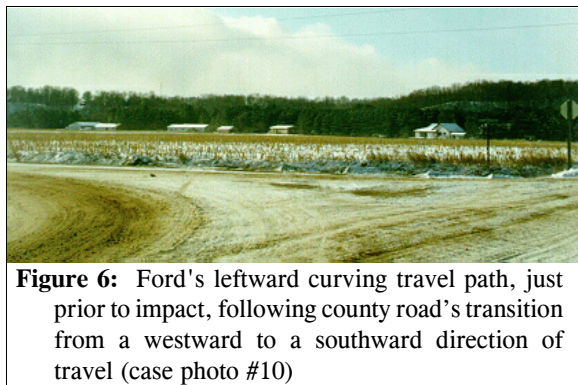
**Figure 6:** Ford's leftward curving travel path, just prior to impact, following county road's transition from a westward to a southward direction of travel (case photo #10)

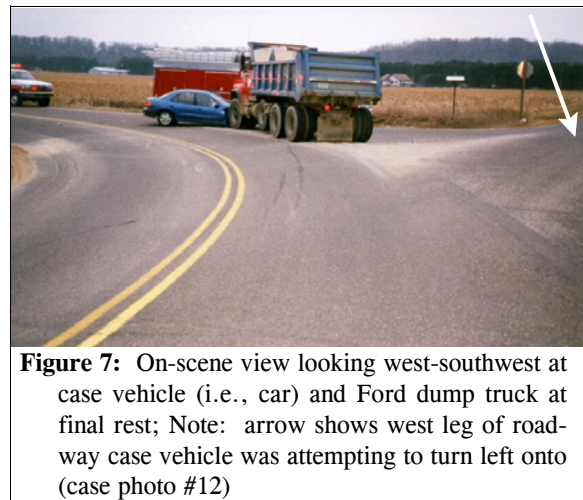
**Figure 7:** On-scene view looking west-southwest at case vehicle (i.e., car) and Ford dump truck at final rest; Note: arrow shows west leg of roadway case vehicle was attempting to turn left onto (case photo #12)

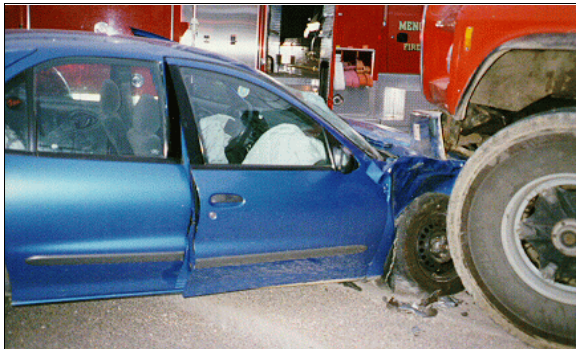
**Figure 8:** On-scene close-up of case vehicle under Ford's front bumper; Note: deployed driver and front right passenger air bags (case photo #15)

The front right of the case vehicle was impacted and subsequently overridden by the front left of the Ford (**Figure 8**), causing the case vehicle's driver and front right passenger supplemental restraints (air bags) to deploy. The damage on the case vehicle was primarily above the bumper resembling an underride impact pattern (**Figures 9** and **10**). The underride type damage resulted in the air bag deploying late during the duration of the impact. This late deployment occurred due to the prolonged change in time (Delta T) relative to the change in speed (magnitude of Delta V--i.e., ramp versus spike). Both vehicles came to rest near the point of impact in the southwest quadrant of the intersection. The case vehicle rotated approximately 5 degrees counterclockwise and came to rest heading in a northwesterly direction; the Ford came to rest heading in a southwesterly direction.

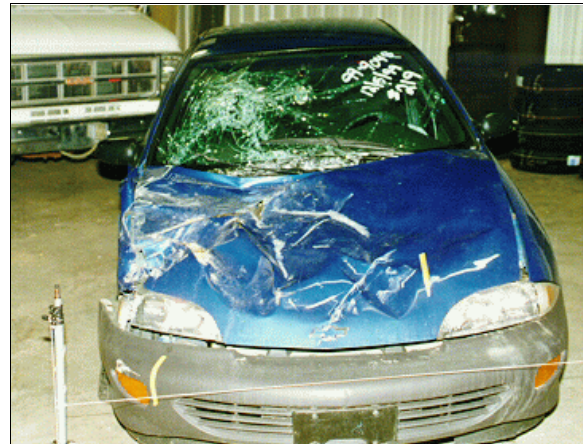
**Figure 9:** Case vehicle's underride type damage to front and right side from impact with Ford; Note: yellow tape highlights width of hood that was overridden (case photo #17)

The case vehicle's initial contact with the Ford involved the majority of the front, with the crush primarily above the bumper (**Figure 9** above). Direct damage extended from above the right bumper corner (passenger side) to the left, a measured distance of 97 centimeters (38.2 inches). Maximum above bumper crush to the case vehicle's front extended 127 centimeters (50.0 inches) rearward. In addition, the base of the right windshield was also severely cracked from direct contact with the Ford's front bumper. Although the case vehicle's front bumper was not directly contacted, the front right corner sustained induced damage and was pulled rearward 3 centimeters (1.2 inches). The case vehicle's hood and right fender were crushed downward, and the right fender was also crushed inward. The entire length of the case vehicle's right fender sustained direct damage from contact with the Ford's left front tire and bumper. The direct damage width along the right side was 124 centimeters (48.8 inches), with a maximum crush of 24 centimeters (9.4 inches). The right front tire was directly contacted, resulting in it being deflated and tilted inward at the top (**Figure 10** above). The case vehicle was towed due to damage.

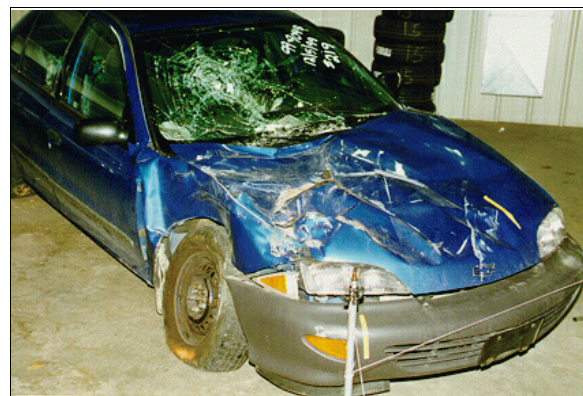
**Figure 10:** Case vehicle's frontal damage; Note: override type deformation, damaged right front wheel, and starred windshield (case photo #33)

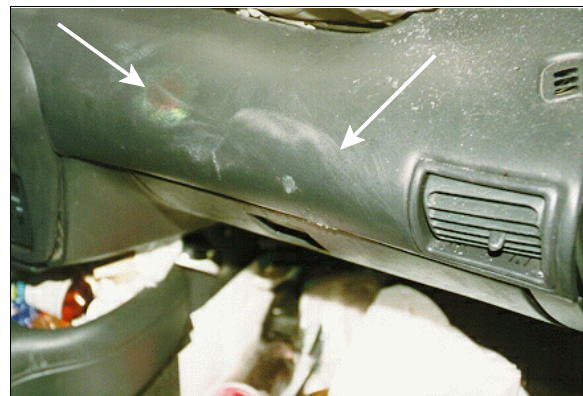
An examination of the case vehicle's interior revealed a scuff mark to the driver's knee bolster, from contact by the driver, and the presence of cloth transfers to the right knee bolster/instrument panel (**Figure 11**) from impact by the torso of the case vehicle's front unseated passenger. There was a spider web crack to the right windshield from contact by the front unseated passenger's head (**Figures 12** and **13** below). The roof near the front header and rearview mirror was contacted by the front unseated passenger's foot. The rearview mirror was also askew, either from contact with the front unseated passenger's leg, or

**Figure 11:** Apparent occupant cloth transfers to case vehicle's right instrument panel from front unseated passenger (case photo #47)

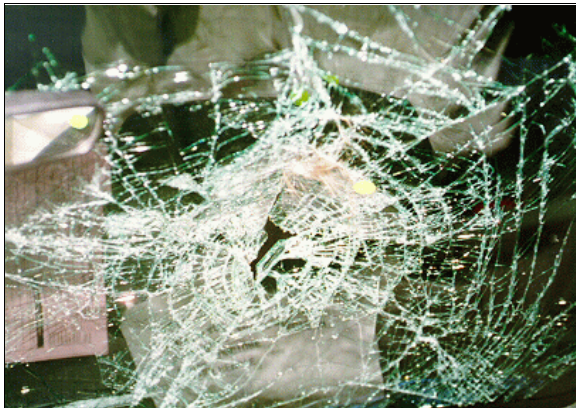
**Figure 13:** Close-up of interior surface of case vehicle’s holed right windshield; Note: windshield contacted by head of front unseated passenger (case photo #50)

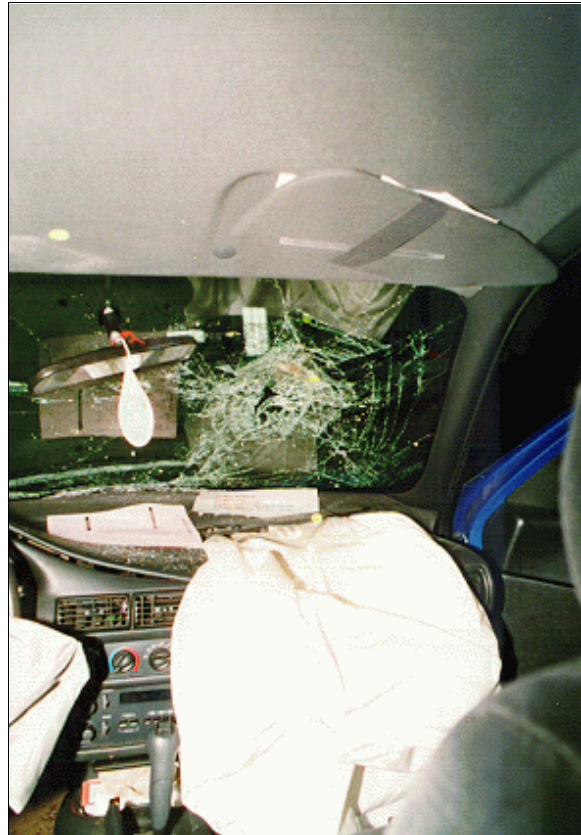
**Figure 12:** Case vehicle’s front right passenger seating area showing occupant contacts to roof, windshield, top of air bag and air bag module’s cover flap (case photo #48)

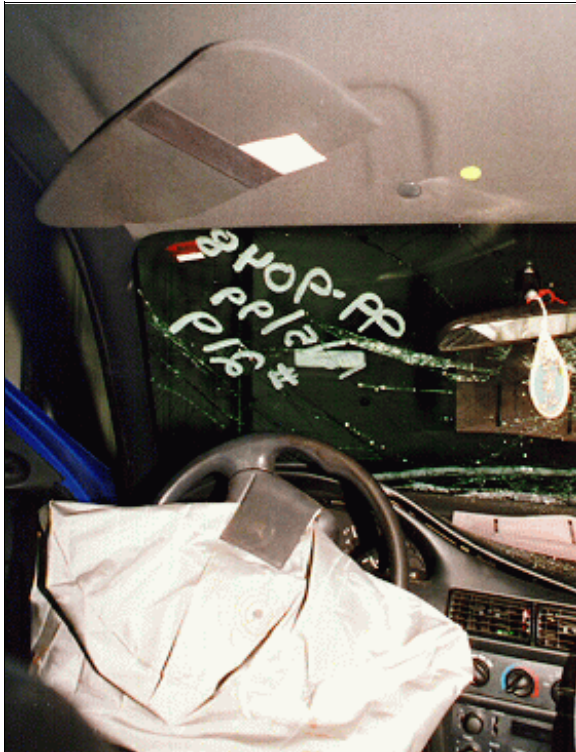
**Figure 14:** Case vehicle's driver seating area showing deployed driver air bag and cloth transfer on air bag module's left cover flap; Note: steering wheel has been rotated approximately 100 degrees clockwise in this photo (case photo #38)

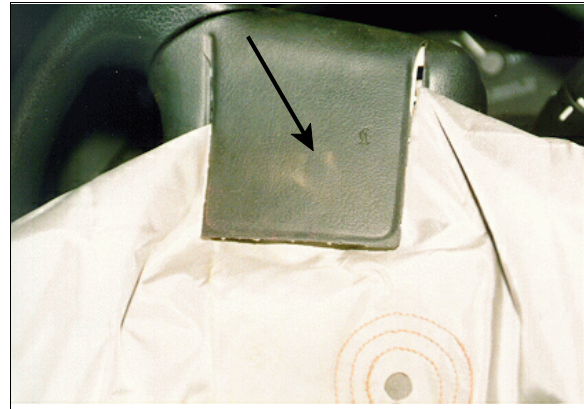
left cover flap from contacting the driver (**Figure 15**). The driver's air bag was designed without any tethers. The driver's air bag had two vent ports, approximately 1 centimeter (0.4 inches) in diameter, located at the 9 and 3 o'clock positions. The deployed driver's air bag was round with diameter 62 centimeters (24.4 inches). According to the case vehicle's driver, her air bag deployed post-crash, as she was exiting the vehicle. This contractor believes this statement is incorrect, and most likely, the driver only realized that her air bag had deployed when she was exiting the vehicle.

**Figure 15:** Close-up of red cloth transfer on case vehicle driver air bag module's left cover flap (case photo #40)

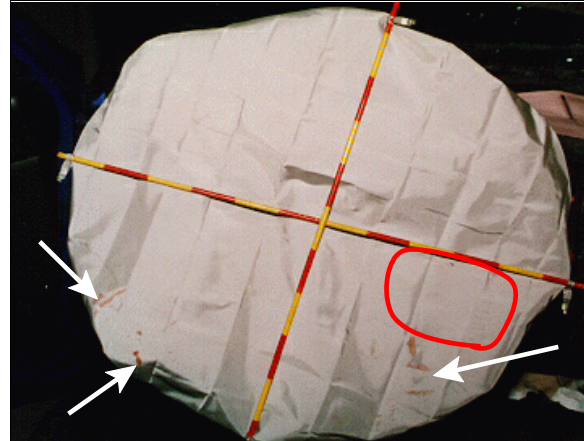
**Figure 16:** Case vehicle's driver air bag showing skin and mucous (within circular area) and blood (arrows) on right half of air bag; Note: steering wheel rotated approximately 100 degrees clockwise (case photo #42)

An inspection of the case vehicle's driver air bag revealed two small areas of contact blood to the right half of the air bag's front surface (**Figure 16**). All the blood, presumably, came from one or both of the driver's abraded hands (i.e., dorsal surfaces) because the front unseated passenger was thrown, post-impact, rearward onto the case vehicle back seat; see kinematic discussion below. In addition, there was an 8 x 7 centimeter (3.1 x 2.8 inch) area of skin and mucous to the upper half of the air bag towards the top. There were black striations to the back portion of the driver's air bag on the right side as a result of the driver temporarily blocking the air bag's deployment path.

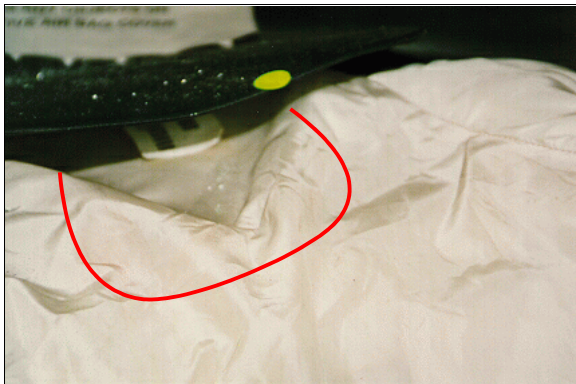
**Figure 17:** Close-up of case vehicle front right air bag module's contacted cover flap (yellow dot) and faint red and green cloth transfer to top of air bag (case photo #53)

The front right air bag was designed with two internal tethers, each 7 centimeters (2.8 inches) in width. Both tethers were sewn to the interior face of the air bag at points that were approximately 20 centimeters (7.9 inches) below the top edge and 12 centimeters (4.7 inches) inwards from each side. The front right air bag had no vent ports. The deployed front right air bag was rectangular with a height of approximately 62 centimeters (24.4 inches) and a width of approximately 53 centimeters (20.9 inches). Examination of the front right passenger air bag revealed a 15 centimeter (5.9 inches) long green and red cloth transfer to the top portion of the air bag towards the left side. The examination also revealed a 9 centimeter (3.5 inches) long skin transfer to the right of the cloth transfer. Both the skin and cloth transfers started just below the cover flap (**Figure 17**). The front

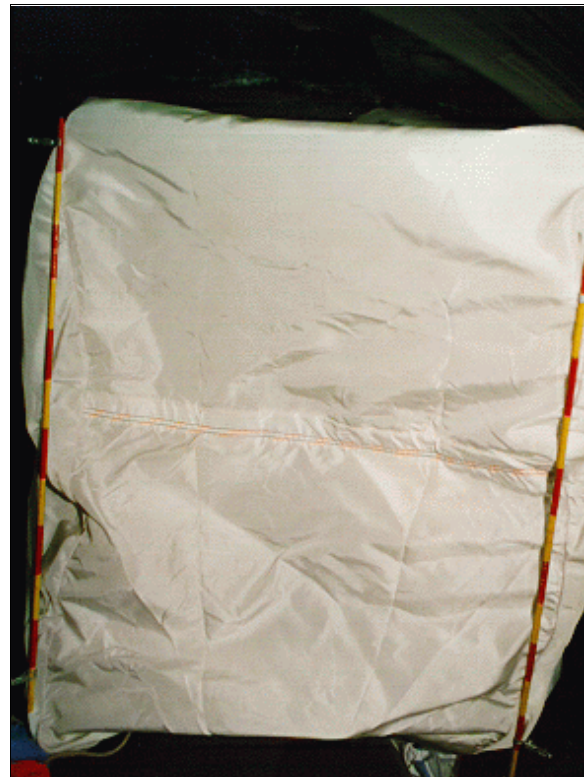
**Figure 18:** Case vehicle's front right passenger air bag showing no apparent evidence of contact from front unseated passenger (case photo #57)

surface of the deployed air bag showed no evidence of occupant contact by the front unseated passenger (**Figure 18** above).

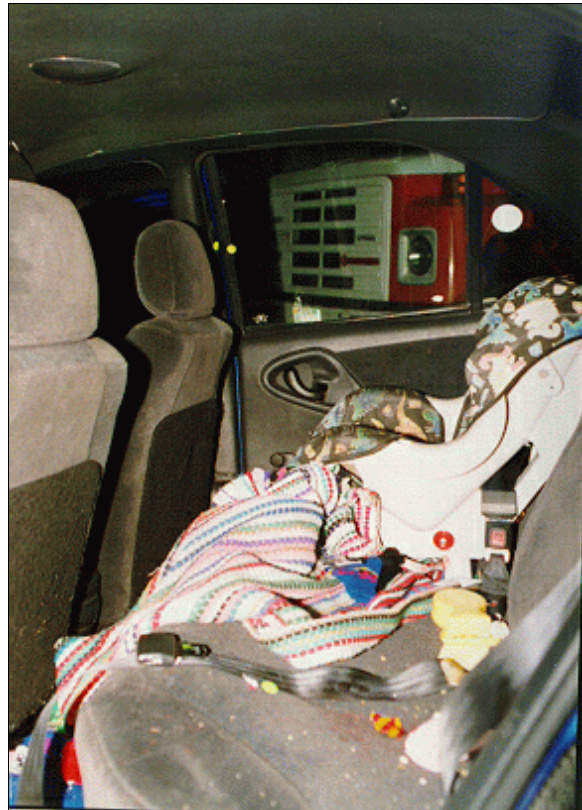
**Figure 19:** Case vehicle's back left seating area and contacted "B"-pillar (i.e., yellow dots); Note: unused, secured, child safety seat in back right position (case photo #58)

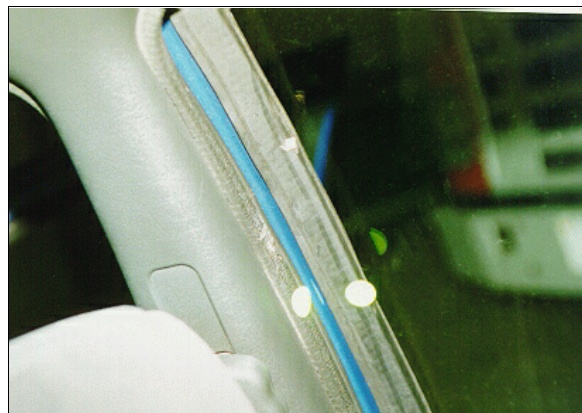
**Figure 20:** Close-up of skin on case vehicle's right "B"-pillar and rear window glazing from contact by back left passenger's face (case photo #60)
