Case 401 : Narrative

Case Vehicle (A): 2001 Dodge	Vehicle (B): 1995 Pontiac
Type: Dakota, Club Cab, 2-door pickup	Type: Sunfire, 4-door sedan
Driver: 28-year-old female	Driver: 17-year-old female
CDC: 12-FYEW-3	CDC: 99-0000-0

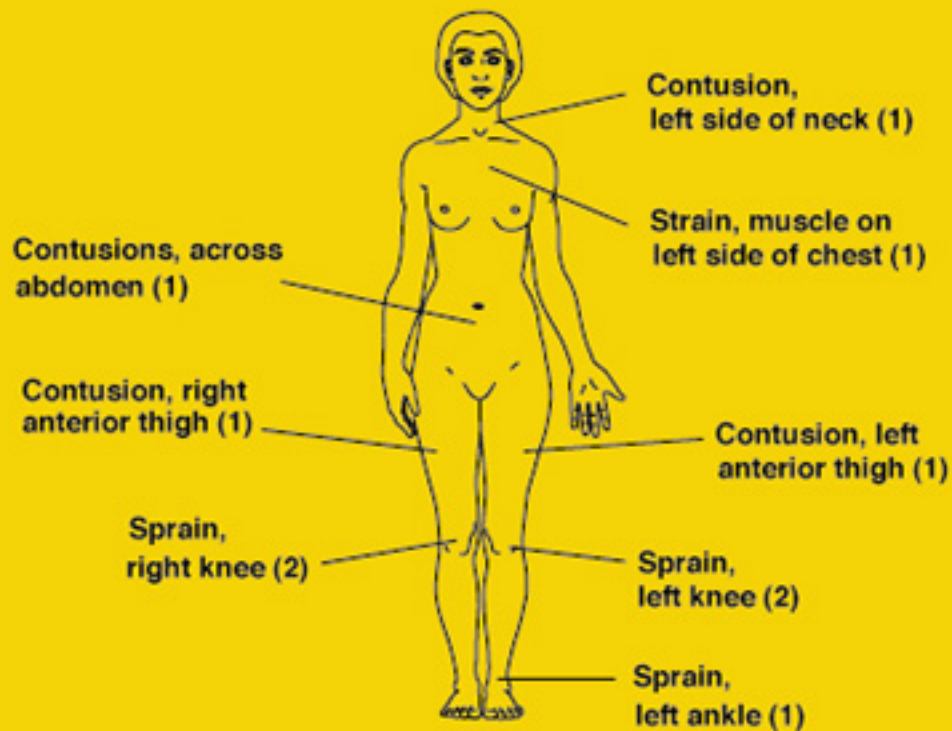
The following table and [59](#) attached drawing summarize the injuries for the restrained driver of case vehicle (A).

Occupant: Driver	Age: 28 years	Gender: Female		
Restraints: 3-point belt; steering-wheel airbag	Stature: 170 cm (5 ft, 7 in)	Mass: 113 kg (250 lb)		
Injury Description	A.I.S.	Injury Source		
		Definite	Probable	Possible
—	—	—	—	—
Contusion, left side of neck	1	Shoulder belt	—	—
Strain, muscle left side of chest	1	Shoulder belt	—	—
Contusions, across abdomen	1	Lap belt	—	—
Contusion, left anterior thigh	1	—	Steering-wheel rim	—
Contusion, right anterior thigh	1	—	Steering-wheel rim	—
Sprain, left knee	2	—	Knee bolster	—
Sprain, right knee	2	—	Knee bolster	—
Sprain, left ankle	1	—	Toepan	—
Maximum A.I.S. Level	2	—	—	—

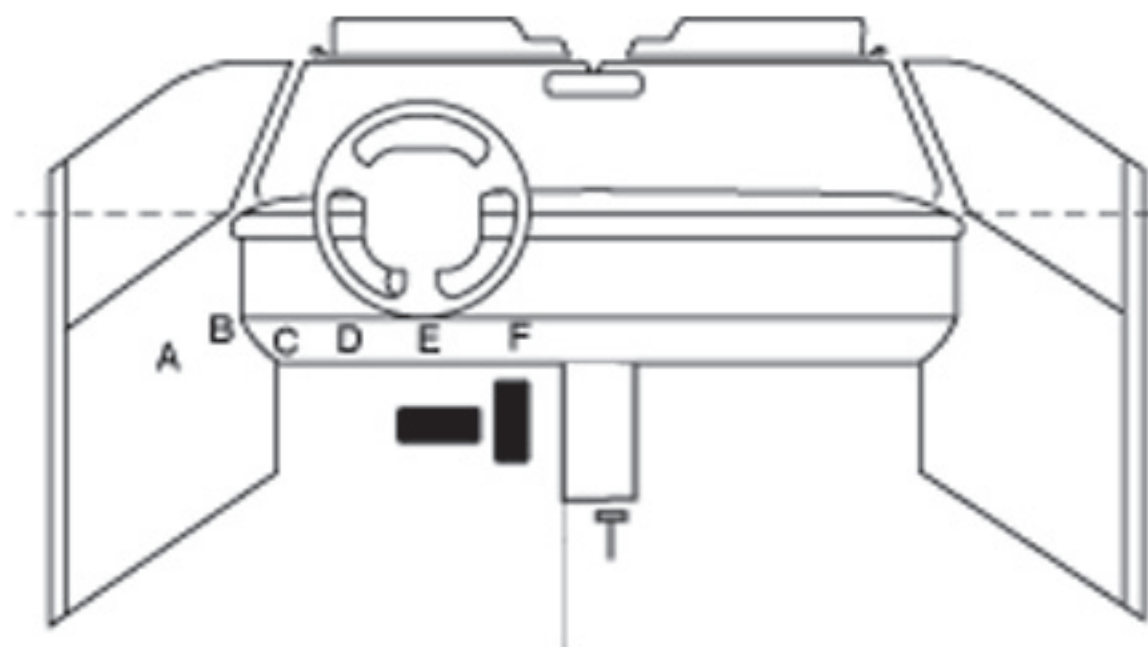
A = Driver door, scuffmark

B = Driver door, scuffmark

Contact	Interior Component Contacted	Occupant No. if Known	Body Region if Known	Supporting Physical Evidence	Confidence Level of Contact Point
A	Driver door	1	Left leg	Scuffmark	2
B	Driver door	1	Left leg	Scuffmark	2
C	Left knee bolster	1	Knee	Scuffmark	2
D	Left knee bolster	1	Knee	Scuffmark	2
E	Mid knee bolster	1	Knee	Scuffmark	2
F	Right knee bolster	1	Knee	Scuffmark	2
G					
H					
I					
J					
K					
L					
M
