## Case 403 : Narrative

Case Vehicle (A): 1998 Ford	Vehicle (B): 1991 Peterbilt
Type: Escort SE, 4-door sedan	Type: 357 Tractor with double trailer
Driver: 31-year-old female	Driver: 42-year-old male
CDC: 12-FDEW-3, 03-RFEN-3, 03-RBEE-2	CDC: 99-0000-0, 99-0000-0, 99-0000-0

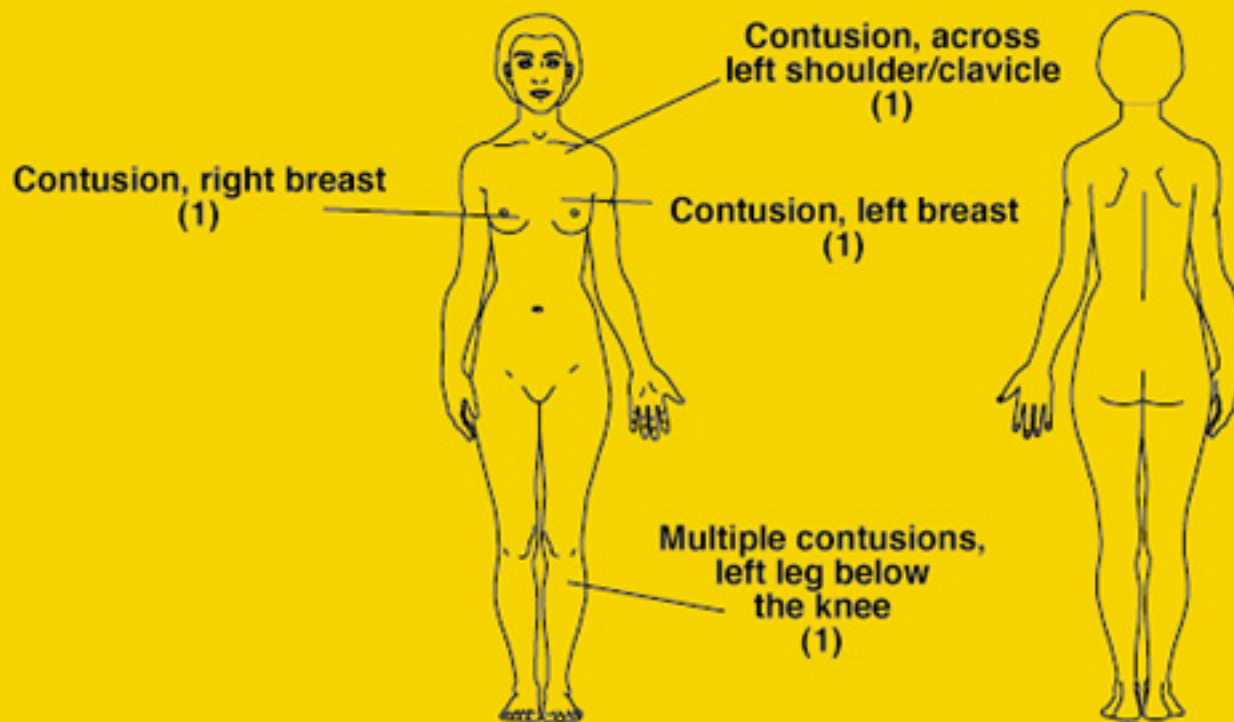
The following table [68](#) and attached drawing summarize the injuries for the belt-plus-airbag restrained driver.

Occupant: Driver	Age: 31 years	Gender: Female		
Restraints: 3-point belt, steering-wheel airbag	Stature: 170 cm (5 ft, 7 in)	Mass: 102 kg (225 lb)		
Injury Description	A.I.S.	Injury Source		
		Definite	Probable	Possible
Contusion, across left shoulder/clavicle	1	Shoulder belt	—	—
Contusion, left breast	1	Shoulder belt	—	—
Contusion, right breast	1	Shoulder belt	—	—
Multiple contusions, left leg below the knee	1	—	Knee bolster/mid instrument panel	—

Maximum A.I.S. Level	1	—	—	—
Injury Severity Score	1	—	—	—

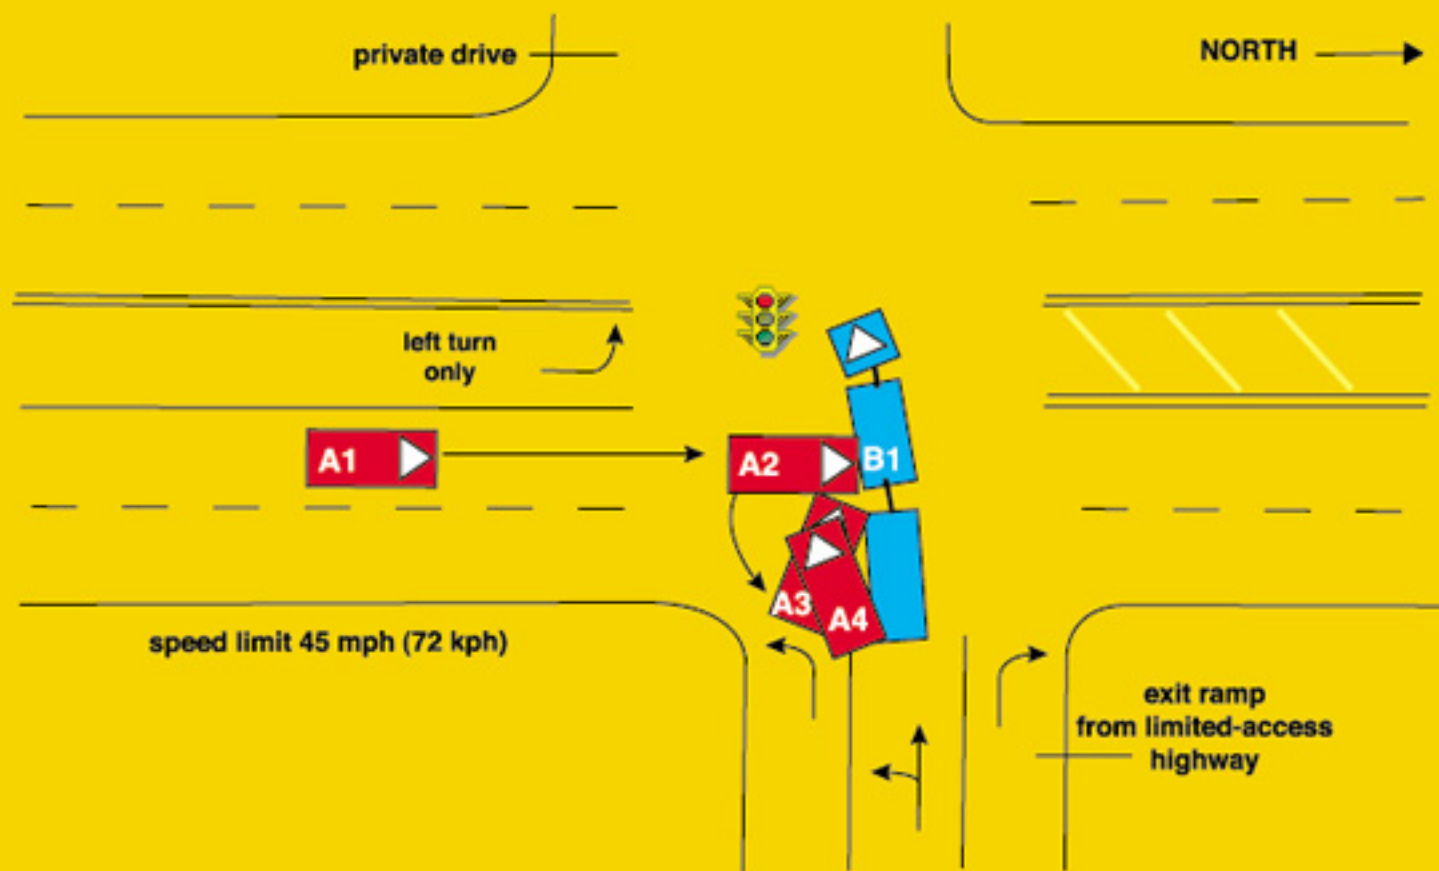
[1](#) [2](#) [3](#) On a clear day, case vehicle (A) was traveling north at an unknown speed in the left through-lane of a dry five-lane, two-way, concrete road, in an urban area. [4](#) Vehicle (B), a tractor-trailer rig with two trailers, was traveling west in the center lane of a three-lane exit ramp from a limited-access highway, which intersects the north-south road at a four-way traffic-light-controlled intersection. [5](#) [6](#) As vehicle (B) entered the intersection on a green light and began turning left to travel south, case vehicle (A) also entered the intersection through a red light and the front of case vehicle (A) struck the left-rear section of the first trailer of vehicle (B). Case vehicle (A) then rotated counterclockwise and the right fender struck the left-front section of the second trailer. Case vehicle (A) continued to rotate counterclockwise and the right quarter panel struck the second trailer. It was reported that the driver of case vehicle (A) has a history of seizures and may have had a seizure prior to the collision. Case vehicle (A) was towed from the scene, while vehicle (B) was driven away.

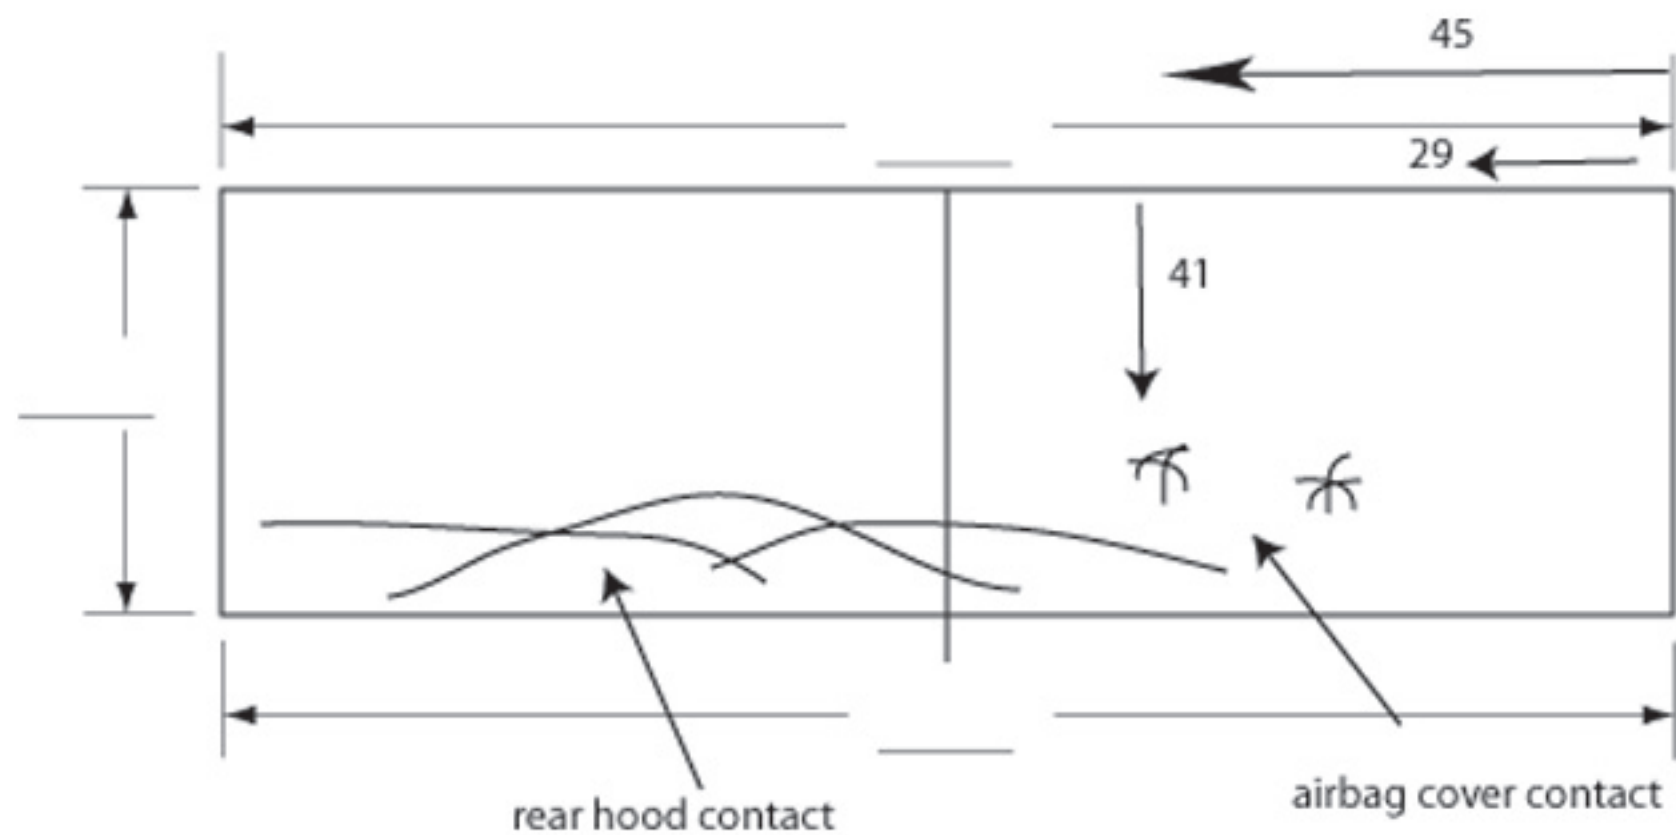
WINDSHIELD MARK ON CASE VEHICLE:

[47](#) [48](#) [49](#) Other than cracks radiating up through the windshield, there was no damage to the interior in the center-front area.

[50](#) In the right-front seating area, there was no damage to the roof, to the roof header, or to the right A-pillar. [51](#) There was a dense pattern of circular shaped cracks in the right section of the windshield from contact by the airbag cover during airbag deployment. [52](#) There was no damage to the dash-mounted airbag or to the airbag cover and there was no damage to the glove box. [53](#) The right-front section of the toepan was displaced to the rear.
