## Case 404 : Narrative

| Case Vehicle (A): 2002 Pontiac | Vehicle (B): 2003 Sterling |
| Type: Grand Am SE, 4-door sedan | Type: LT9, 6 x 4 tractor with trailer |

# Vehicle Report

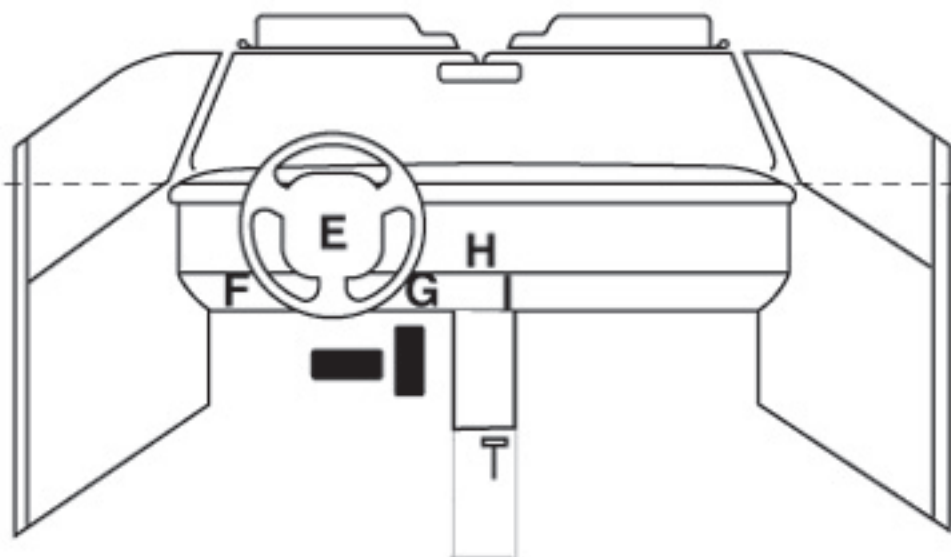
**A = sun roof, scuffmark**

**B = roof headliner, food or skin deposit**

| Contact | Interior Component Contacted | Occupant if Known | Body Region if Known | Supporting Physical Evidence | Confidence Level of Contact Point |
|---|---|---|---|---|---|
| H | Vertical console | DR | Rt. hand | scuffmark | 2 |
| I | Vertical console | DR | Rt. hand | scuffmark | 2 |

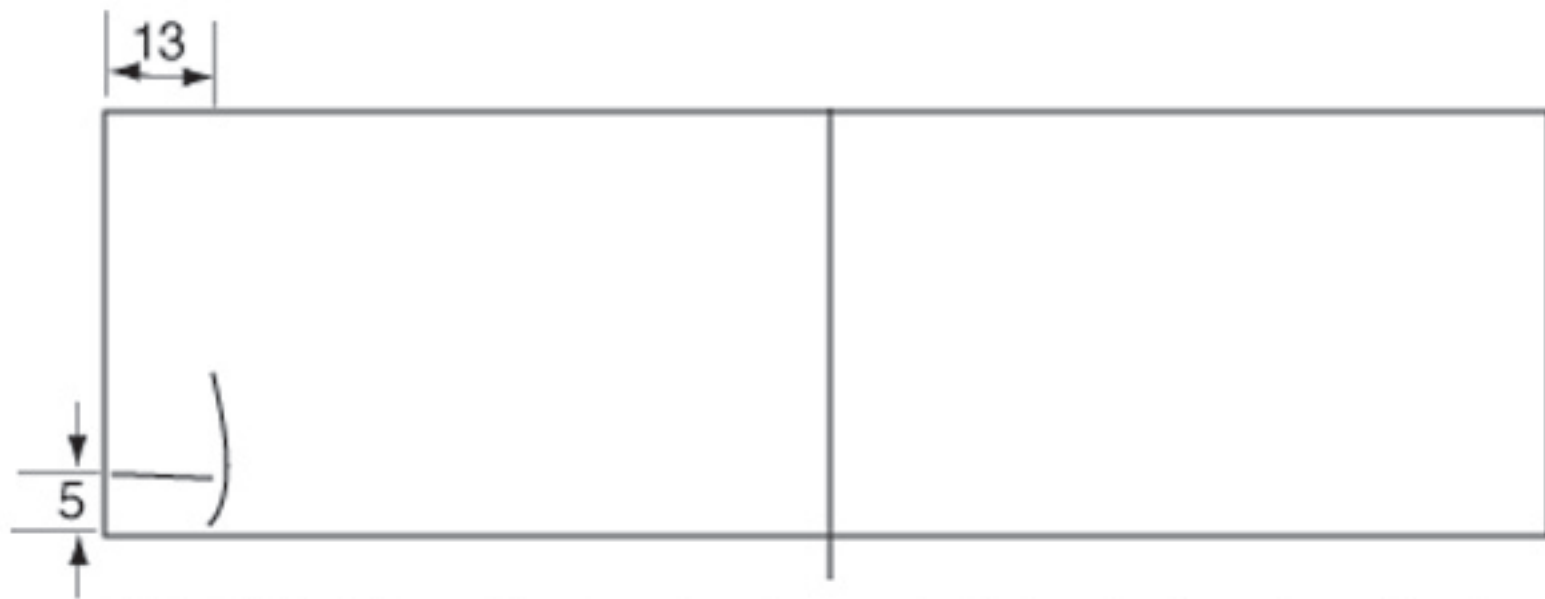
**Windshield cracked on the lower left due to hood contact**

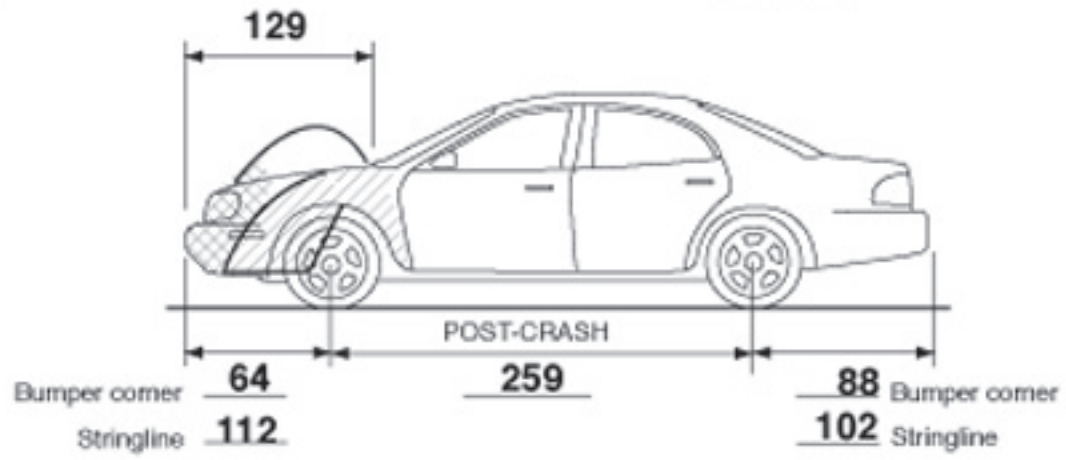
**Max. crush to left-front bumper**
