## Case 408 : Narrative

Case Vehicle (A): 2000 Chevrolet	Vehicle (B): 2001 Toyota
Type: Suburban LS, 4 x 4, 4-door SUV	Type: RAV4, 4 x 2, 4-door SUV
Driver: 35-year-old female	Driver: 50-year-old female
CDC: 12-FYEW-2, 06-BDEW-1	CDC: 99-0000-0

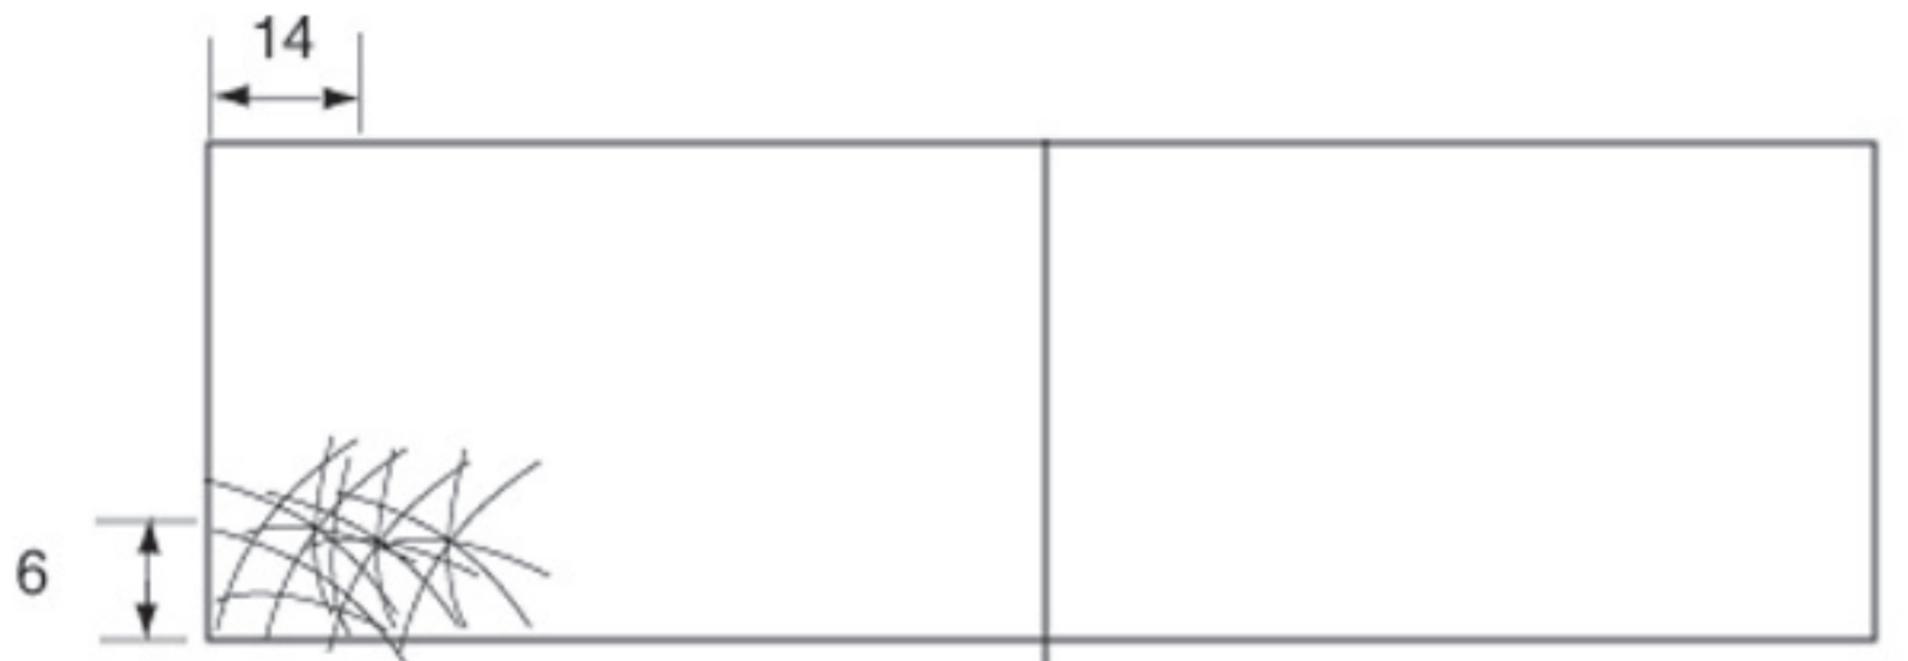
**Windshield cracked on left due to contact by rear hood edge**

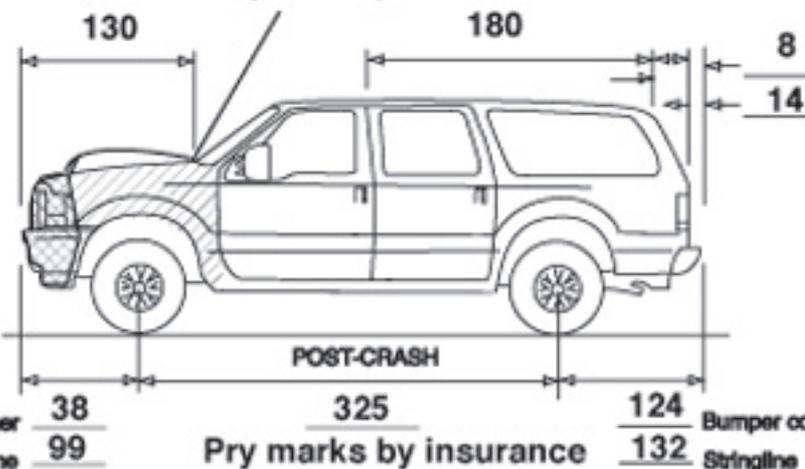
Width of direct damage to front bumper

Hinge cut by rescue

Pry marks by insurance adjuster

Max. crush to front left bumper corner
