Case 412 : Narrative

Case Vehicle (A): 1998 Ford	Vehicle (B): 2001 Ford
Type: Contour SE, 4-door sedan	Type: Ranger, 4x4, 4-door pickup
Driver: 61-year-old female	Driver: 24-year-old female
CDC: 12-FDEW-2	CDC: 99-0000-0

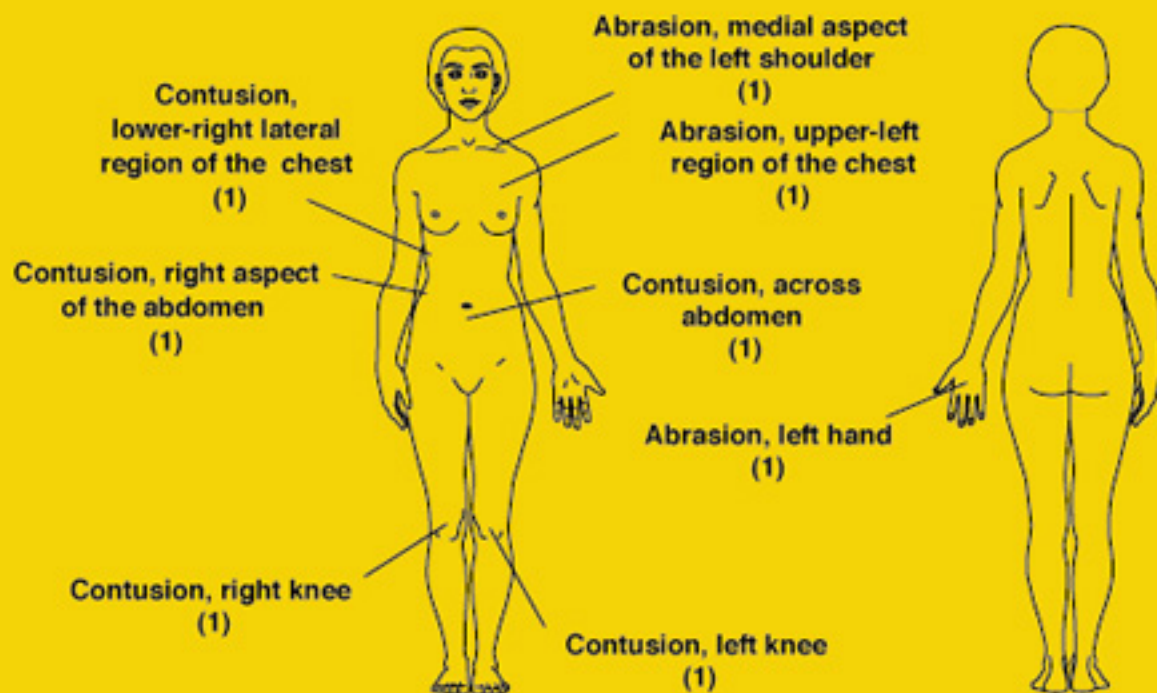
Occupant: Driver	Age: 61 years	Gender: Female		
Restraints: 3-point belt; steering-wheel airbag	Stature: 157 cm (5 ft, 2 in)	Mass: 61 kg (135 lb)		
Injury Description	A.I.S.	Injury Source		
		Definite	Probable	Possible
—	—	—	—	—
Abrasion, medial aspect of the left shoulder	1	Shoulder belt	—	—
Abrasion, upper-left region of the chest	1	Shoulder belt	—	—
Contusion, across abdomen	1	—	Lap belt	—
Contusion, lower-right lateral region of the chest	1	—	Lap and/or shoulder belt	—
Contusion, right aspect of the abdomen	1	—	Lap and/or shoulder belt	—
Abrasion, left hand	1	—	—	Turn-signal stalk
Contusions, both knees	1	Knee bolster	—	—
Maximum A.I.S. Level	1	—	—	—
Injury Severity Score	1	—	—	—

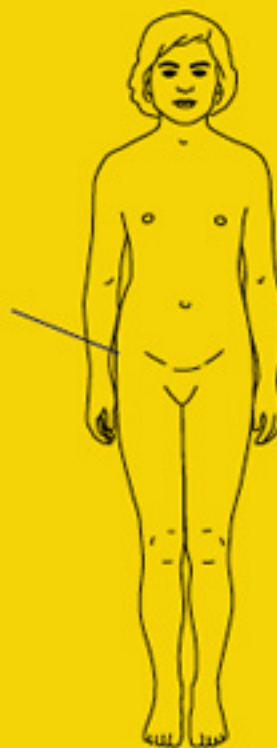
Laceration,
right hip
(1)

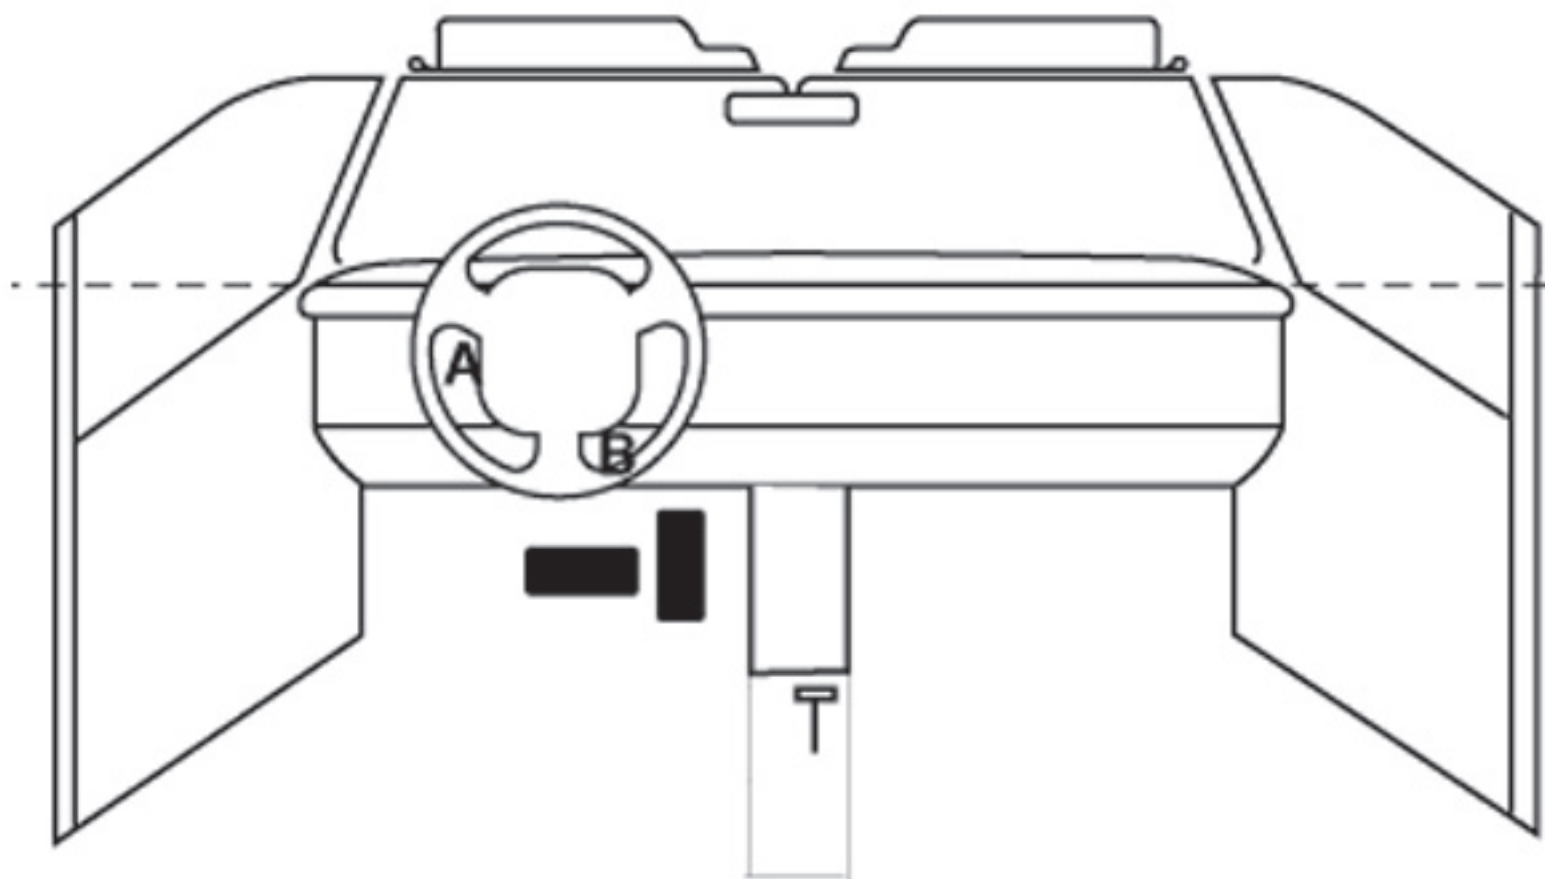
A = turn signal lever, broken off
B = knee bolster, indented

Contact	Interior Component Contacted	Occupant if Known	Body Region if Known	Supporting Physical Evidence	Confidence Level of Contact Point
A	Turn signal lever	DR	Lt. UX	Lever broken off	1
B	Knee bolster	DR	Rt. knee	Indented	1
C					
D					
E					
F					
G					
H					
I					
J

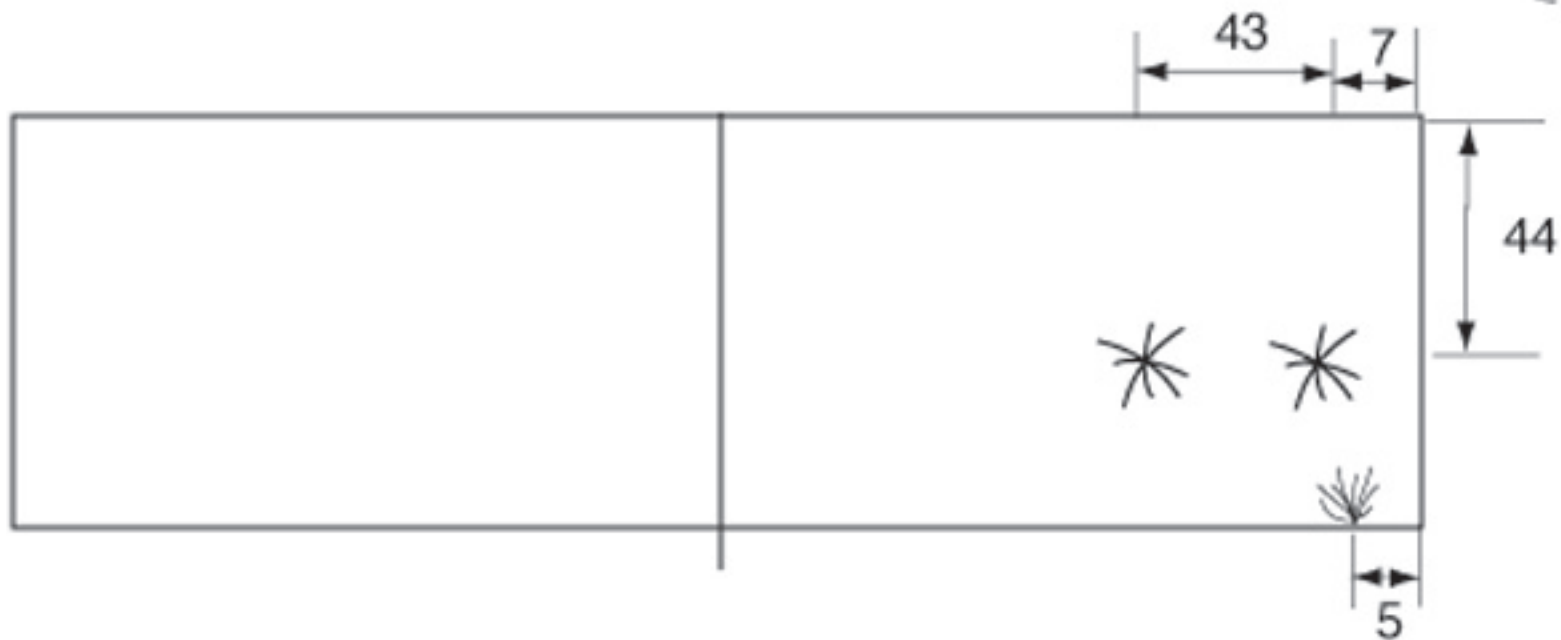
WINDSHIELD MARK ON CASE VEHICLE:

Windshield cracked on the right by dash-mounted airbag flap contact, and cracked on lower right by the rear edge of the hood

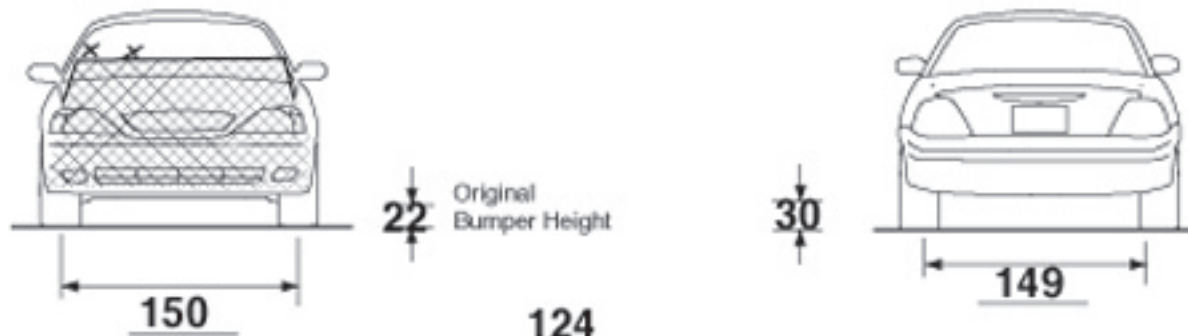
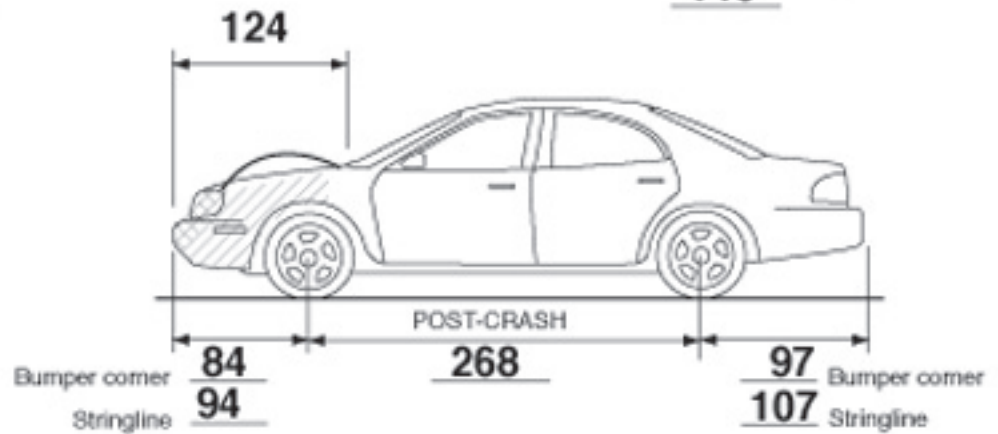
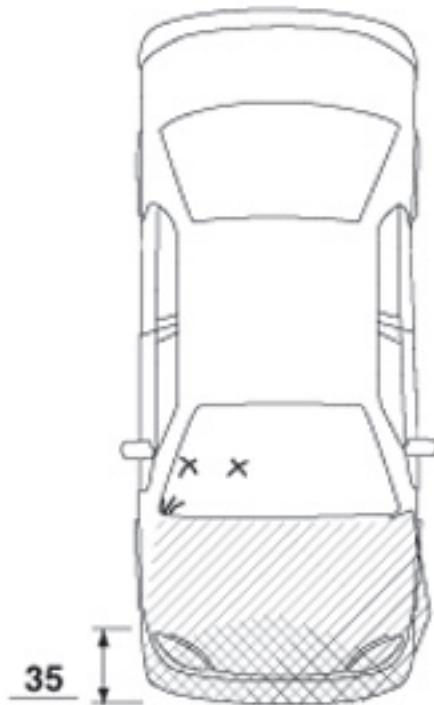
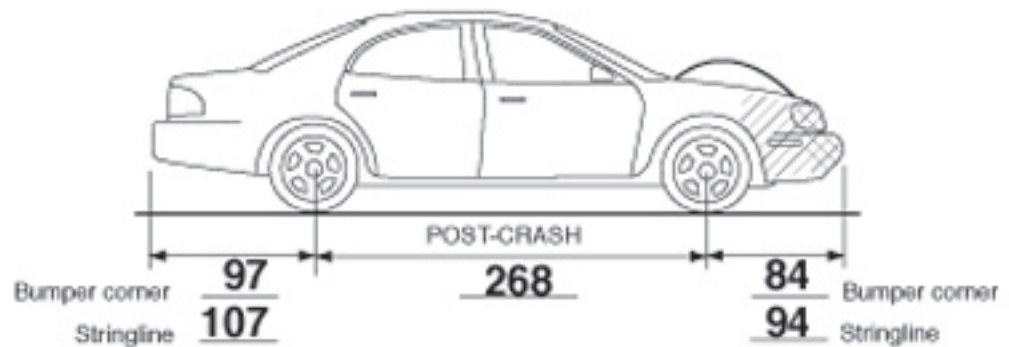
Max. crush to center of front bumper
