Case 423 : Narrative

Case Vehicle (A): 2004 Ford
Type: Ranger XLT, 4x4 pickup, 2-door
Driver: 47-year-old male
CDC: 12-FLEE-1, 12-FRAE-7, 12-FCEN-1, 09-LBEW-2

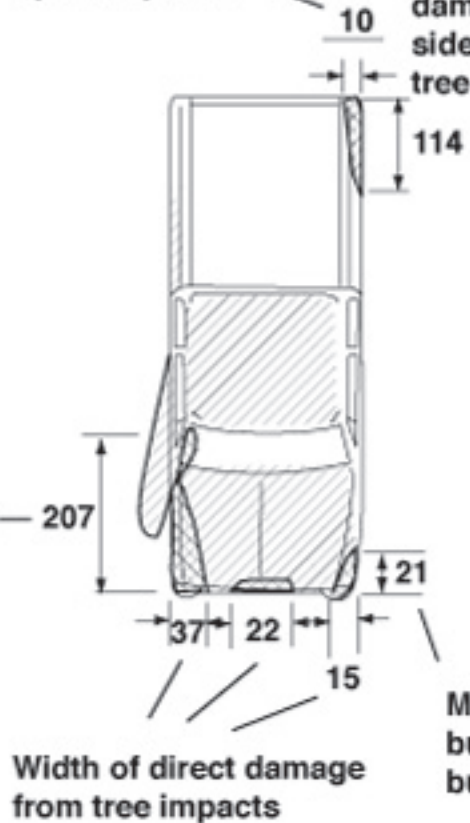
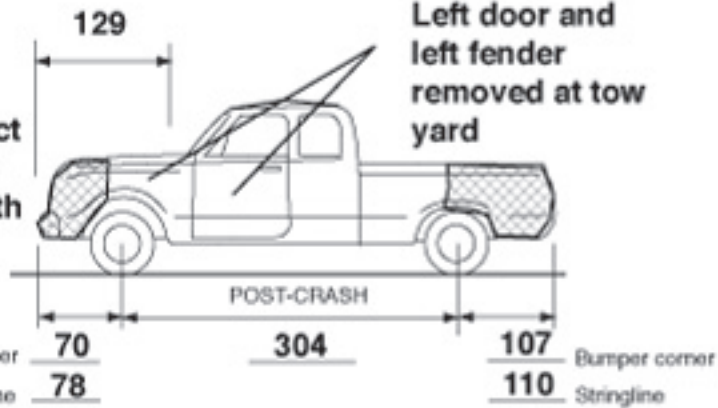
Width of direct damage from sideswipe with tree

Length of damage down right side from the 2nd tree impact

Max. crush to left-front bumper corner
