Case 430 : Narrative

Case Vehicle (A): 1999 Pontiac	Vehicle (B): 1999 Dodge
Type: Grand Am SE, 4-door sedan	Type: Ram 1500, 4x4, 2-door pickup
Driver: 20-year-old female	Driver: 38-year-old female
CDC: 12-FRAW-6	CDC: 06-BDEW-1

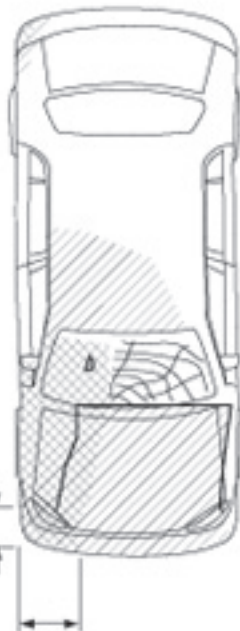
Max. crush to front 39
at right bumper
corner

50 Width of direct damage
to front

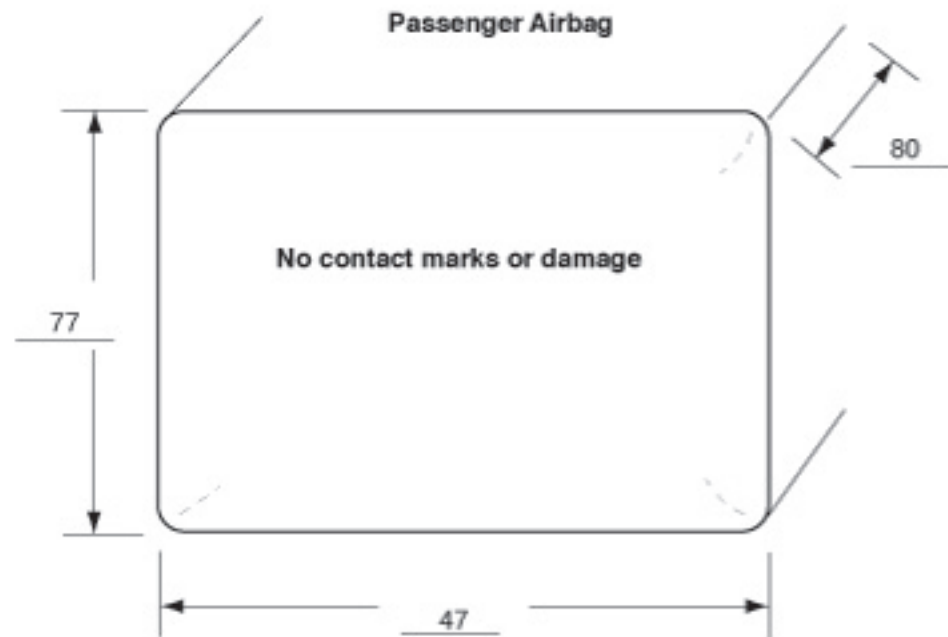
Passenger Airbag Door

Vents: Y N

if yes, how many: 2

Vents @ 11 and 1

Tethers: Y N

if yes, how many: 1
