Case 432 : Narrative

Case Vehicle (A): 2004 Jeep	Vehicle (B): 1997 Ford
Type: Liberty Sport, 4x4, 4-door SUV	Type: Taurus GL, 4-door sedan
Driver: 36-year-old female	Driver: 79-year-old female
CDC: 12-FYEW-1	CDC: 01-FDEW-3

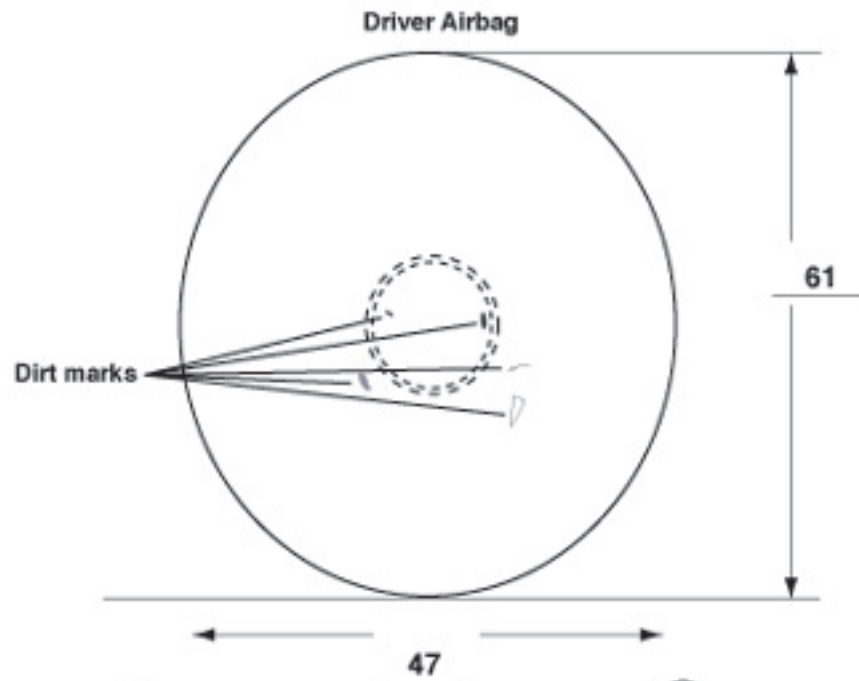
Driver Airbag Door

Vents: Y N
 if yes, how many: 2
 @10 & 2 o'clock

Tethers: Y N
 if yes, how many: 2

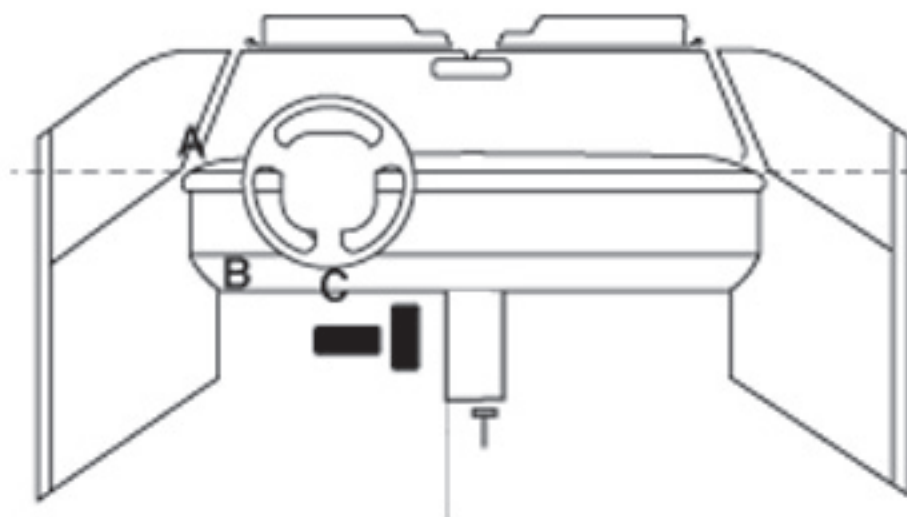
OCCUPANT CONTACT WORKSHEET

A = A-pillar, scrape mark

B = Knee bolster, scrape mark

C = Knee bolster, scuffmark

Location of Intrusion	Intruded Component	(All Measurements Are in Centimeters)				Dominant Crush Direction
		Comparison Value	–	Intruded Value	= Intrusion	
11	Toe pan	68	–	61	= 7	to rear

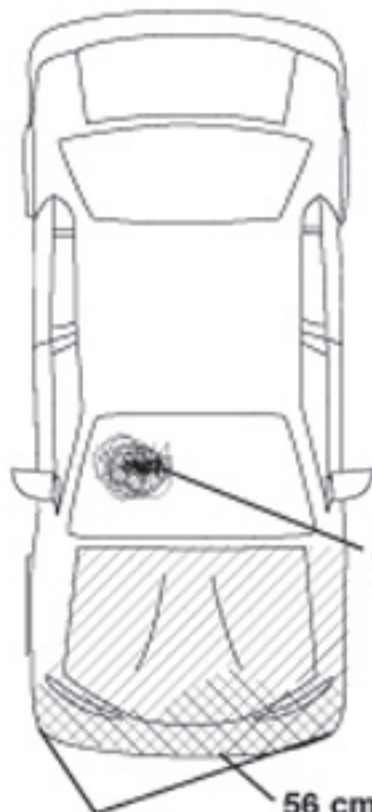
Airbag module cover contact

148 cm Direct damage

56 cm Max crush
