Case 435 : Narrative

Case Vehicle (A): 1999 Chevrolet	Vehicle (B): 2001 Chrysler
Type: Blazer LS, 4-door SUV, 4x4	Type: Sebring LX, 4-door sedan
Driver: 31-year-old female	Driver: 45-year-old male
CDC: 12-FDEW-2	CDC: 10-LPAW-3

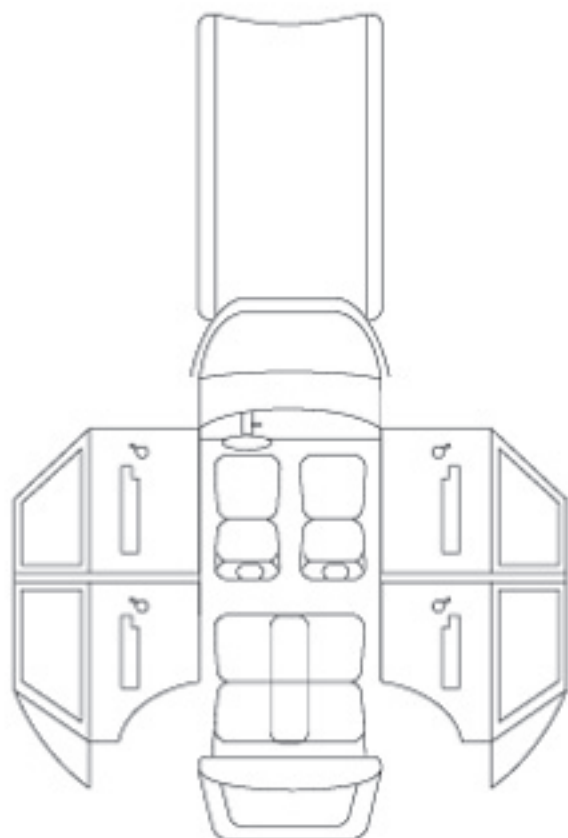
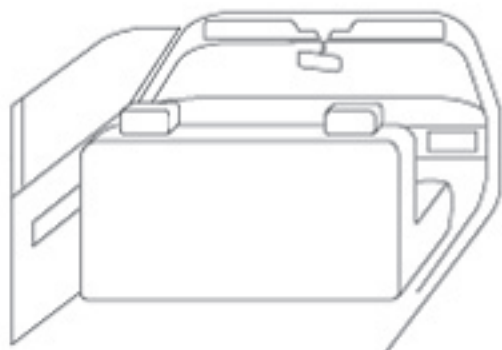
driver evidence of belt use - yes:

- scratch on D-ring
- replacement tab pulled out

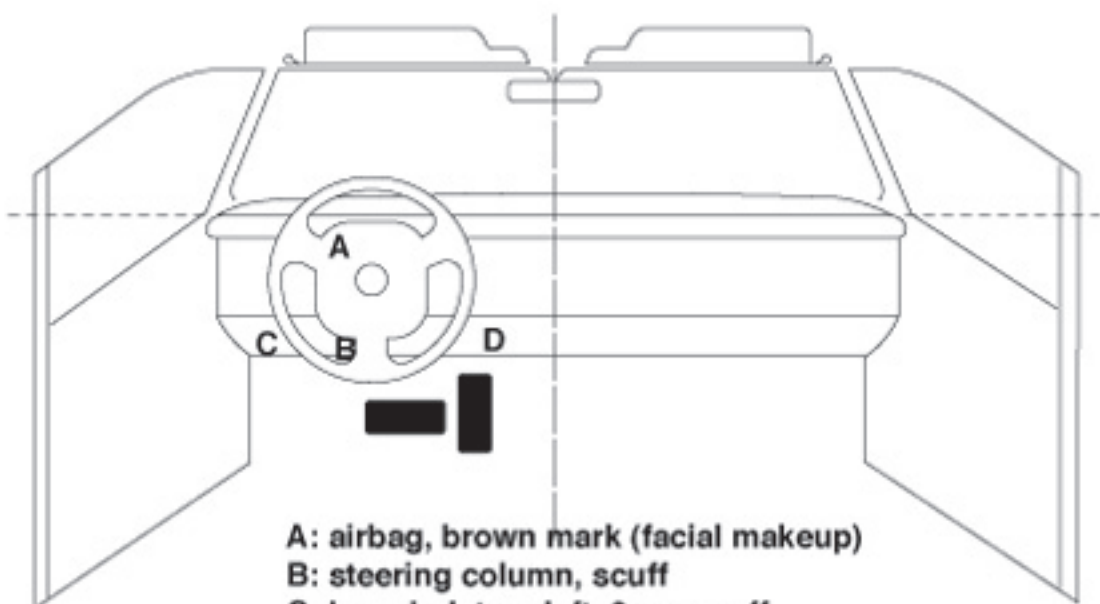
A: airbag, brown mark (facial makeup)

B: steering column, scuff

C: knee bolster - left, 2-cm scuff

D: knee bolster - right, 4-cm and 2-cm scuffs

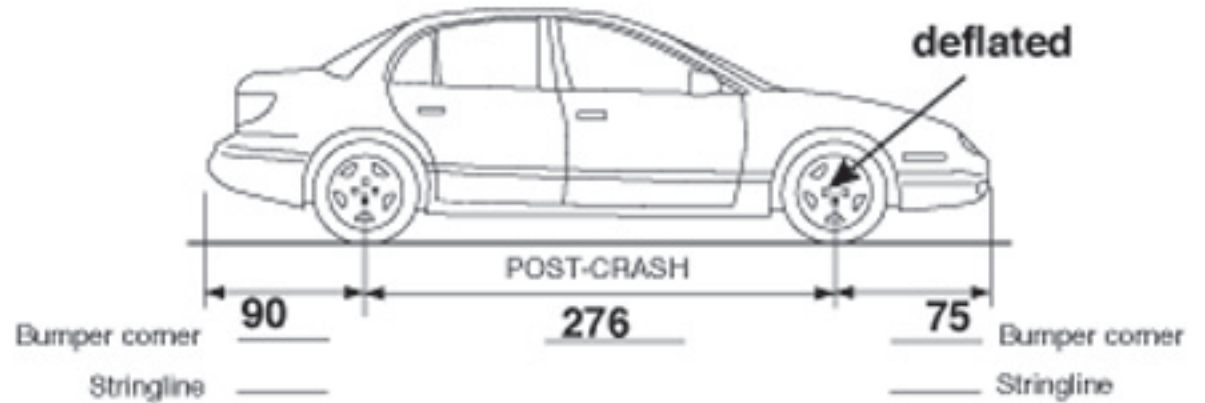
198 cm direct damage
38 cm maximum crush
