# Case 437 : Narrative

Case Vehicle (A): 2002 Dodge
Type: Stratus SXT, 4-door sedan
Driver: 61-year-old female
CDC: 12-FCEN-3

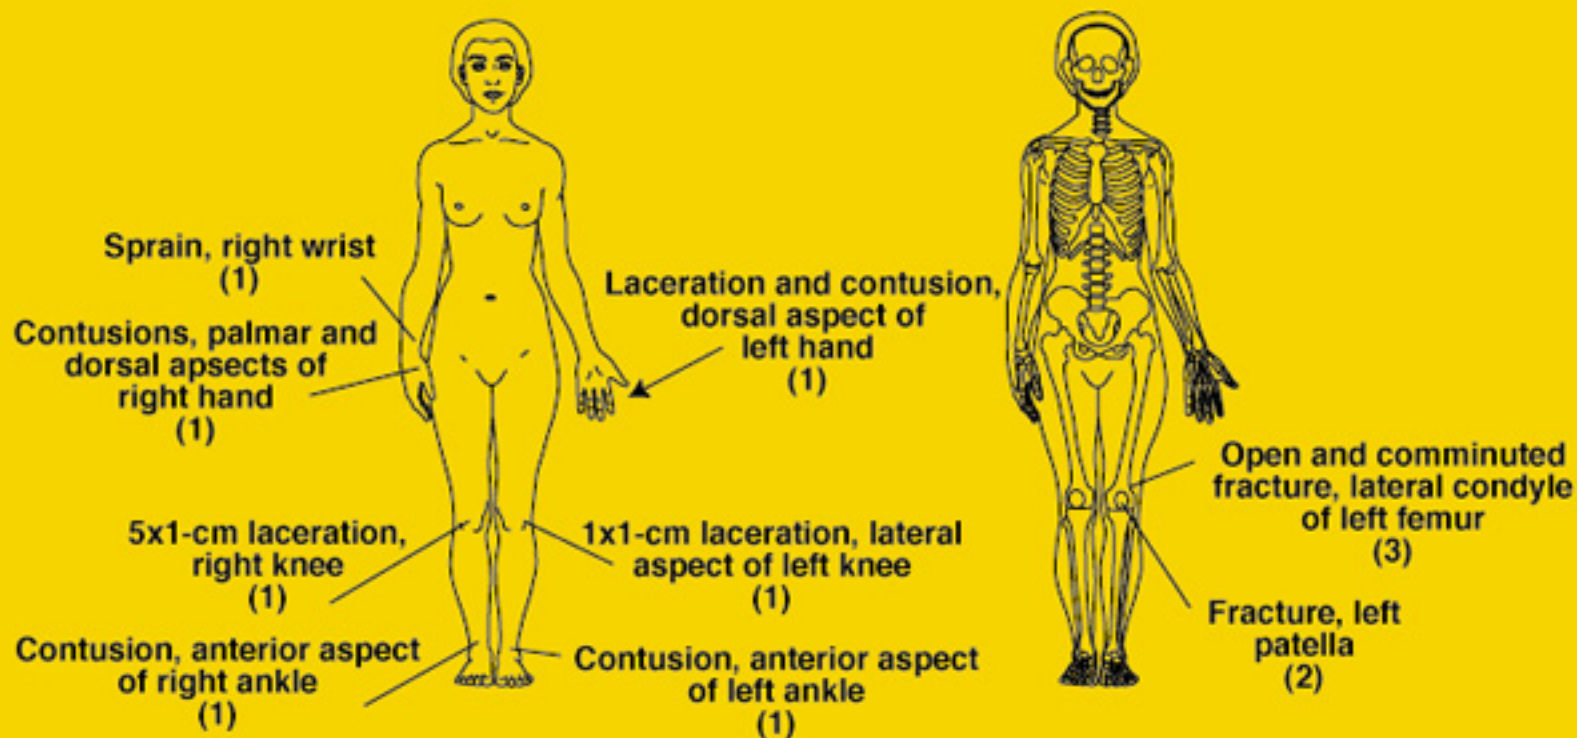
The following table and attached drawing [67](#) summarize the injuries for the unbelted driver.

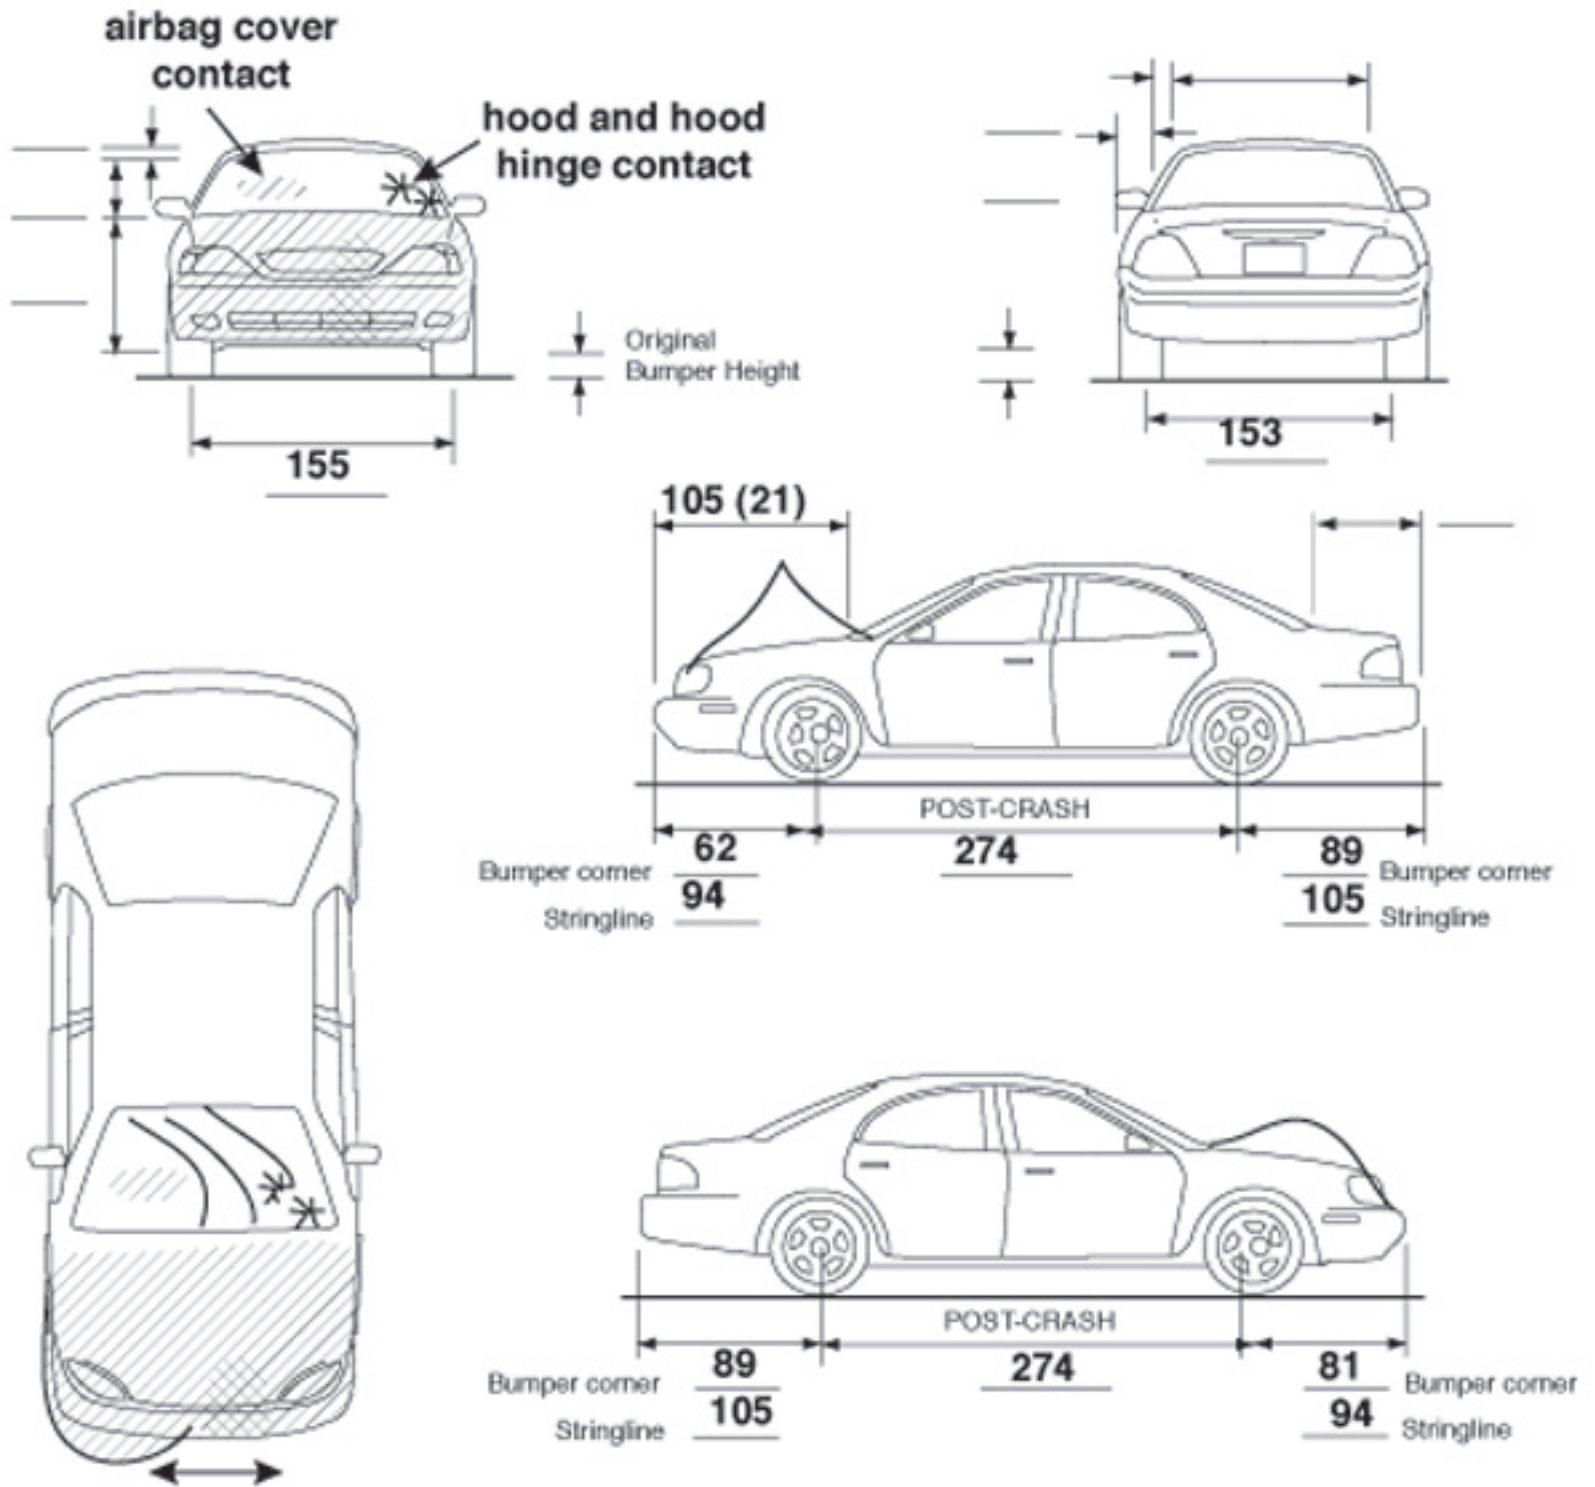
[7](#) Damage to the front of case vehicle (A) from impact with the tree was to the center area. [8](#) Direct damage began 22-cm from the left-front bumper corner of the vehicle and extended 25 cm to the right. The maximum frontal crush was 60 cm and it occurred just to the left of the vehicle centerline.

25-cm direct damage  
60-cm max crush
