Case 438 : Narrative

Case Vehicle (A): 2000 Oldsmobile	Vehicle (B): 2002 Chevrolet
Type: Bravada, 4-door SUV	Type: Suburban, 4-door SUV
Driver: 53-year-old female	Driver: 44-year-old male
CDC: 12-FZEW-2	CDC: 99-0000-0

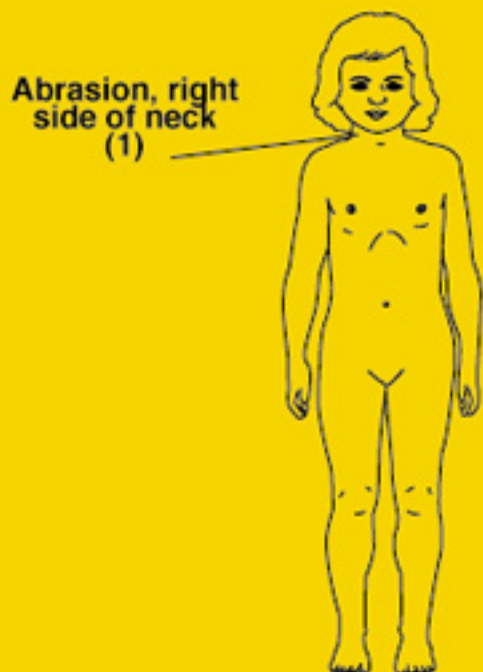
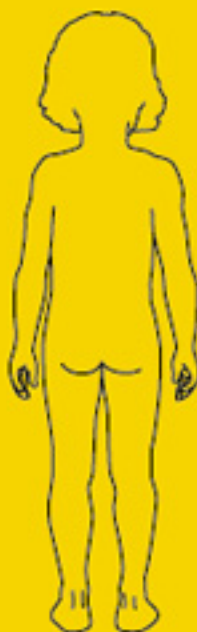
Occupant: Driver	Age: 53 years	Gender: Female		
Restraints: Seat-integrated 3-point belt;steering-wheel airbag	Stature: 165 cm (5 ft, 5 in)	Mass: 54 kg (118 lb)		
Injury Description	A.I.S.	Injury Source		
		Definite	Probable	Possible
—	—	—	—	—
Sprain, left wrist	1	—	—	Airbag/airbag-module cover
Contusions, across left knuckles	1	—	—	Airbag/airbag-module cover
Contusion, right knee	1	Knee bolster	—	—
Maximum A.I.S. Level	1	—	—	—
Injury Severity Score	2	—	—	—

Occupant: Center rear	Age: 6 years	Gender: Female		
Restraints: Seat-integrated 3-point belt	Stature: 122 cm (4 ft)	Mass: 23 kg (50 lb)		
Injury Description	A.I.S.	Injury Source		
		Definite	Probable	Possible
—	—	—	—	—
Abrasion, right side of neck	1	Shoulder belt	—	—
Maximum A.I.S. Level	1	—	—	—
Injury Severity Score	1	—	—	—

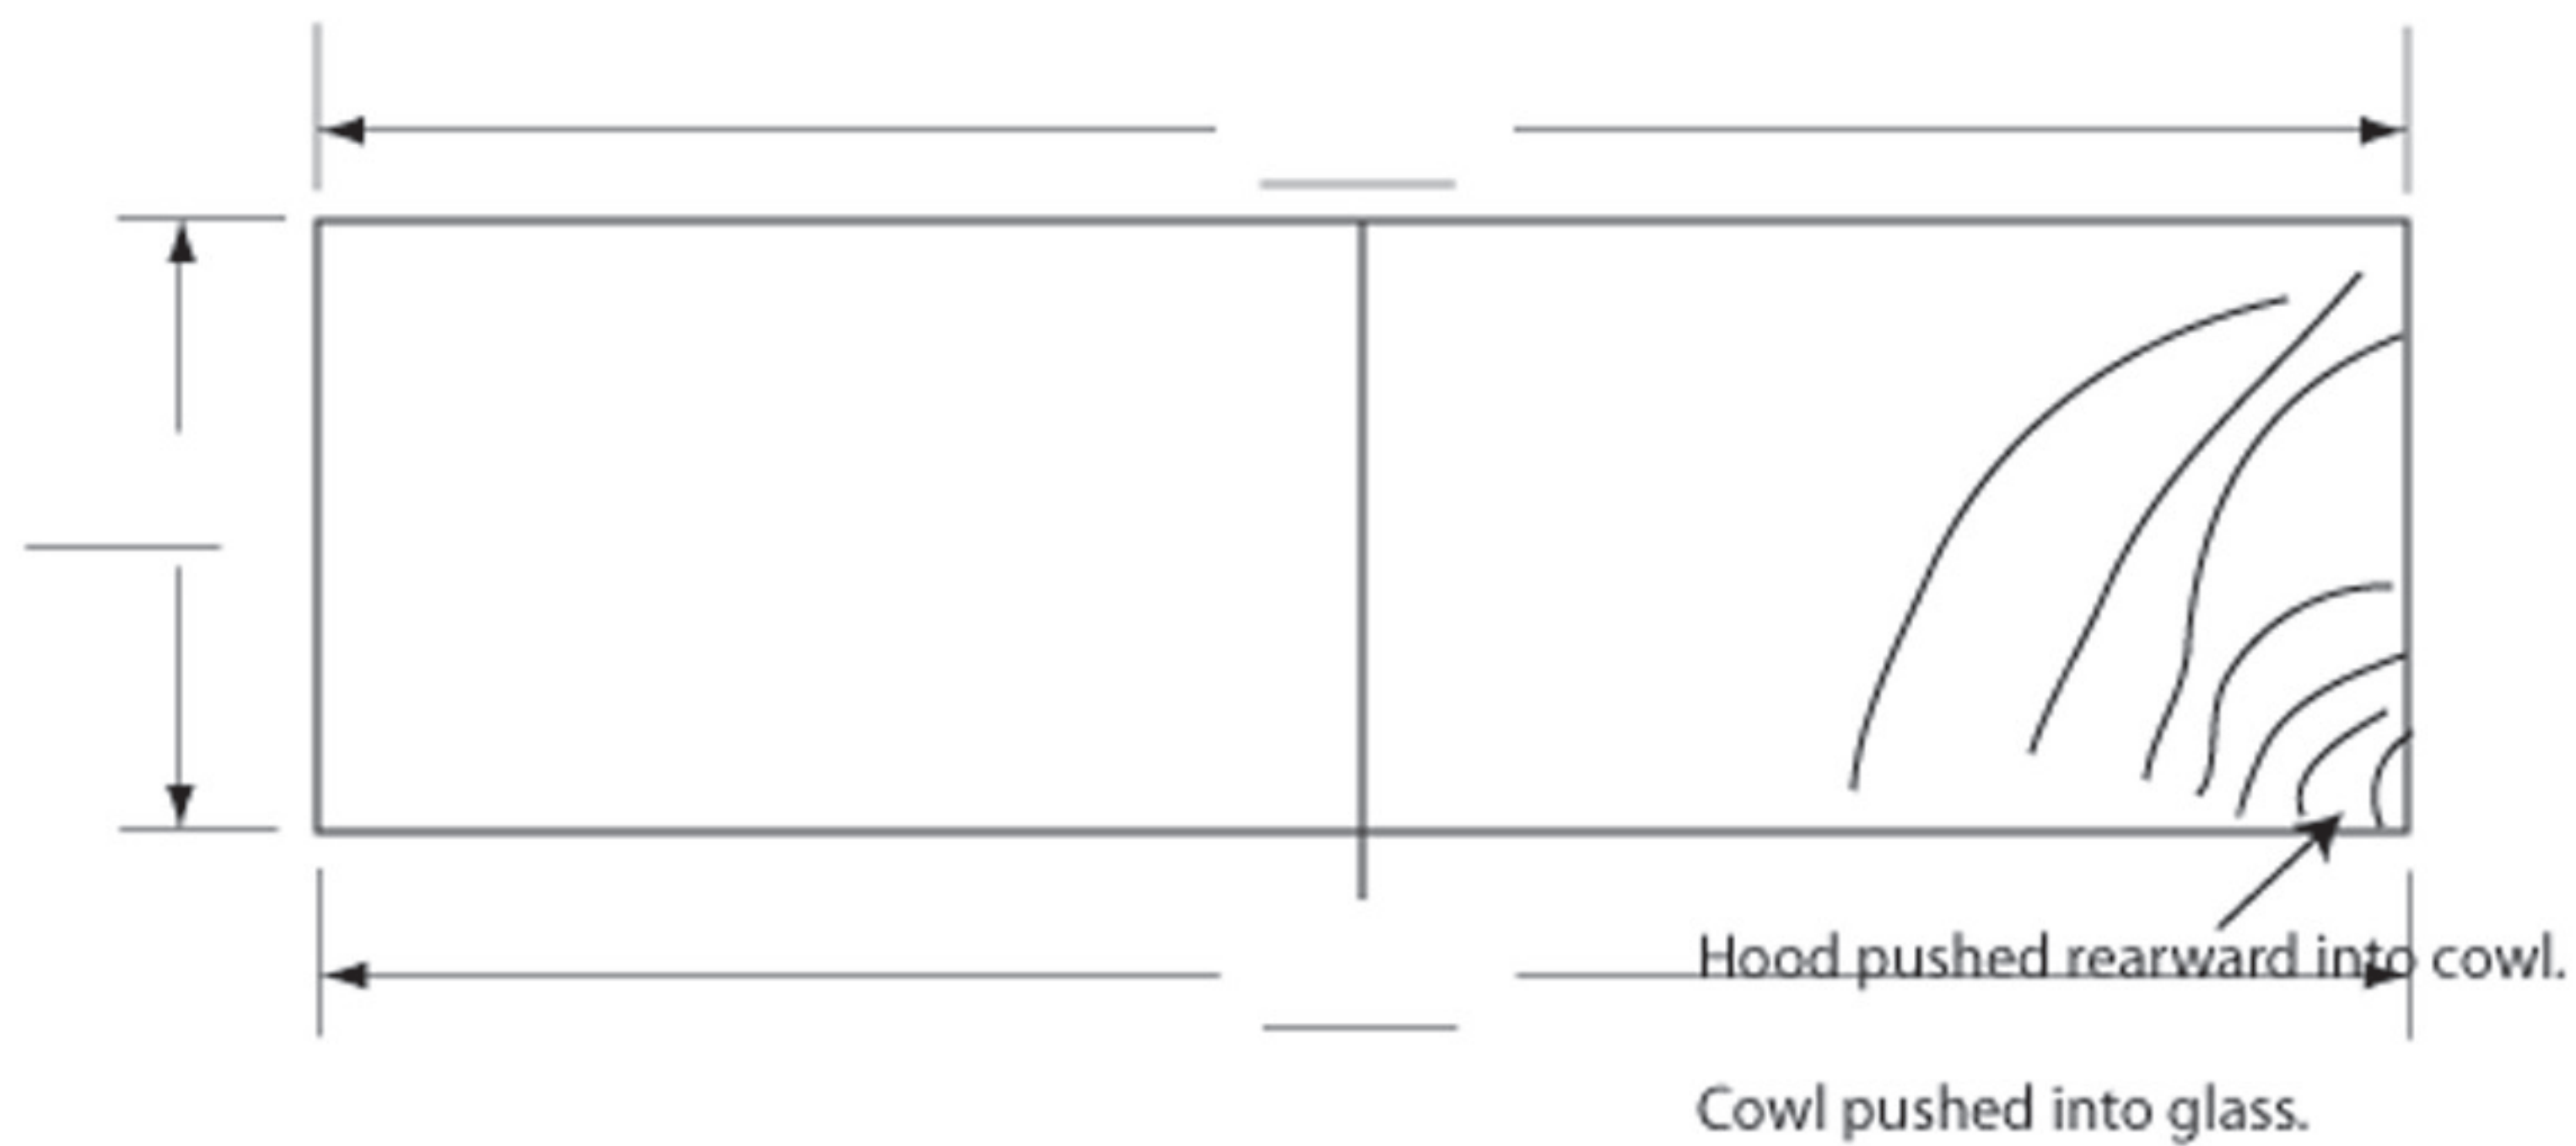
WINDSHIELD MARK ON CASE VEHICLE:

[52](#) [53](#) There was no damage in the center-front area and the only [54](#) [55](#) [56](#) [57](#) damage in the right-front seating area was cracks in the lower-right corner of the windshield due to contact by the cowl.

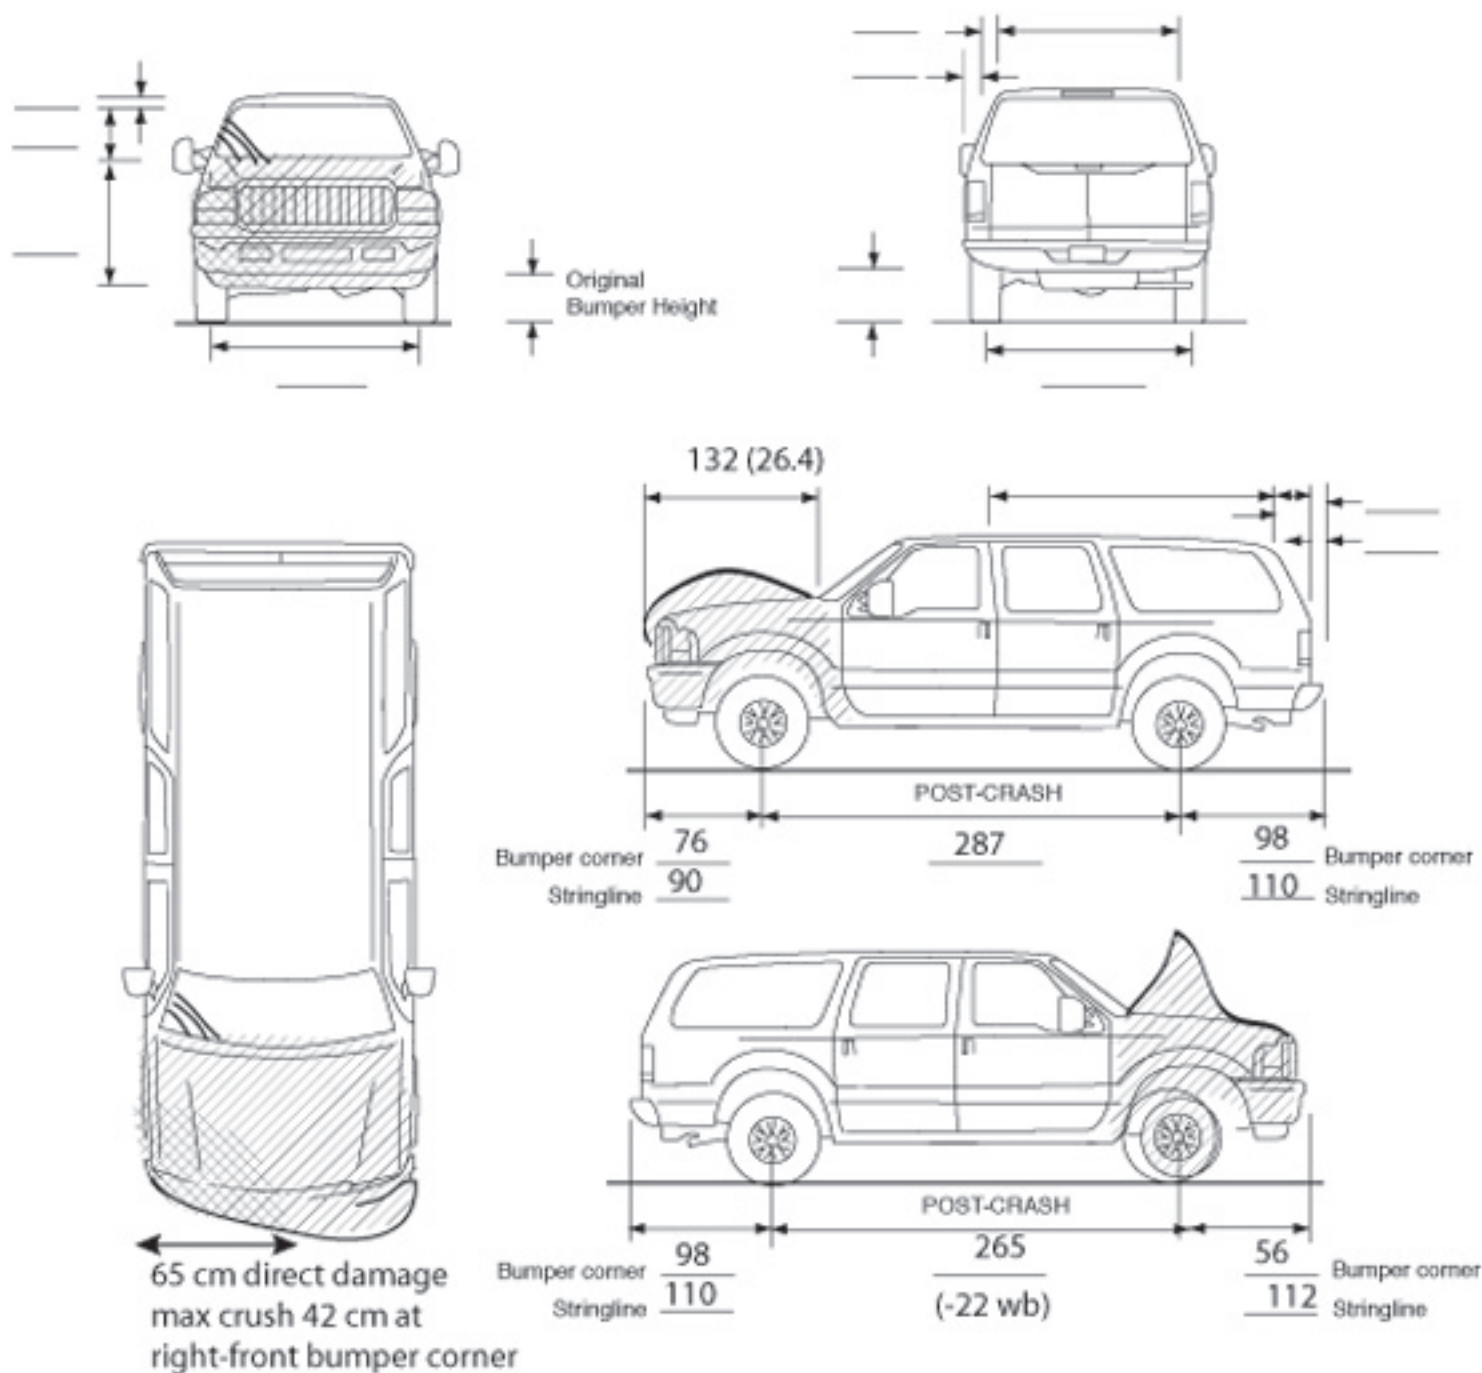
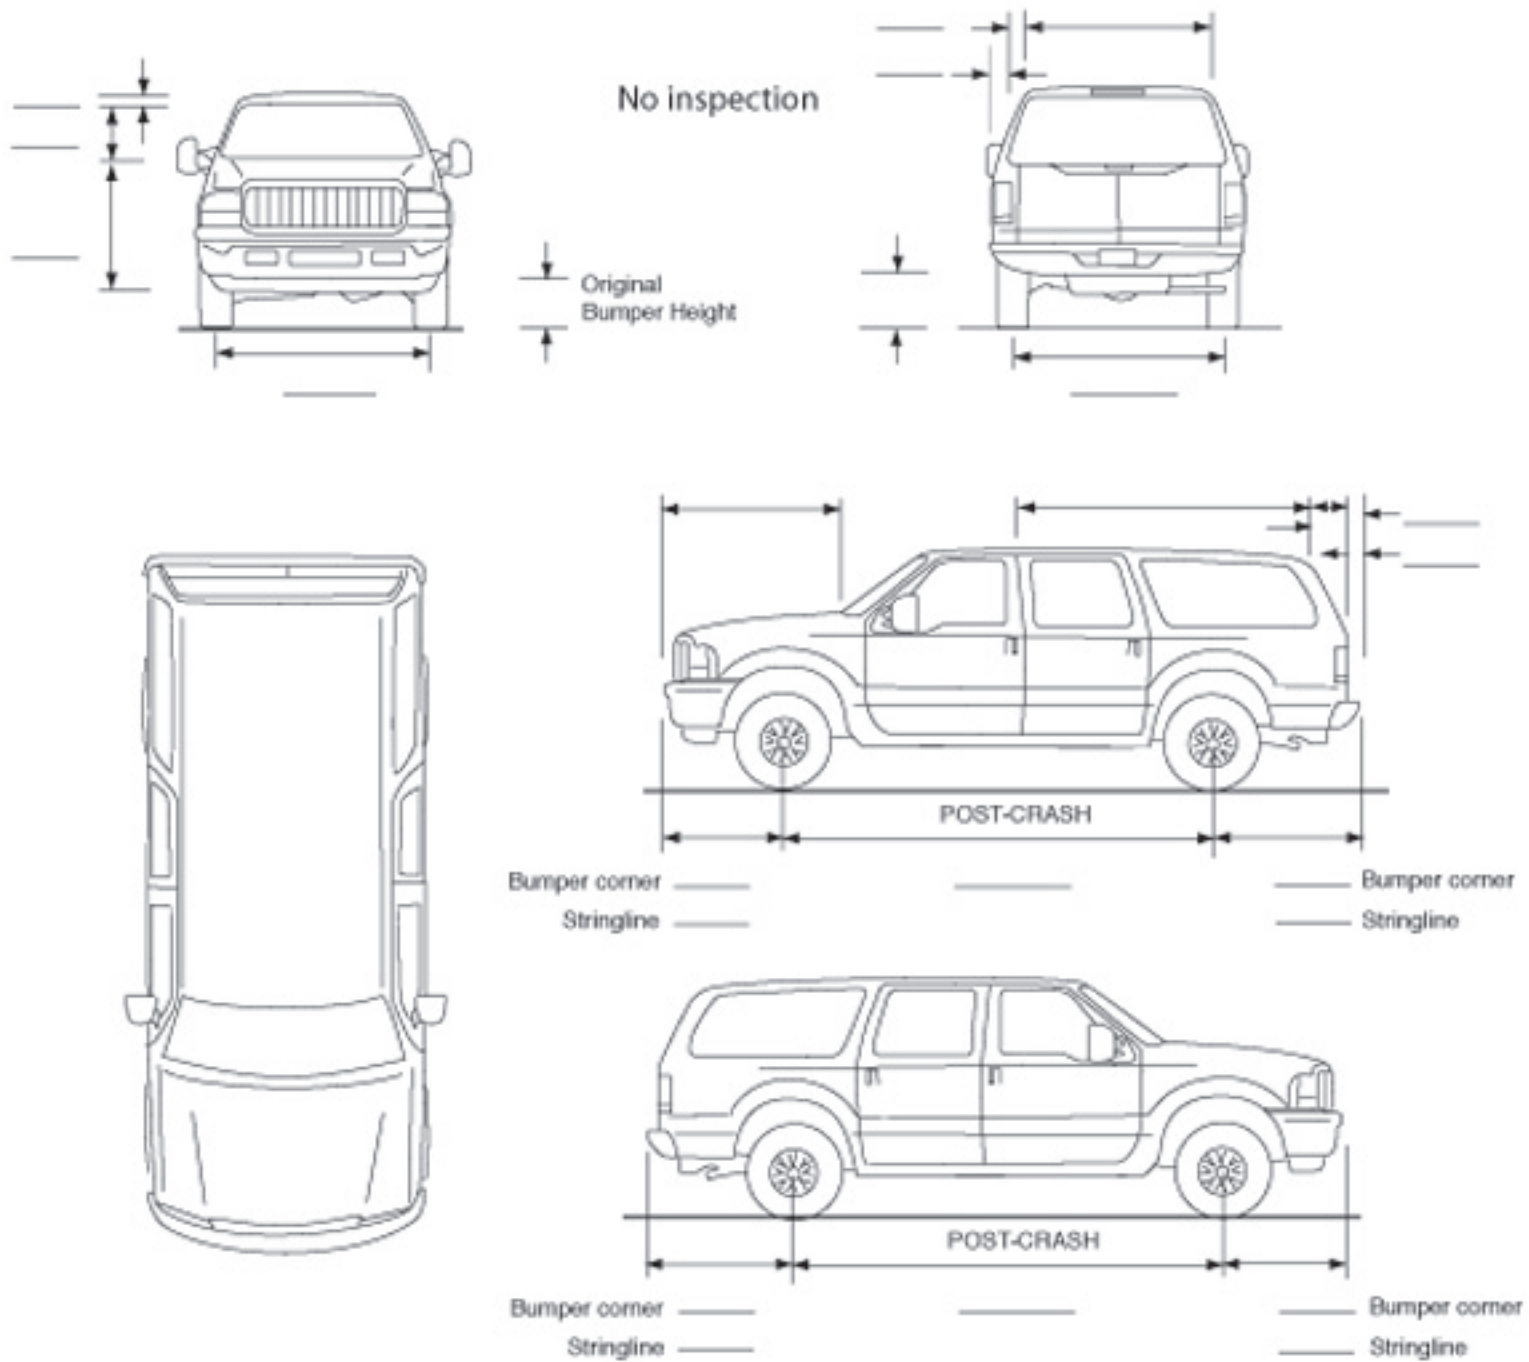
[8](#) Direct damage to case vehicle (A) began at the right-front bumper corner and extended 65-cm across the front, resulting in a 47-percent vehicle overlap (% VOL). The maximum crush was 42 cm and it occurred at the right-front bumper corner.
