Case 441 : Narrative

Case Vehicle (A): 2003 Ford	Vehicle (B): 1995 Saturn
Type: Ranger XLT, Supercab 4-door pickup	Type: SL1, 4-door sedan
Driver: 20-year-old male	Driver: 38-year-old female
CDC: 12-FDEW-1	CDC: 06-BDEW-7, 12-FDEW-1

This was a fatal crash. The belt-restrained 5-year-old female passenger seated in a booster seat in the left-rear seat of vehicle (B) died as a result of head trauma sustained in a severe rear-end impact.

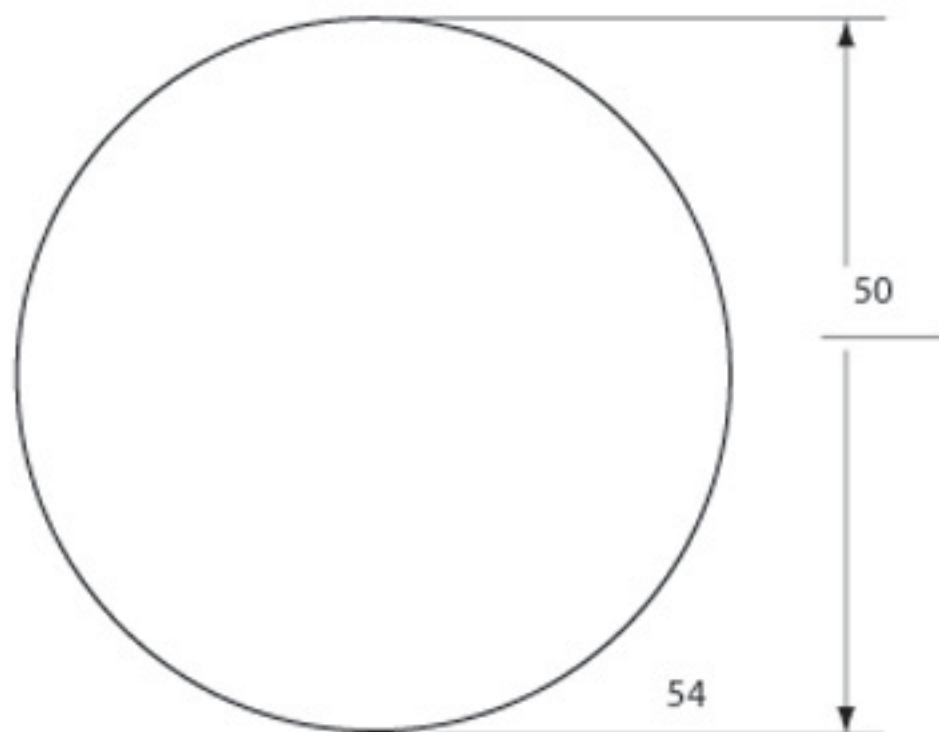
Driver Airbag

Vents: Y N
if yes, how many: 2
vents at 11 and 1 o'clock

Tethers: Y N
if yes, how many: 4

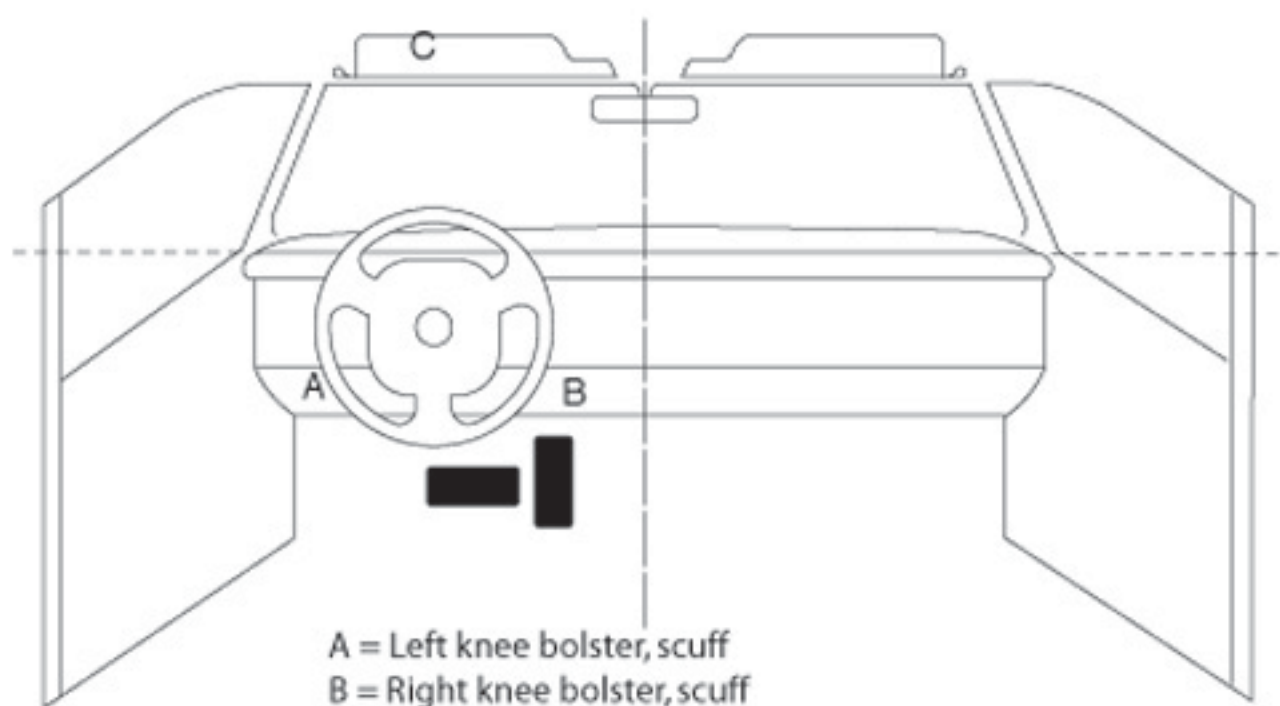
A = Left knee bolster, scuff
B = Right knee bolster, scuff
C = Sunvisor, scuff
