# Case 448 : Narrative

Case Vehicle (A): 1998 Buick
Type: LeSabre Custom, 4-door sedan
Driver: 79-year-old male
CDC: 12-FYEN-3

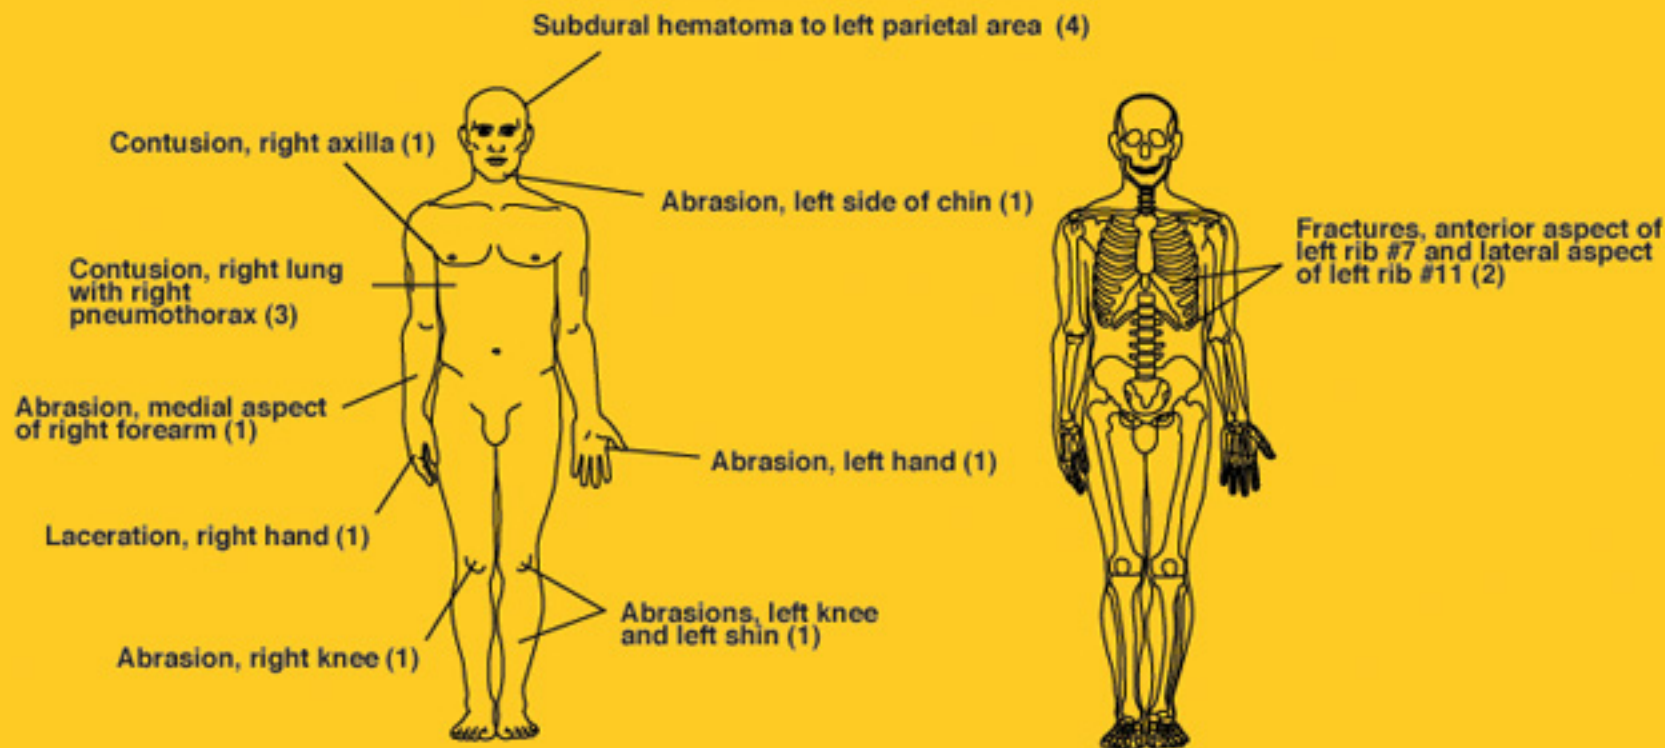
Injury Description	A.I.S.	Injury Source		
		Definite	Probable	Possible
—	—	—	—	—
Subdural hematoma to left parietal area	4	—	—	Head rotation induced by close-proximity airbag loading to the head/face
Abrasion, left side of chin	1	—	Airbag	—
Contusion, right lung with right pneumothorax	3	—	Airbag	—
Fractures, anterior aspect of left 7th rib and lateral aspect of left 11th rib	2	—	Airbag	—
Contusion, right axilla	1	—	Airbag	—
Abrasion, medial aspect of right forearm	1	—	Airbag	—
Abrasion, left hand	1	Unknown	—	—
Laceration, right hand	1	Unknown	—	—
Abrasion, right knee	1	Knee bolster	—	—
Abrasions, left knee and left shin	1	Knee bolster	—	—
Maximum A.I.S. Level	4	—	—	—
Injury Severity Score	26	—	—	—

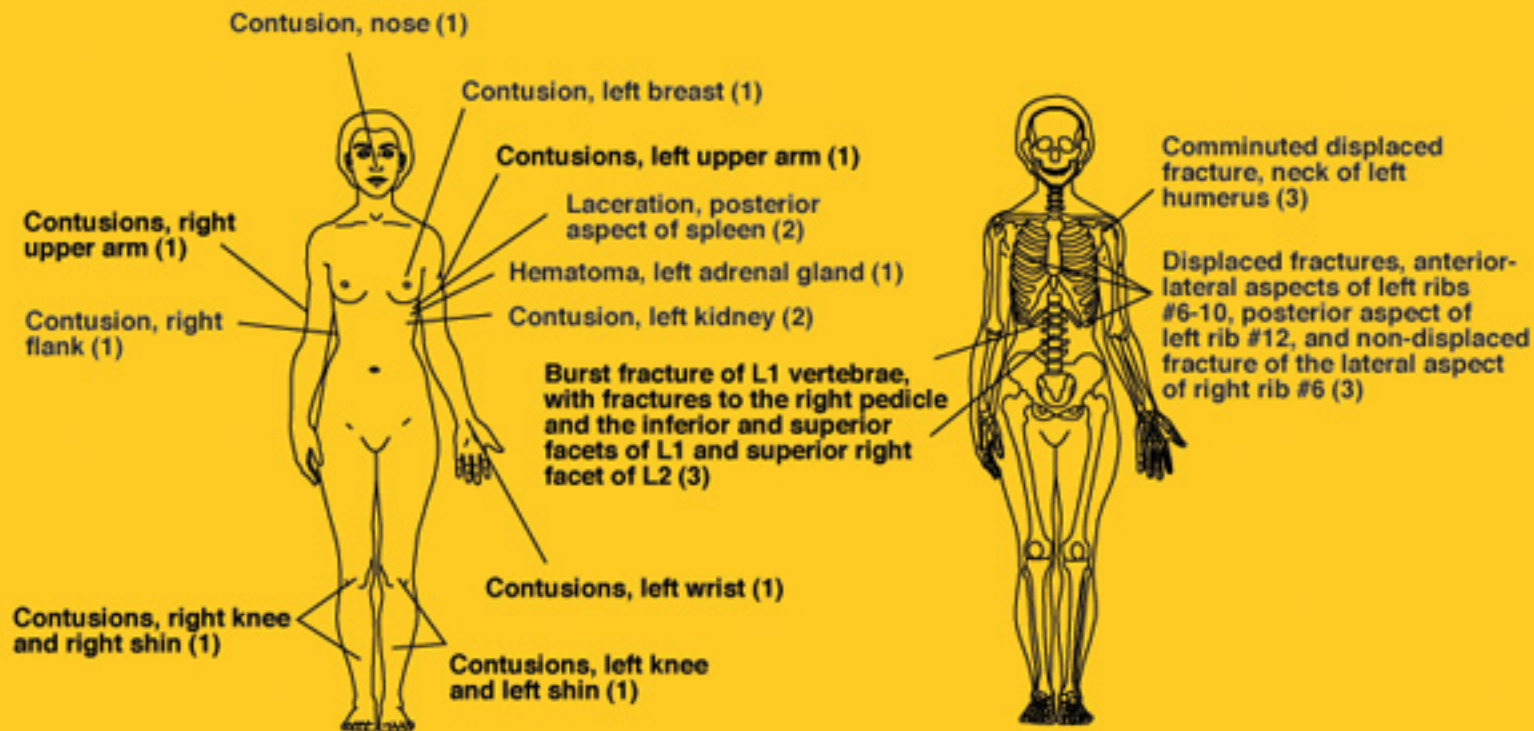
Occupant: Right front	Age: 79 years	Gender: Female		
Restraints: 3-point belt; dash-mounted airbag	Stature: 168 cm (5 ft, 6 in)	Mass: 57 kg (125 lb)		
Injury Description	A.I.S.	Injury Source		
		Definite	Probable	Possible
—	—	—	—	—
Contusion, nose	1	—	—	Airbag
Comminuted displaced fracture, neck of left humerus	3	Unknown	—	—
Contusions, left arm	1	Unknown	—	—
Contusions, left wrist	1	—	—	Dashboard
Contusion, right arm	1	—	—	Airbag
Displaced fractures, anterior-lateral aspects of left 6th-10th ribs; non-displaced fracture to the lateral aspect of right 6th rib	3	—	Shoulder belt	—
Fracture, posterior aspect of left	1	—	—	Lap belt

12th rib				
Contusion, left breast	1	—	Shoulder belt	—
Hematoma, left adrenal gland	1	—	—	Lap belt
Contusion, left kidney	2	—	—	Lap belt
Laceration, posterior aspect of spleen	2	—	—	Lap belt
Burst fracture of L1 vertebrae, with fractures to the right pedicle and the inferior and superior facets of L1, and the superior right facet of L2	3	—	Bending/twisting of spine due to impact forces and lap belt loading of abdomen	—
Contusion, right flank	1	—	—	Lap belt
Contusions, right knee and right shin	1	Knee bolster	—	—
Contusions, left knee and left shin	1	Knee bolster	—	—
Maximum A.I.S. Level	3	—	—	—
Injury Severity Score	27	—	—	—

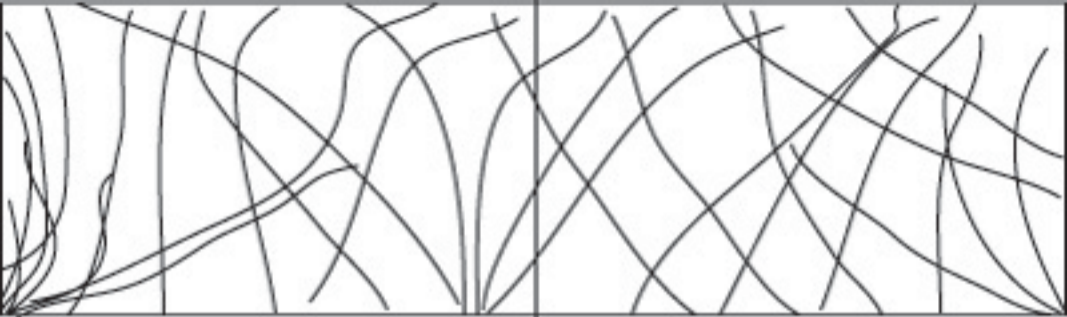
**Windshield cracked due to impact forces and left upper A-pillar displacement**

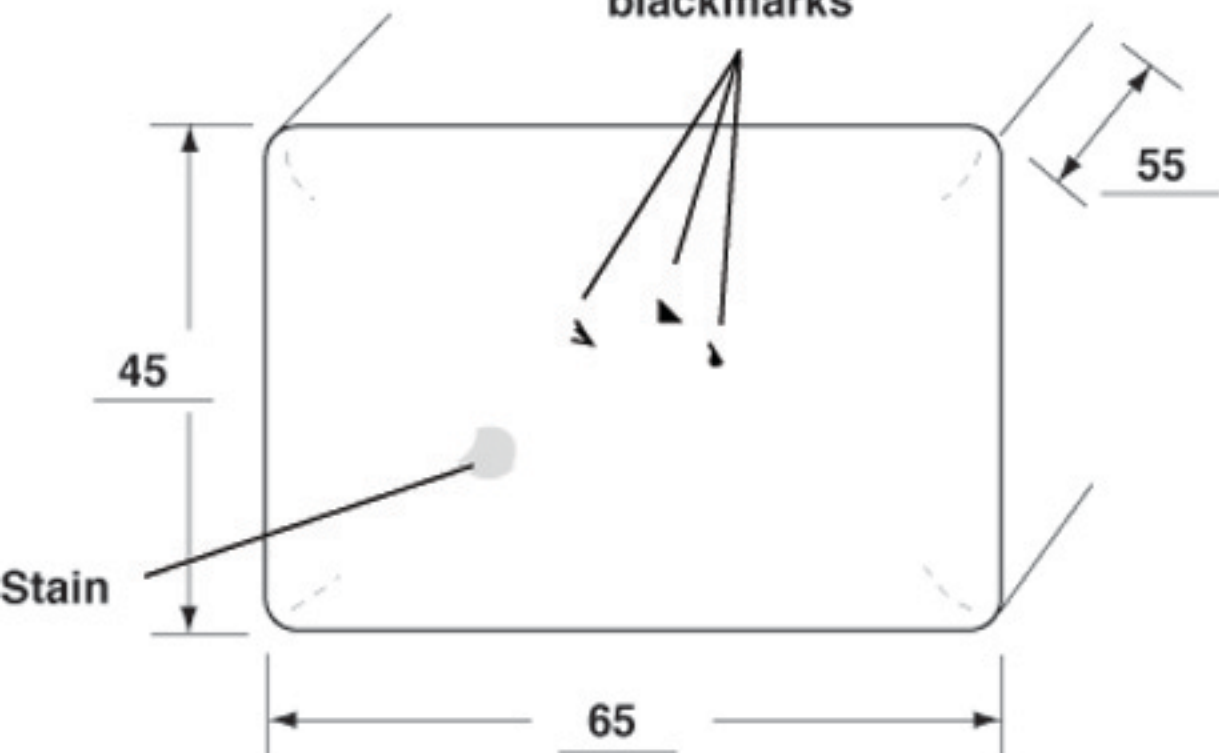
Passenger Airbag

blackmarks
