## Case 449 : Narrative

Case Vehicle (A): 1998 Ford	Vehicle (B): 2000 Hyundai
Type: Explorer Sport, 4x2, 2-door SUV	Type: Accent GL, 4-door sedan
Driver: 38-year-old female	Driver: 59-year-old female
CDC: 12-FYEW-2	CDC: 01-FZEW-2

# UM-4262: Vehicle Report

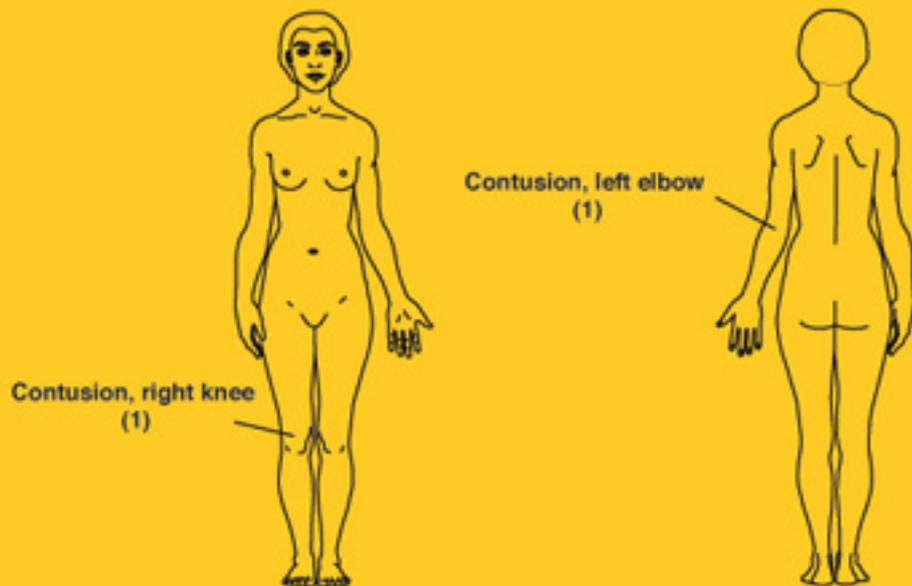
Occupant: Driver	Age: 38 years	Gender: Female		
Restraints: Steering-wheel airbag	Stature: 170 cm (5 ft, 7 in)	Mass: 145 kg (320 lb)		
Injury Description	A.I.S.	Injury Source		
		Definite	Probable	Possible
—	—	—	—	—
Contusion, left elbow	1	—	—	Interior of driver door
Contusion, right knee	1	Knee bolster	—	—
Maximum A.I.S. Level	1	—	—	—
Injury Severity Score	1	—	—	—

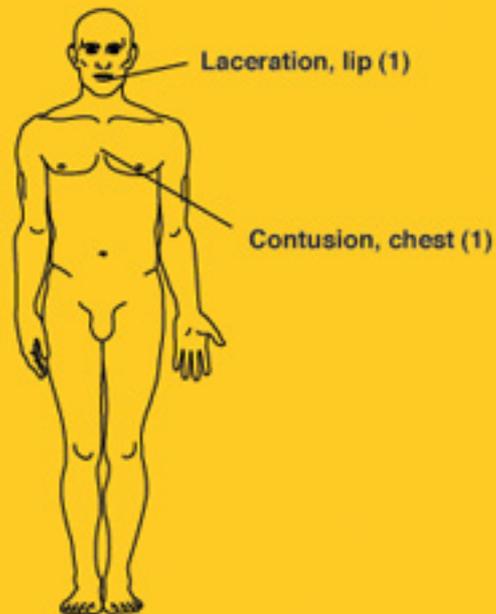
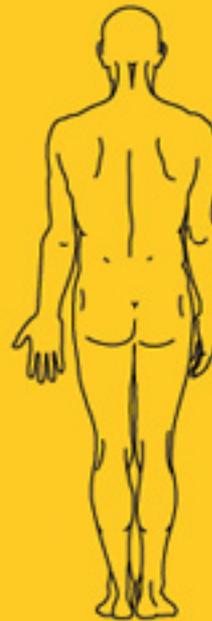
Occupant: Right front	Age: 55 years	Gender: Male		
Restraints: Dash-mounted airbag	Stature: 180 cm (5 ft, 11 in)	Mass: 88 kg (195 lb)		
Injury Description	A.I.S.	Injury Source		
		Definite	Probable	Possible
—	—	—	—	—
Laceration, lip	1	—	Airbag	—
Contusion, chest	1	—	Airbag	—
Maximum A.I.S. Level	1	—	—	—
Injury Severity Score	1	—	—	—

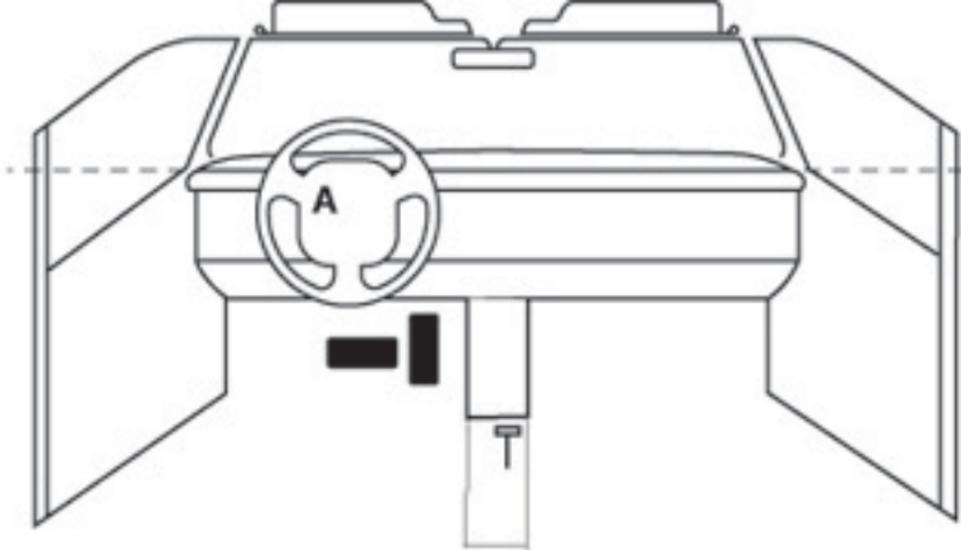
**A = upper airbag flap, scuffmark**

Contact	Interior Component Contacted	Occupant No. if Known	Body Region if Known	Supporting Physical Evidence	Confidence Level of Contact Point
A	Steering wheel airbag flap	DR	LX	scuffed	1
B					
C					
D					
E					
F					
G

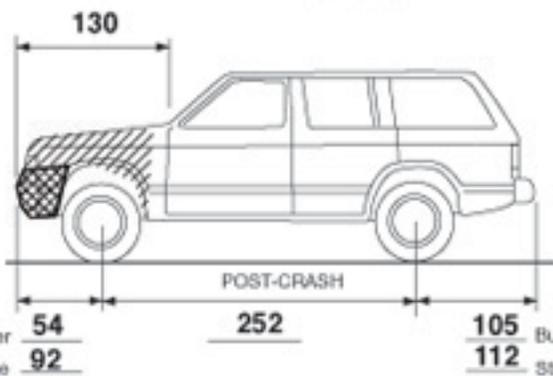
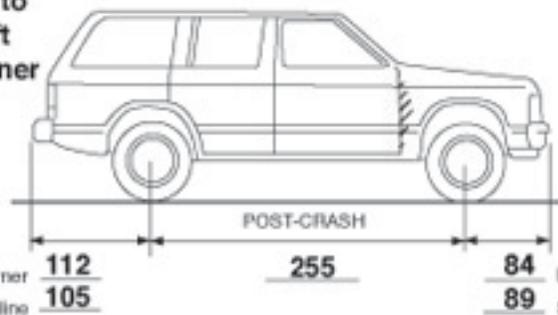
Width of direct damage to front

**Bumper corners shifted to left**

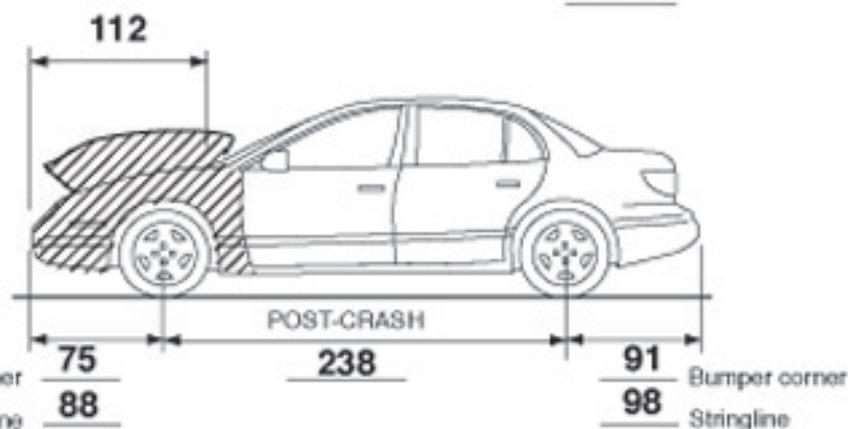
**Max. crush to right bumper corner**

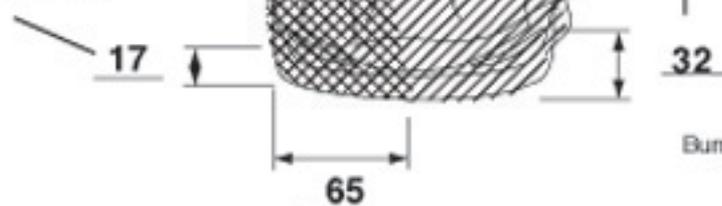
**Width of direct damage to front**

**Max. crush to center of upper radiator support**
