## Case 450 : Narrative

Case Vehicle (A): 2000 Hyundai	Vehicle (B): 1998 Ford
Type: Accent GL, 4-door sedan	Type: Explorer Sport, 4x2, 2-door SUV
Driver: 59-year-old female	Driver: 38-year-old female
CDC: 01-FZEW-2	CDC: 12-FYEW-2

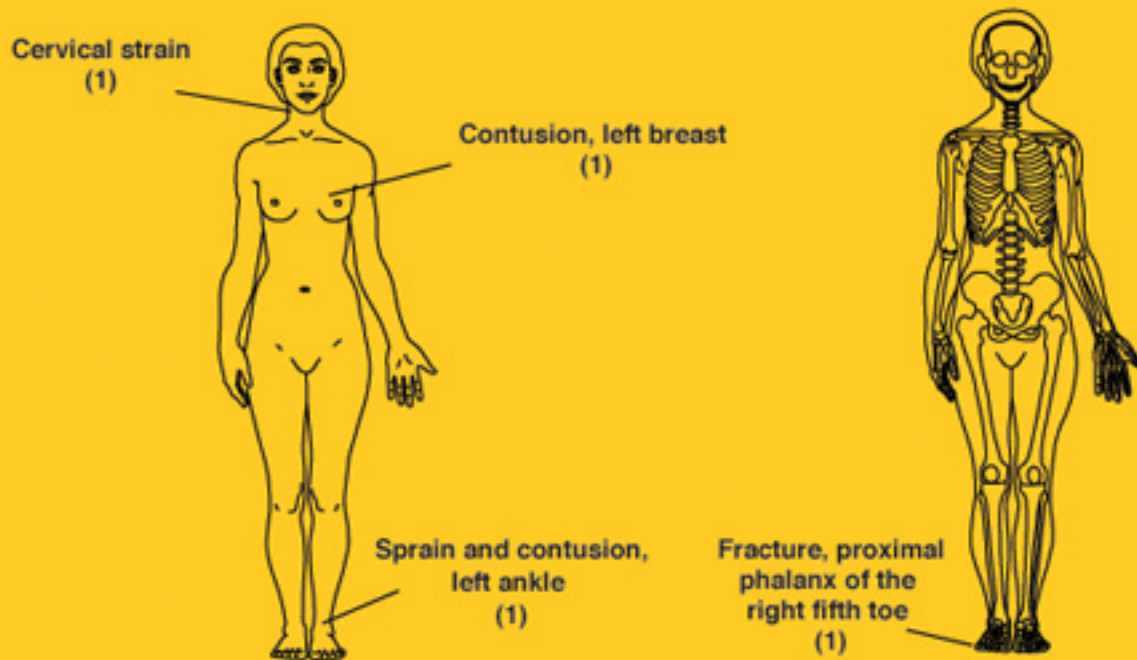
The following table and attached drawing [62](#) summarize the injuries for the driver of case vehicle (A).

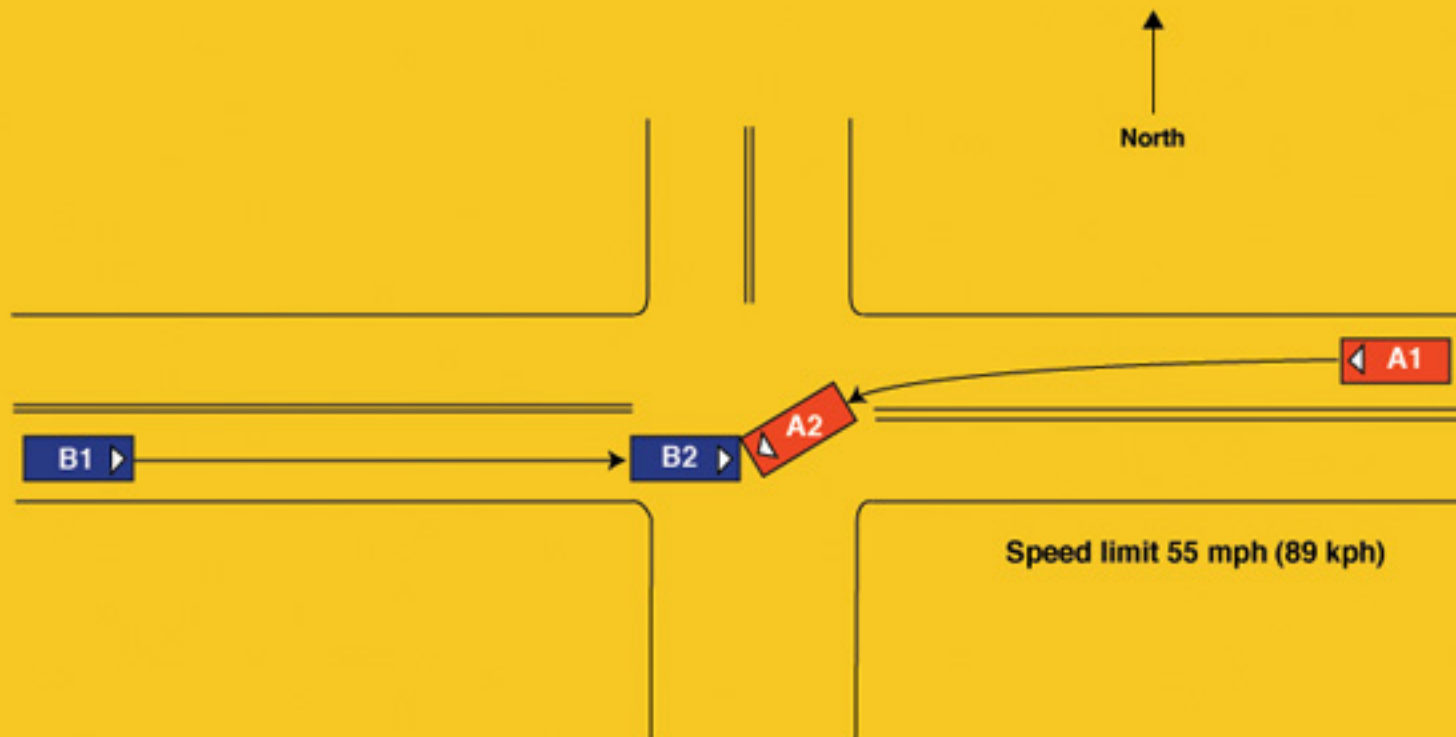
1 It was daylight and cloudy and the road surface was wet and slippery as 2 case vehicle (A) was traveling west at an unknown speed in the westbound lane of a two-lane, east-west asphalt road. 3 Vehicle (B) was traveling east at an unknown speed in the eastbound lane of the same road. 4 As both vehicles approached a four-way intersection with a north-south road, the driver of case vehicle (A) thought vehicle (B) was going to stop and 5 began to make a left turn to travel south. The driver of vehicle (B) did not take any evasive action and the left-front corner of vehicle (B) struck and overrode the right front of case vehicle (A). Both vehicles were towed due to damage.

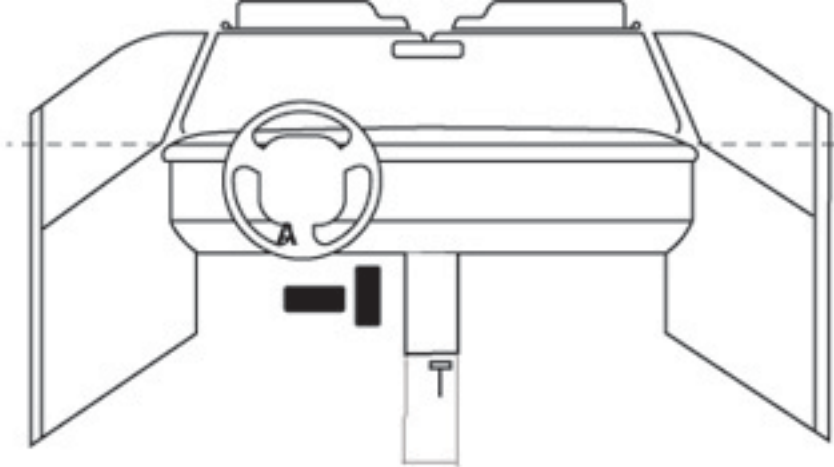
**A = knee bolster, scuffed**

Contact	Interior Component Contacted	Occupant No. if Known	Body Region if Known	Supporting Physical Evidence	Confidence Level of Contact Point
A	knee bolster	DR	LX	scuffed	1
B					
C					
D					
E					
F					
G

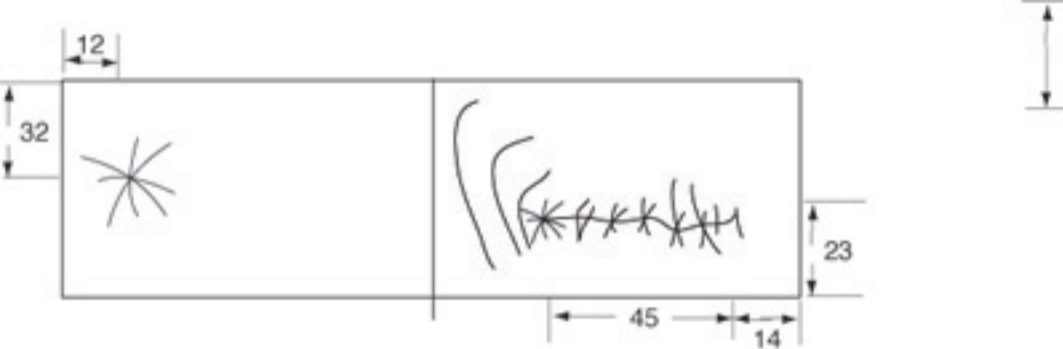
WINDSHIELD MARK ON CASE VEHICLE:

Windshield cracked on the upper left by hood contact and on the right by dash-mounted airbag flap contact

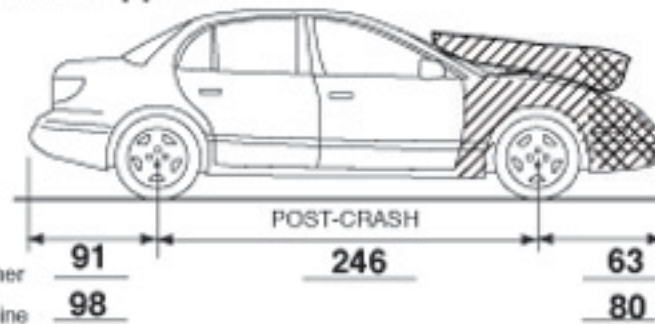
Max. crush to right bumper corner

Width of direct damage to front

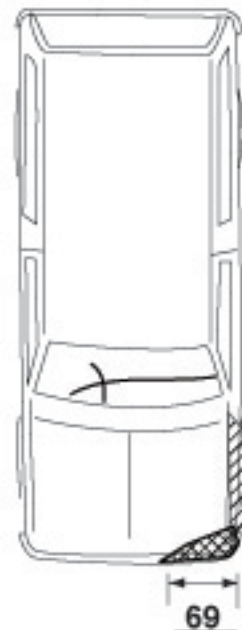
Width of direct damage to front

Max. crush to front at left bumper corner
